# INSPECTION REPORT

Pressure Vessel Survey			
<b>Location:</b>	Point Tupper	<b>EM&amp;I J Report No.:</b>	PT-D2005-090315-BR-R1
<b>Client Name:</b>		<b>Client Ref No.:</b>	PT-11573607-001-D2005
<b>Client Rep.:</b>		<b>Inspector Name:</b>	Barry Ritchie
<b>WO No.:</b>		<b>Inspection Date:</b>	March 15, 2009
<b>SPO No.:</b>		<b>System:</b>	Propane + Liquids
<b>Workscope No.:</b>	PT-2008-VESSEL-EXT-02	<b>EM&amp;I J Job No:</b>	EMJ0132.33
<b>Tag No.:</b>	D-2005	<b>Equipment Description:</b>	Depronanizer Feed Drum D-2005
<b>Date of Last Inspection:</b>	NA	<b>Previous Records Seen:</b>	NA
<b>Drawing No.:</b>	LA-B22-F-22-8005-01-Z5, 98-CA-399735-1A, 98-CA-399735-4B-0

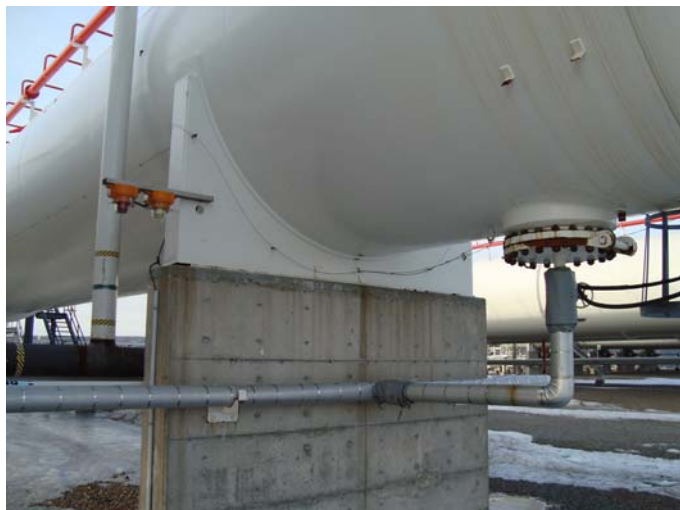
Photo 1 – North face of North vessel support, coating breakdown on flange connection to concrete, also coating breakdown on and around bolt connections for deluge continuous loop breaker

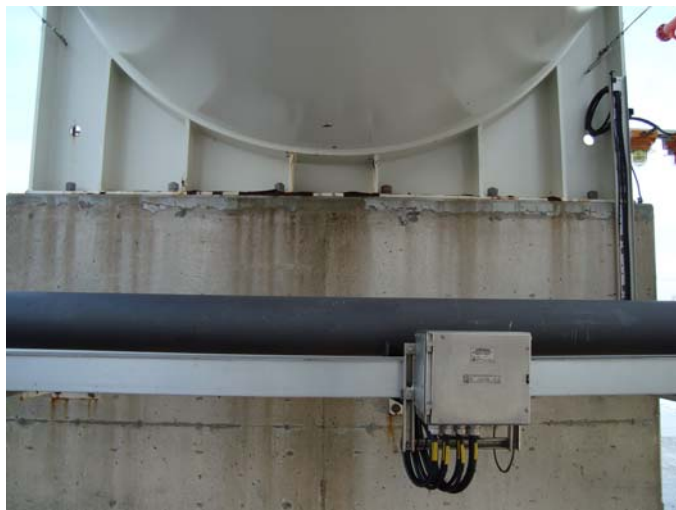
Photo 2 – South face of North vessel support, coating breakdown only on lower flange connection to concrete

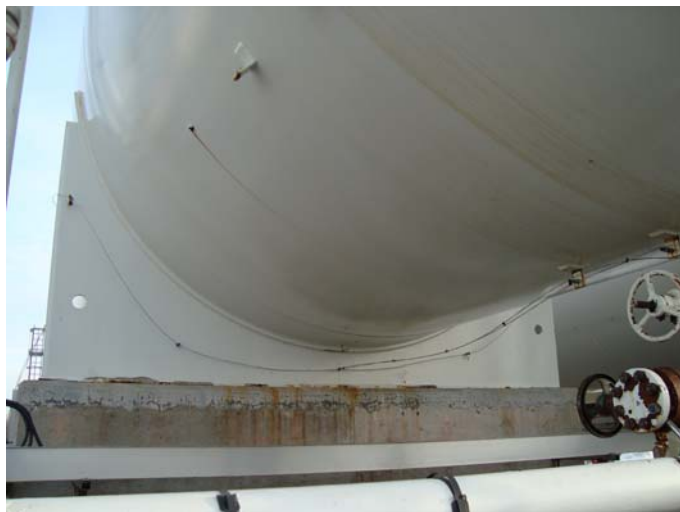
2. If applicable, check vessel supports for signs of deterioration, settlement, deflection, and/or corrosion.	<input type="checkbox"/>	<input checked="" type="checkbox"/>	<input type="checkbox"/>	<input type="checkbox"/>	Four areas of coating breakdown on bolt connections for continuous deluge break wire (see Photo #3)

Photo 3 – South face of South vessel support, in good condition. Coating breakdown only on lower flange

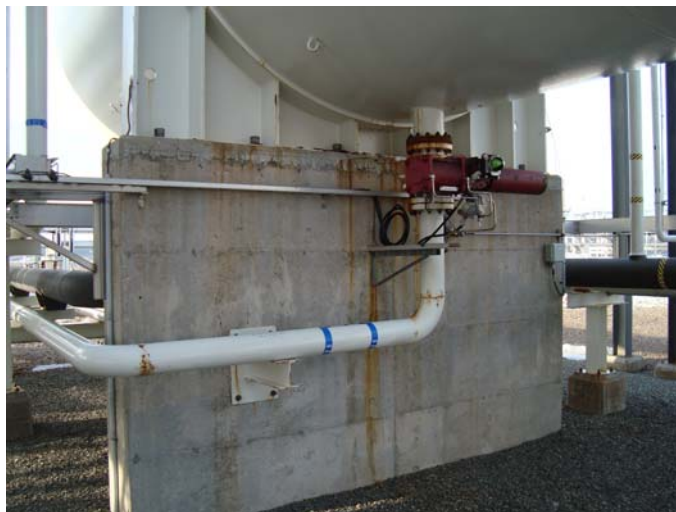
Photo 4 – North face of South vessel support, coating breakdown on lower flange and on edges of vertical stiffeners

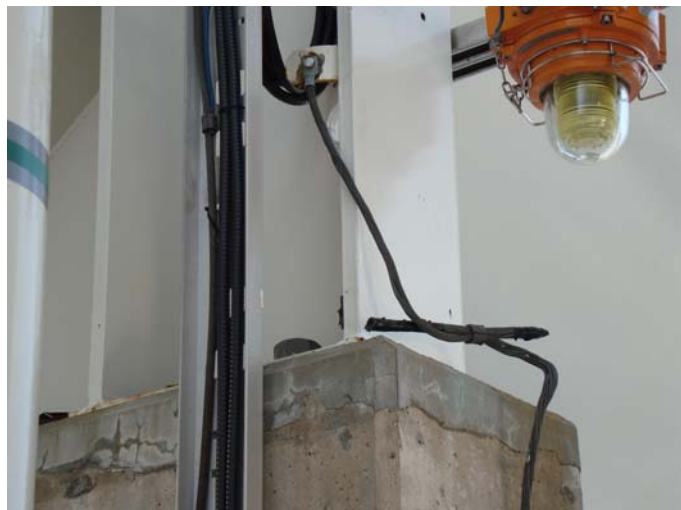
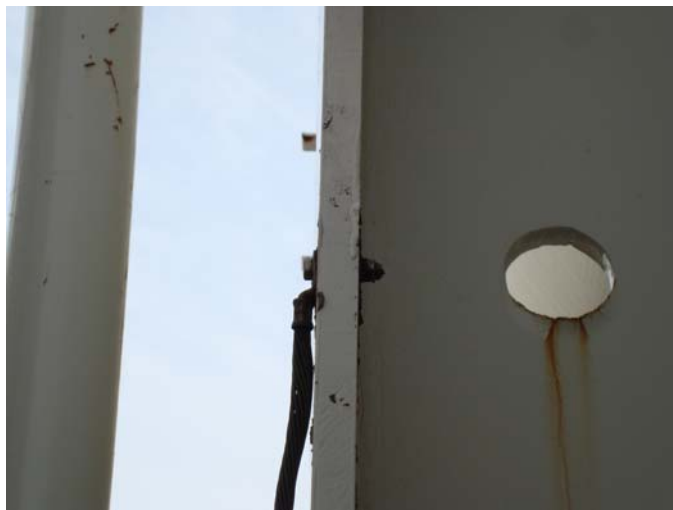
5. Check the grounding connection is correctly installed, with cable connections tight and ground wires in good condition.	<input checked="" type="checkbox"/>	<input type="checkbox"/>	<input type="checkbox"/>	<input type="checkbox"/>	See Photos #5 & 6

Photo 5 – Showing Earthing strap

Photo 6 – Showing Earthing strap

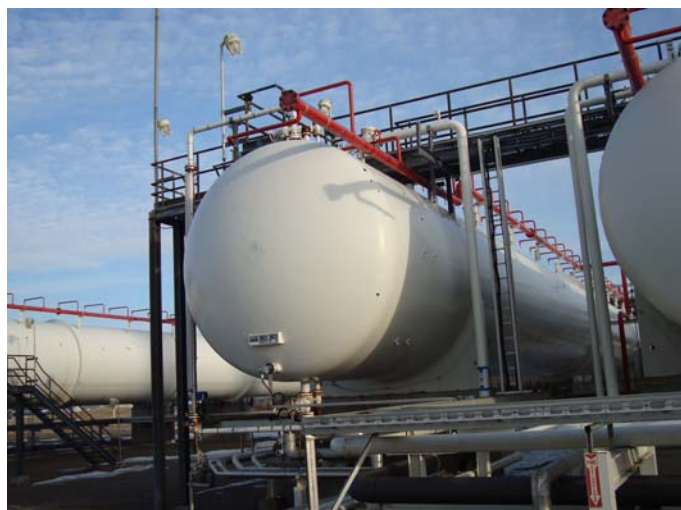
7. Carry out visual inspection of the exterior surface of the vessel, including coatings for any signs of leaks, cracks, deformation, distortion, pitting, corrosion or other forms of deterioration. If so, specify type, location and extent.	<input type="checkbox"/>	<input checked="" type="checkbox"/>	<input type="checkbox"/>	<input type="checkbox"/>	See Photos #7-14

Photo 7 – General condition of paint coating, photo of the East side shell, taken facing North. Small isolated patches of coating coating breakdown along upper section of sidewall, largest patch measuring approx 150mm x 150mm

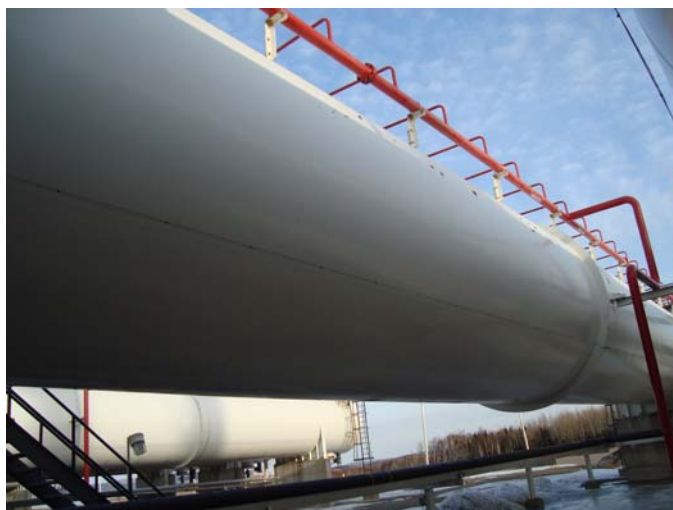
Photo 8 –General condition of paint coating, photo of the East side shell, taken facing North. Small isolated patches of coating coating breakdown along upper section of sidewall, largest patch measuring approx 150mm x 150mm

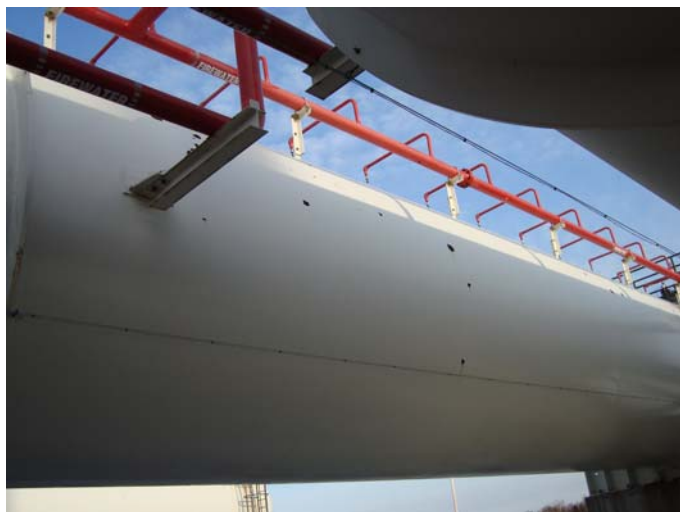
Photo 9 – General condition of paint coating, photo of the East side shell, taken facing North. Small isolated patches of coating breakdown along upper section of sidewall, largest patch measuring approx 150mm x 150mm

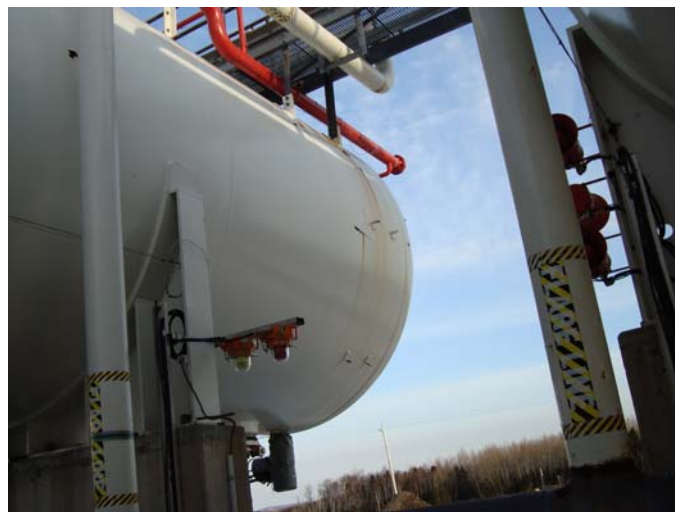
Photo 10 – General condition of paint coating, photo of the East side shell, taken facing North. Small isolated patches of coating breakdown along upper section of sidewall, largest patch measuring approx 150mm x 150mm

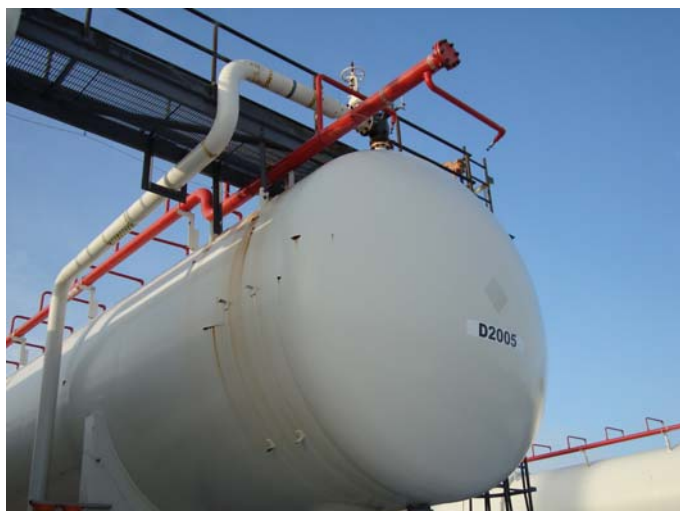
Photo 11 – North dome end, one isolated patch of coating breakdown, slight corrosion evident, and water staining coming from vessel walkway support

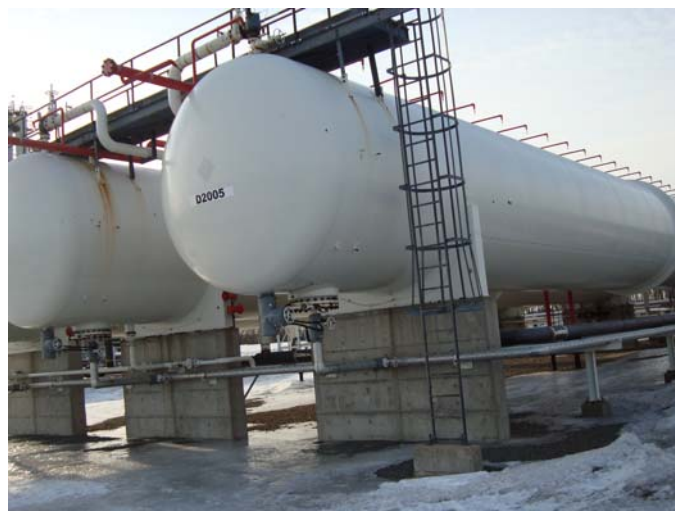
Photo 12 – West side of dome facing South, small isolated patches of coating breakdown on upper South end (see Photo 14)

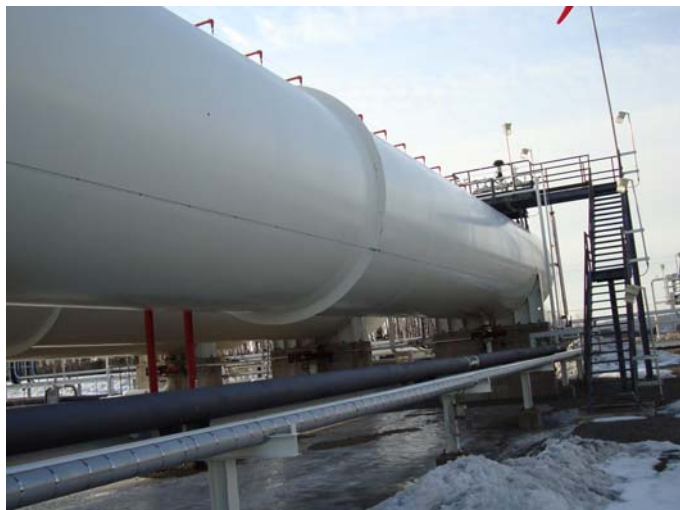
Photo 13 – West side of dome facing South, small isolated patches of coating breakdown on upper South end (see Photo 14)

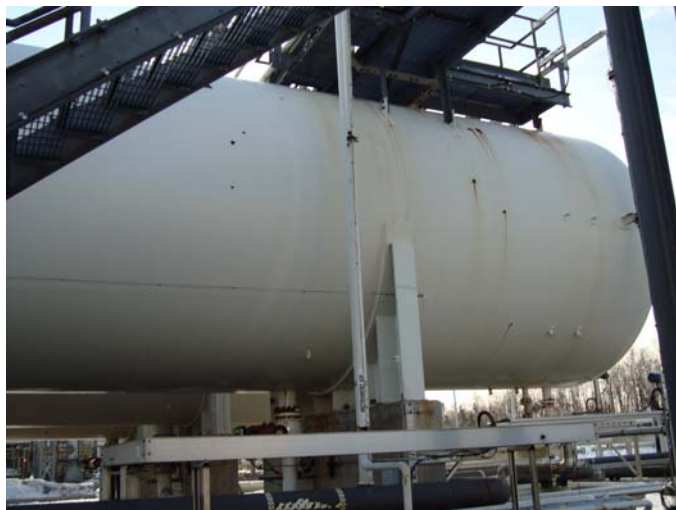
Photo 14 – West side of dome facing South, small isolated patches of coating breakdown on upper South end

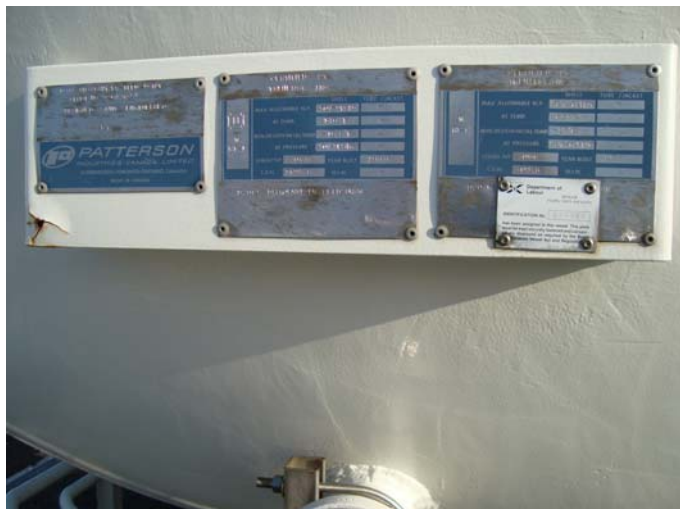
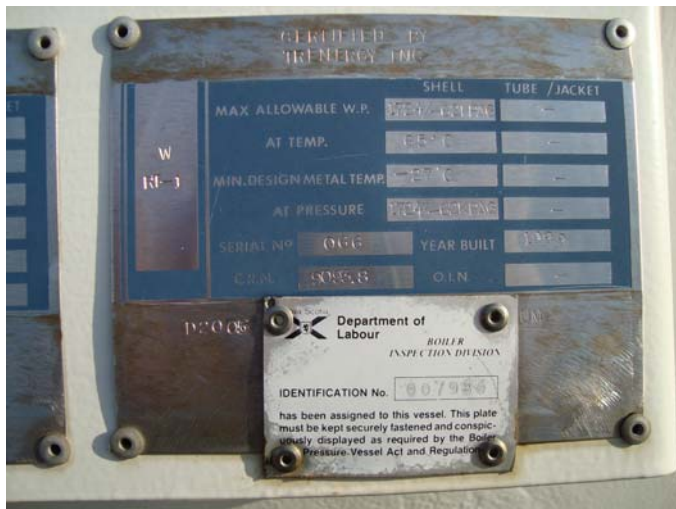
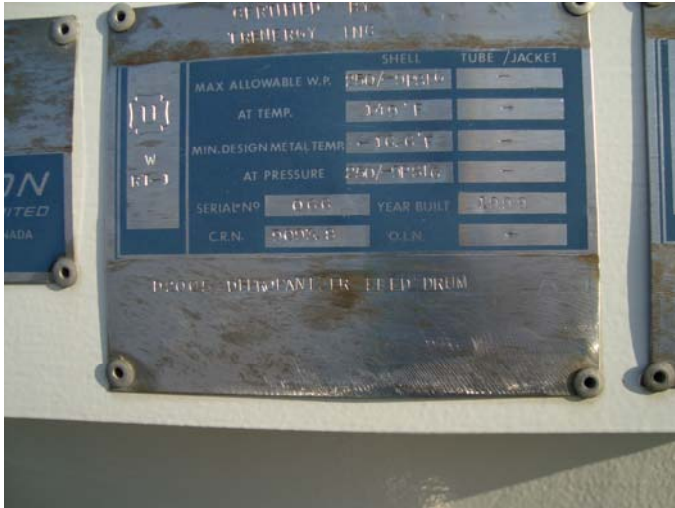
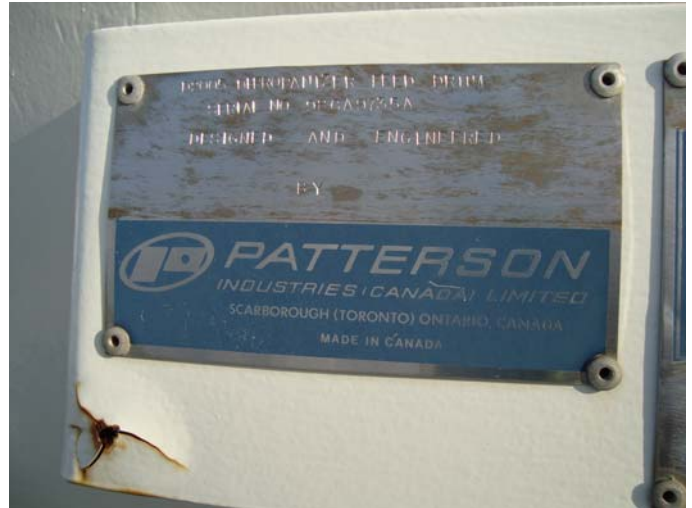
1. Check permanent identifying tags on vessel are legible and present the required information.	<input checked="" type="checkbox"/>	<input type="checkbox"/>	<input type="checkbox"/>	<input type="checkbox"/>	See Photos #15,16,17, 18

Photo 15 – Showing ID tags

Photo 16 – Showing ID tags

Photo 17 – Showing ID tags

Photo 18 – Showing ID tags

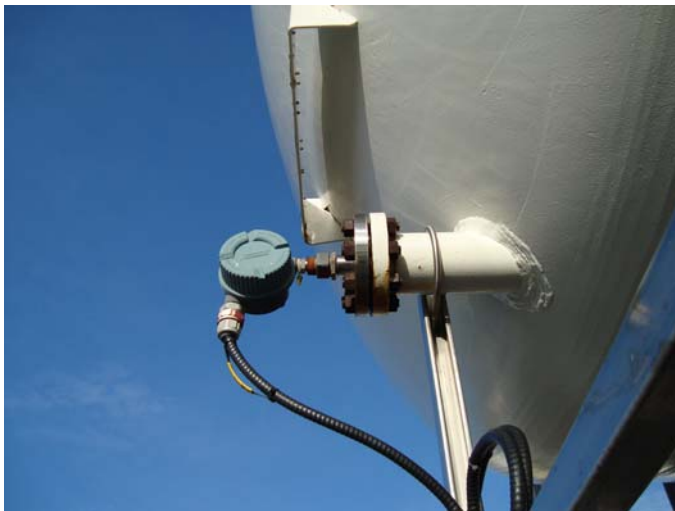
Photo 19 – Nozzle N6, generally in good condition. Stud bolts and nuts CAT III

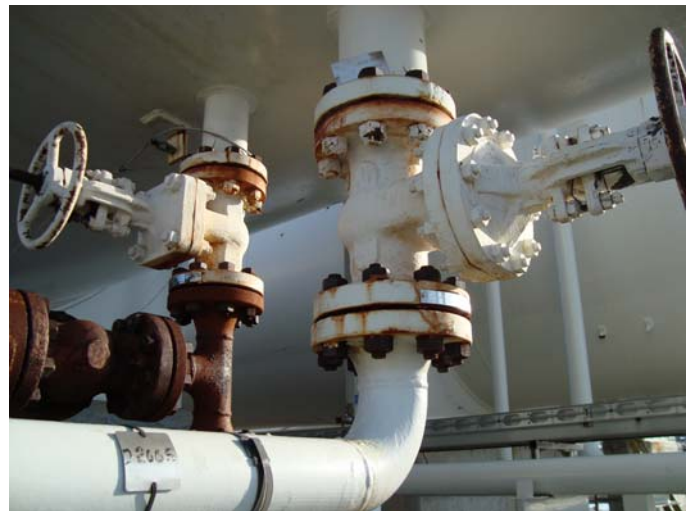
Photo 20 – Nozzles N3B &amp; N4B, coating breakdown and slight corrosion. Studs and nuts CAT III

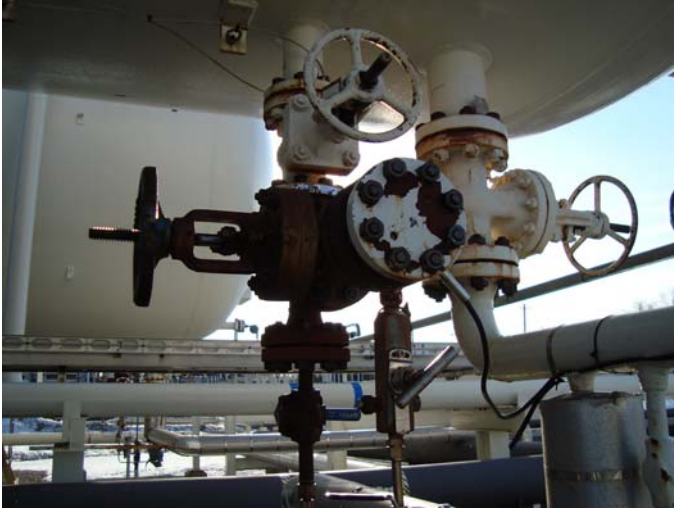
Photo 21 – Nozzles N3B & N4B, coating breakdown and slight corrosion. Studs and nuts CAT III

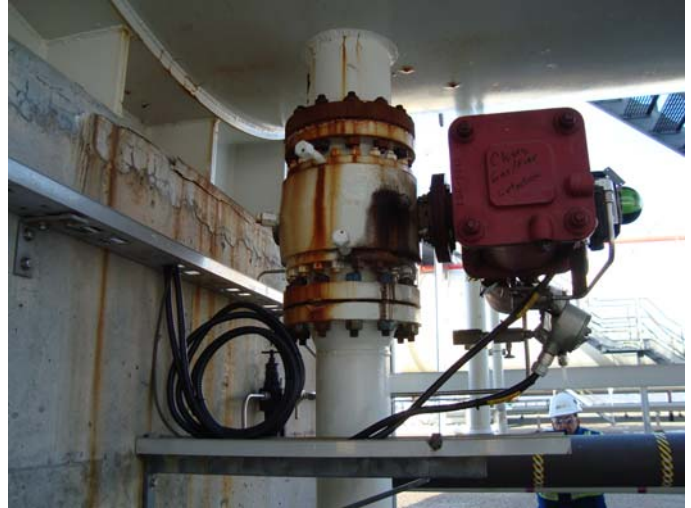
Photo 22 – Nozzle N2 with light to moderate corrosion and coating breakdown. Studs and nuts CAT III

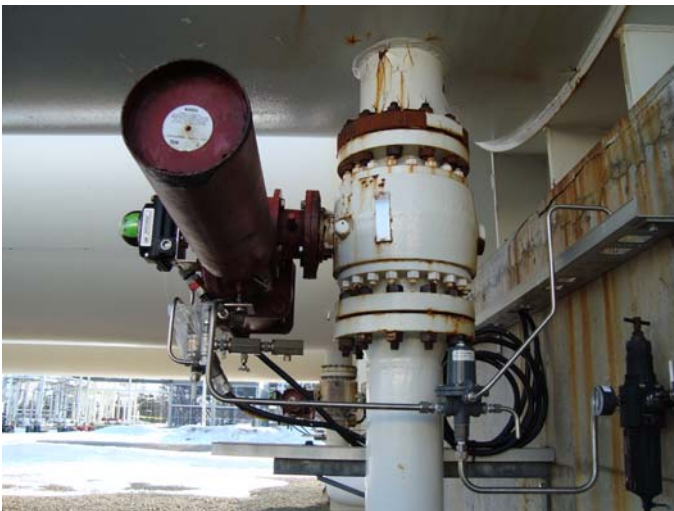
Photo 23 – Nozzle N2 with light to moderate corrosion and coating breakdown. Studs and nuts CAT III

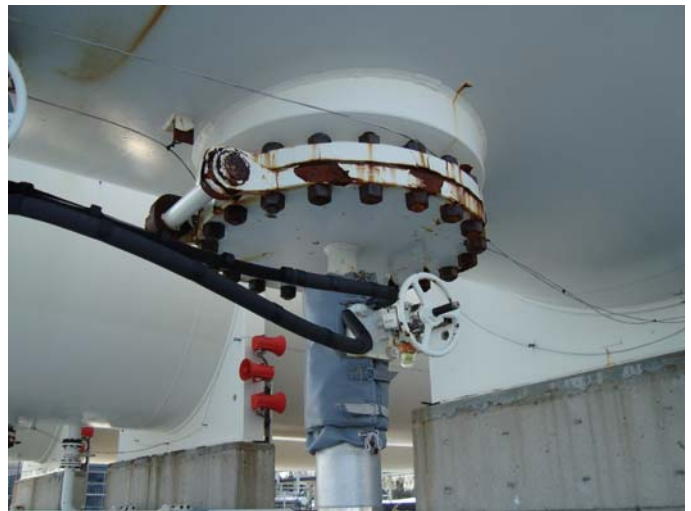
Photo 24 – Manhole, showing coating breakdown and light corrosion. Studs and nuts CAT III

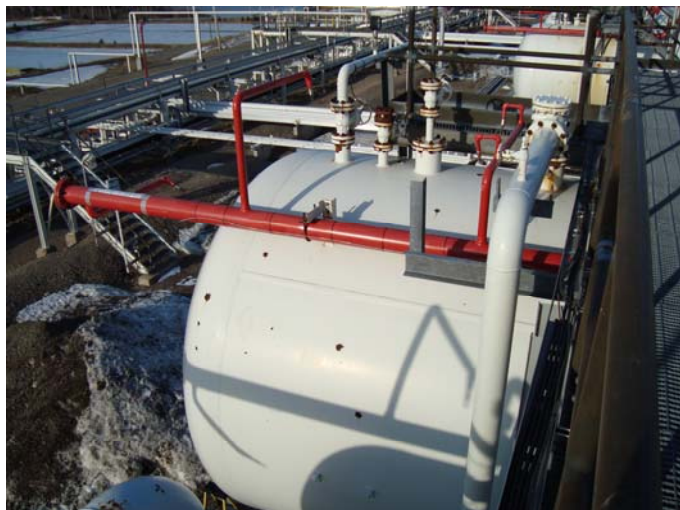
Photo 25 – Top of dome South end, with nozzles N3A, N4A, NB, & N1. Taken facing West showing isolated coating breakdown on top of dome and around nozzles with light corrosion. Studs and nuts CAT III

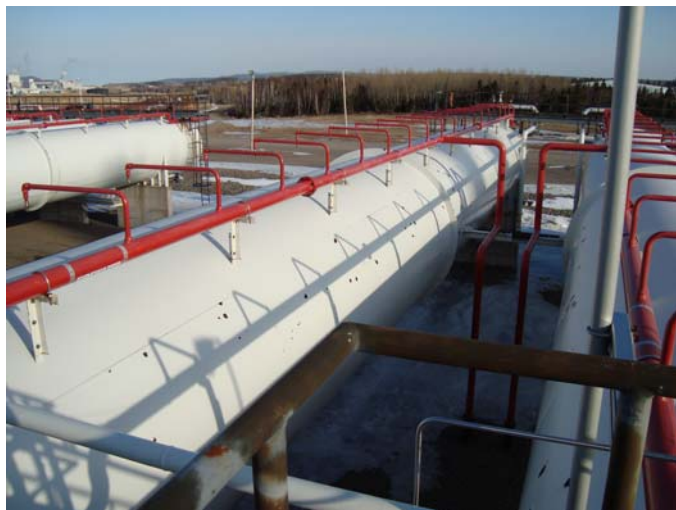
Photo 26 – West side shell, photo taken facing North, showing small isolated patches of coating breakdown

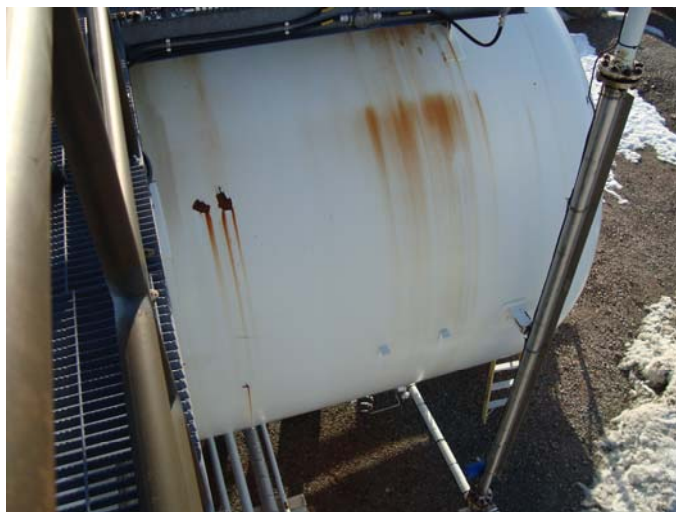
Photo 28 – West side wall next to South dome end showing discoloration of vessel and coating breakdown

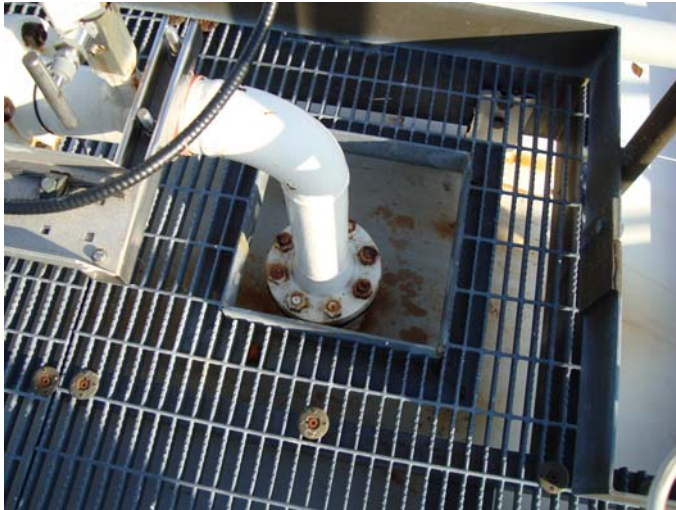
Photo 29 – Nozzle N9, slight coating breakdown, studs and nuts CAT III

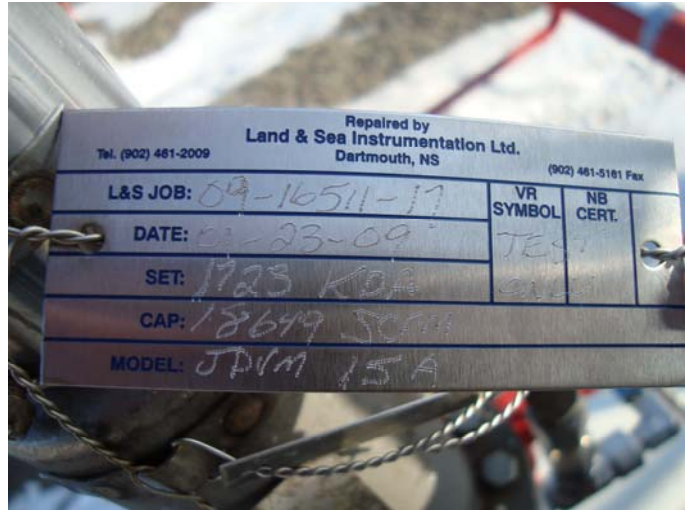
Photo 30 – PSV tag

2. If applicable, check if the PSV on the vessel is in calibration. Record tag number of PSV and calibration date.	<input checked="" type="checkbox"/>	<input type="checkbox"/>	<input type="checkbox"/>	<input type="checkbox"/>	See Photo #30

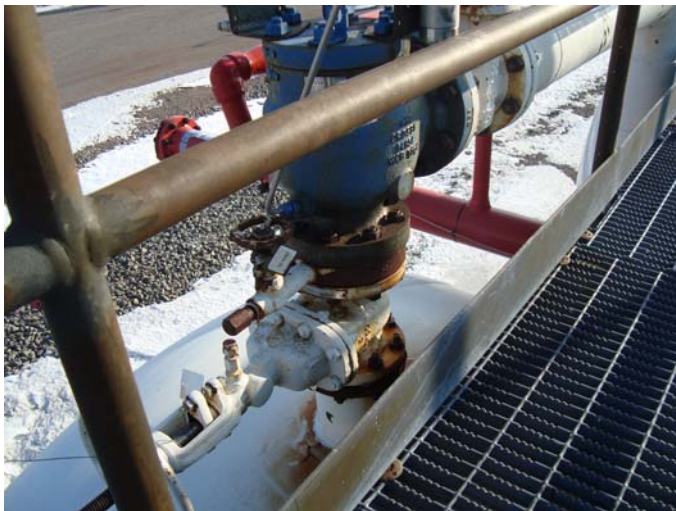
Photo 31 – Nozzle N7, slight coating breakdown, studs and nuts CAT III

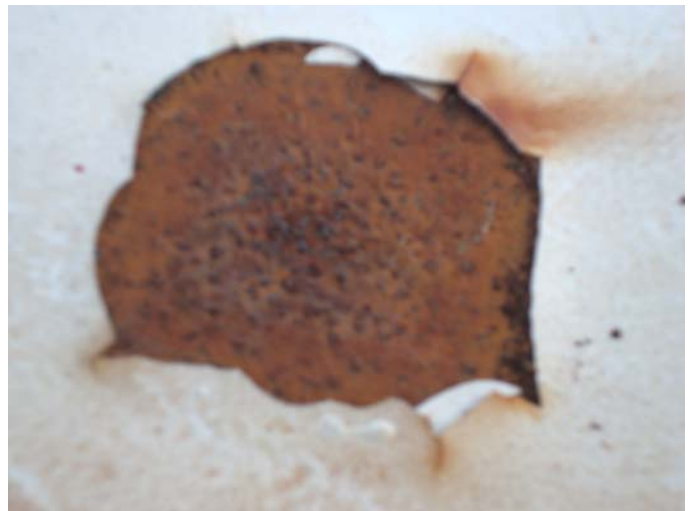
Photo 32 – Example of coating breakdown
