Р	ressure Ve	ssel Survey						
Location:	Point Tupper	EM&I J Report No.:				PT-D2005-090820-GG-R0			
Client Name:		Client Ref No.:			PT	PT-11564908-001-D2005			
Client Rep.:	Inspector Nar						aylan Green		
WO No.:		Inspection Date:				August 20, 2009			
SPO No.:			System:				Propane Plus Liquids		
Workscope No.:	PT-2009-D2005-INT-0	1	EM&I J Job N	No:			EMJ0132.43		
Tag No.:	D-2005		Equipment D				Depropanizer Feed Drum D-2005		
Date of Last Inspection:			Previous Red	cords Seen: NA

Drawing No.:	98-CA-399735-1A								
Inspection Summary									
Restriction?	☐ Yes	☑ No		Com	ments	: :			
	Item				Condition Comments			Comments	
External Ladders, Access a	and Support Structure			Good	Fair	Poor	NA

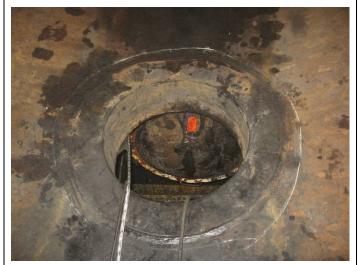
Photo 1 - Manway and manway weld seam

Photo 2 - Riser with grating

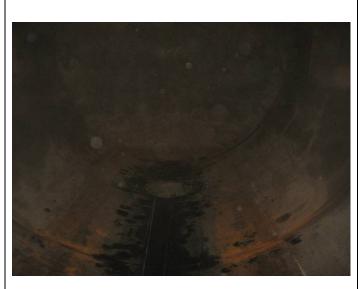
Photo 3 - Shell

Photo 4 – Typical condition of weld seams

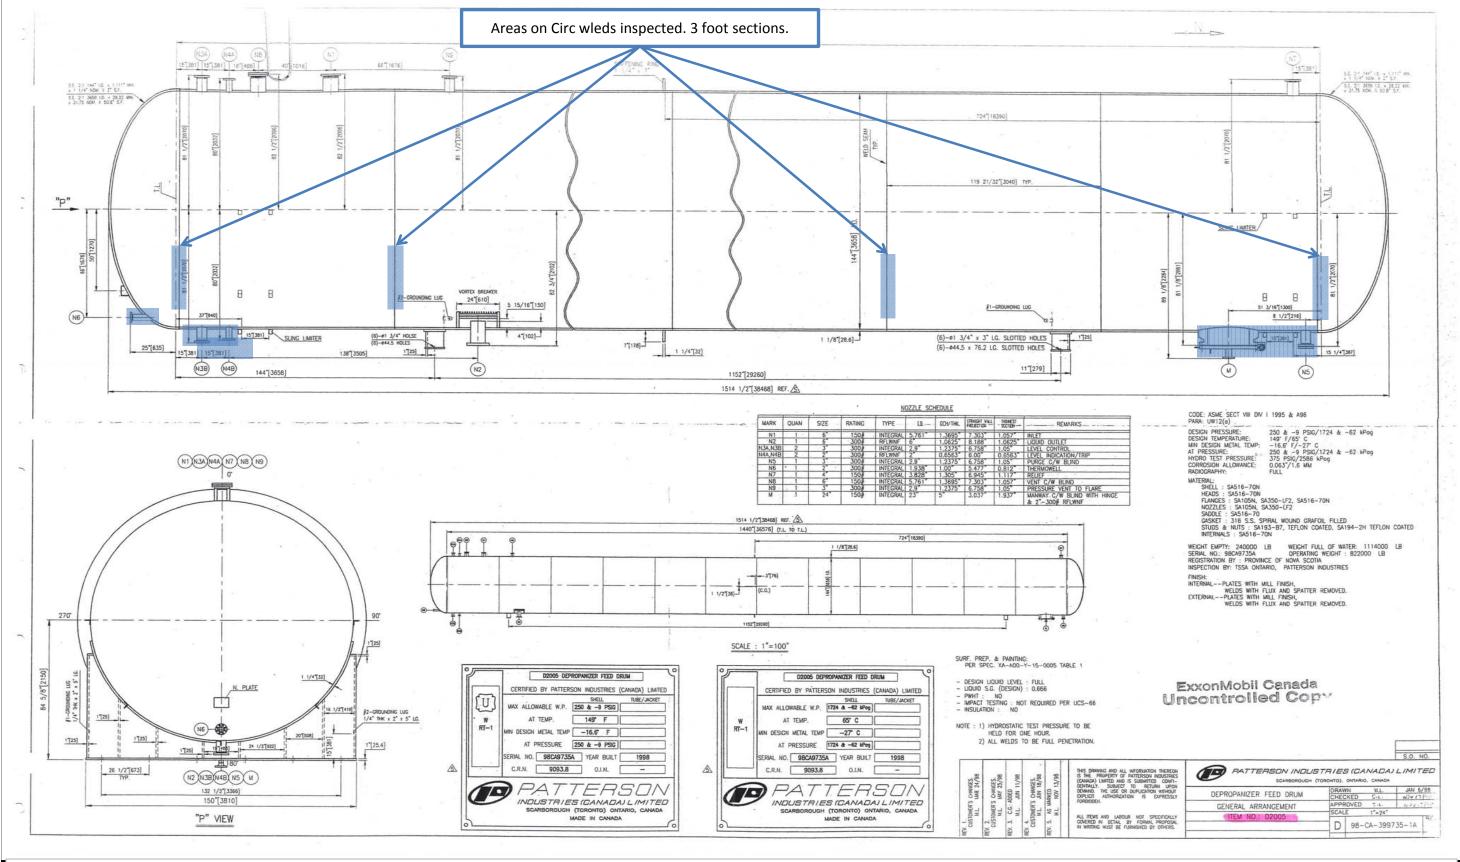
Attachment 2: MPI Locations

Inspection Summary							
Restriction?	C Yes	☑ No	Comments:				
Fluorescent magnetic partic API request items inspected All inspected areas - no disc	I - Nozzles M, N3B, N	6, 3 foot sections on					
See Attachment 2 for location	ons.	·
