INSPECTION REPORT

Pressure Vessel Survey			
Location:	Point Tupper	EM&I Report No.:	PT-D2006-090512-DM-R0
Client Name:		Client Ref No.:	PT-11564905-002-D2006
Client Rep.:		Inspector Name:	Doug MacDonald
WO No.:		Inspection Date:	May 12, 2009
SPO No.:		System:	Propane + Liquids
Workscope No.:	PT-2009-D2006-INT-01	EM&I Job No:	EMJ0132.43
Tag No.:	D2006	Equipment Description:	Off-Spec Storage Vessel D-2006
Date of Last Inspection:	NA	Previous Records Seen:	NA
Drawing No.:	LA-B22-F-22-8006-01-Z4, 98-CA-399735-1D-5

D2006 OFF-SPEC STORAGE VESSEL

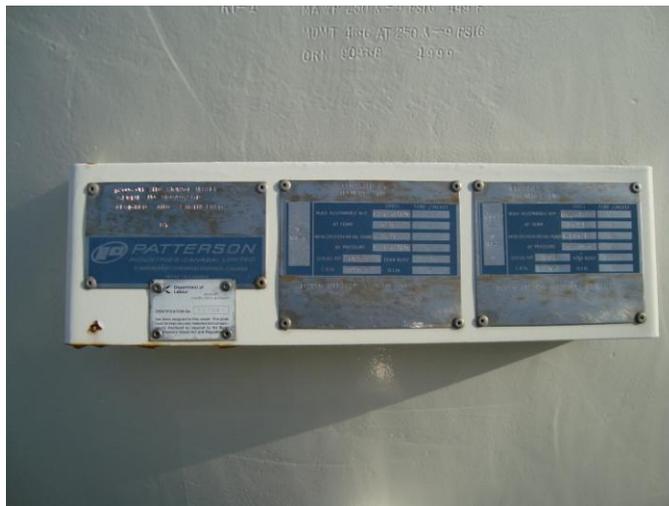
1. Check permanent identifying tags on vessel are legible and present the required information.	<input checked="" type="checkbox"/>	<input type="checkbox"/>	<input type="checkbox"/>	<input checked="" type="checkbox"/>	See Photo 2 and Note 1

Designed and Engineered by
Patterson Industries Canada Limited
Scarborough (Toronto) Ontario Canada
Made in Canada
Serial No. 986A9735D

Certified by Trenergy Inc.
Max Allowable W.P. : 1724/-62 KPag (250/-9 PSIG)
at Temp 65 C (149 F)
Min Design Metal Temp: -27 C (-16.6 F)
at Pressure: 1724/-62 KPag (250/-9 PSIG)
Serial No. 065
CRN: 9096.8
Year Built: 1999
D-2006 Offspec Storage Vessel
Department of Labour Identification No. 007981

Photo 2 – Name plate manufacturer.

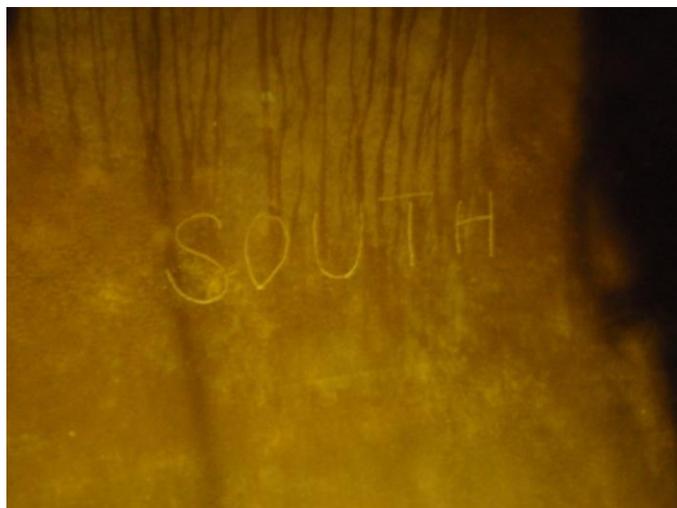
Inspection Summary					
Item	Condition				Comments
	Good	Fair	Poor	NA	
Vessel Internal Surfaces					
1. Check for signs of corrosion, erosion, cracks, blisters, pitting, distortion, or other forms of deterioration on the internal vessel surfaces. If any, specify type, location and extent.	<input checked="" type="checkbox"/>	<input type="checkbox"/>	<input type="checkbox"/>	<input type="checkbox"/>	Overall vessel interior good condition. See Note 2 and Photos 3-5.

Photo 3 – Vessel internal south head above nozzle N2

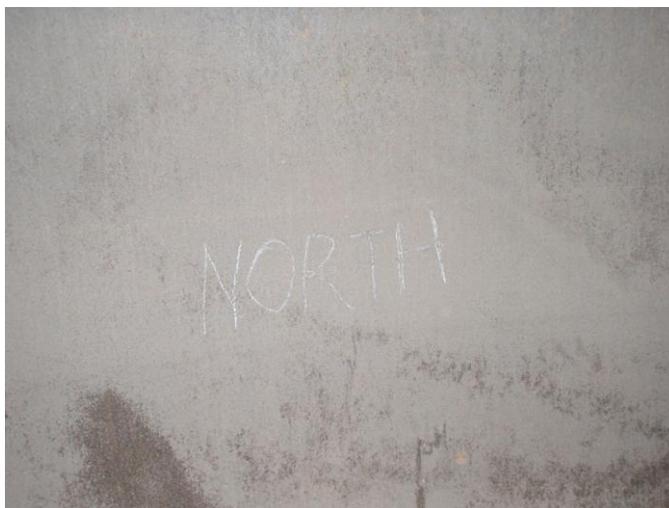
Photo 4 – Vessel internal north head adjacent to manway.

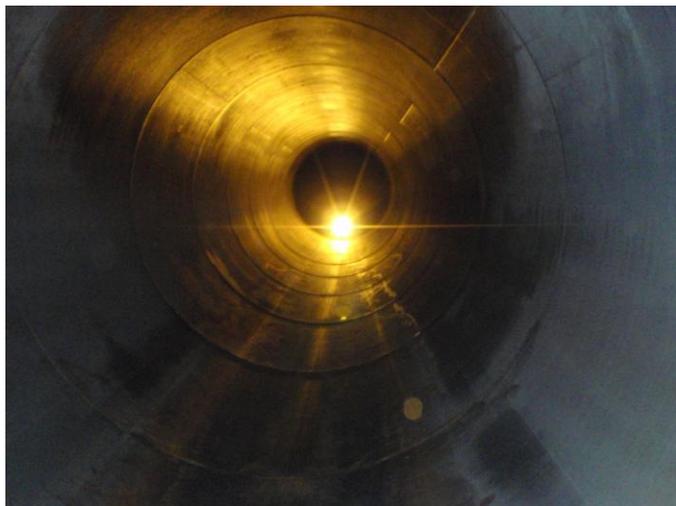
Photo 5 – Overall view internal vessel from north end manway looking south.

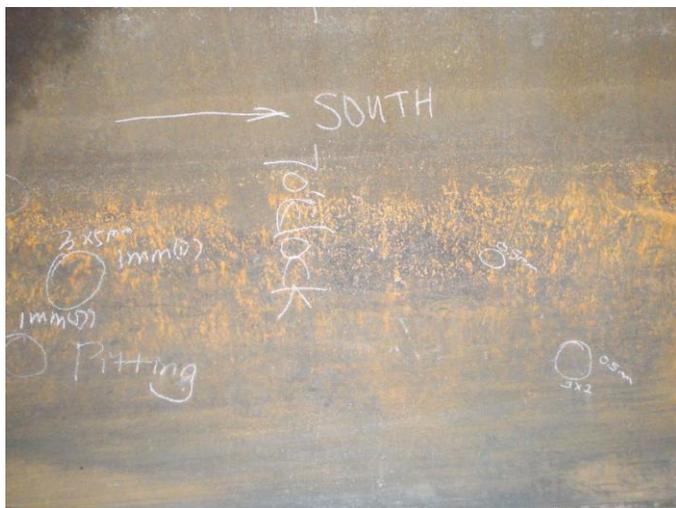
Internal surfaces of vessel generally in good condition exhibiting just light surface corrosion and mill scale. Some minor pitting was discovered in the bottom of the vessel between the 4 and 7 o'clock positions and between the 1st and 3rd circumferential weld seams north of the vortex breaker (see details in photos 7-9). All pitting was less than the specified shell corrosion allowance of 1.6 mm.

Photo 7 – Overall view of scatter pits. - 6-7 o'clock. 3x5 mm and 0.5 to 1.0mm deep.

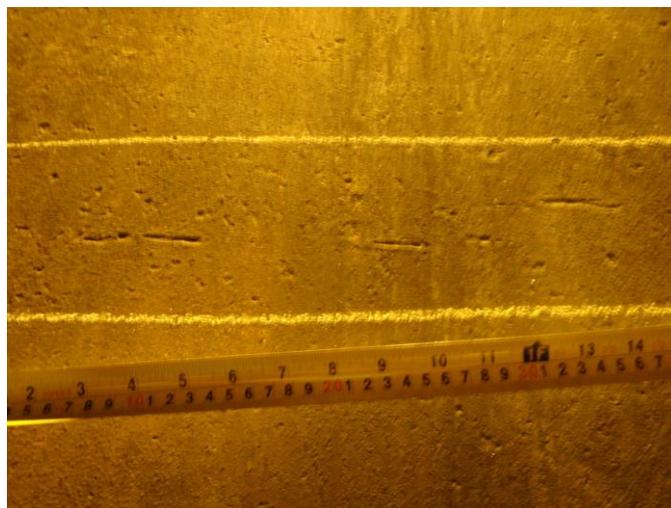
Photo 8 – Overall view of pitting at 6 o'clock with circumferential orientation.

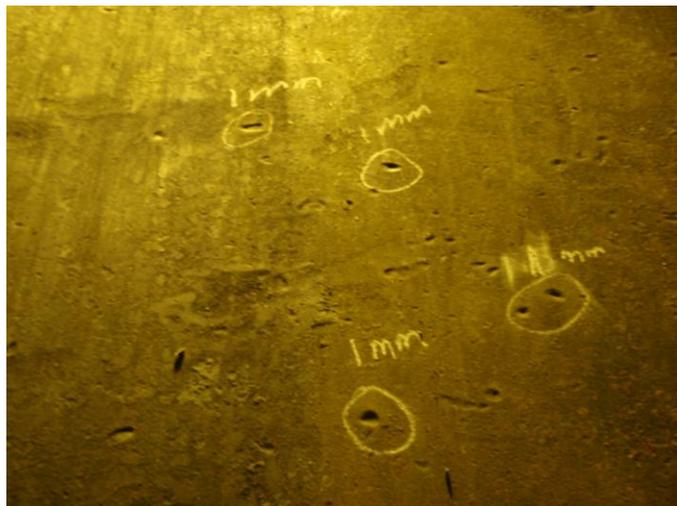
Photo 9 – Isolated pitting at 6 o'clock.

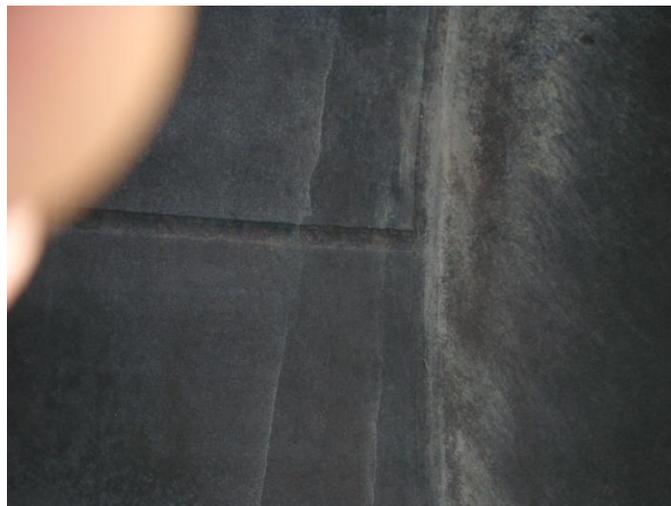
2. Check all welded joints for any signs of deterioration, corrosion, cracking, pitting or other sign of failure. Specify.	<input checked="" type="checkbox"/>	<input type="checkbox"/>	<input type="checkbox"/>	<input type="checkbox"/>	Weld seams in good condition based on CVI. MPI used to check weld seams as well. One discontinuity found in circ. weld seam. See Note 3 and attached MPI report. See also Photos 10-12.

Photo 10 – Typical weld seam. Tee intersection of longitudinal and circumferential welds.

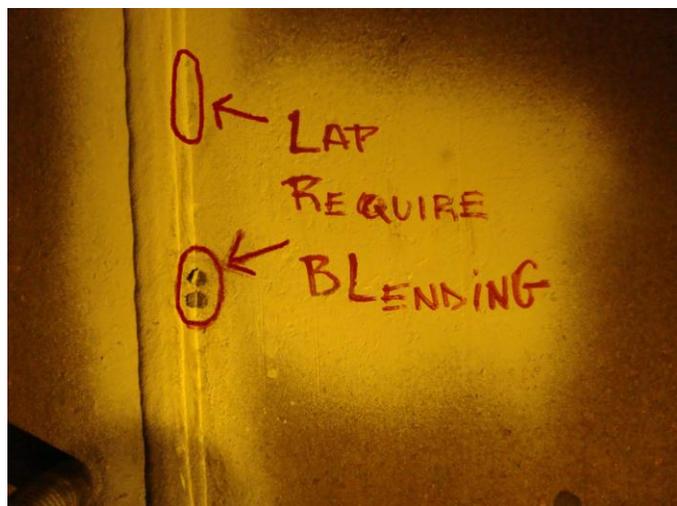
Every second circumferential weld seam was checked for discontinuities using MPI. The full seam from 3 through 9 o'clock positions was tested. Just one discontinuity was noted at the 3rd weld seam from the south head at approximately the 4 o'clock position (see Photo10). Blend grinding was subsequently used to feather out the edge of the weld and remove the discontinuity. A subsequent MPI test verified the removal of the discontinuity (see Photo 11). A UT measurement indicated the grinding did not remove more than 1mm of material, hence the wall thickness remains within the corrosion allowance. See also attached MPI report.

Photo 11 – Circumferential weld seam exhibiting discontinuity.

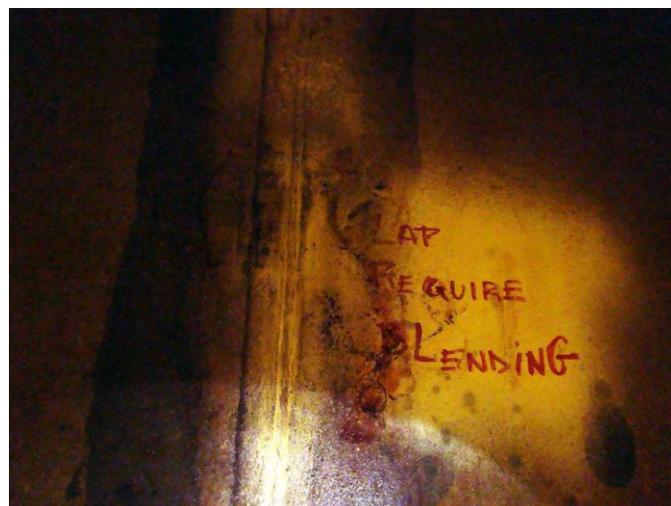
Photo 12 – Grinding was used to remove discontinuity. MPI subsequently verified soundness of weld seam.

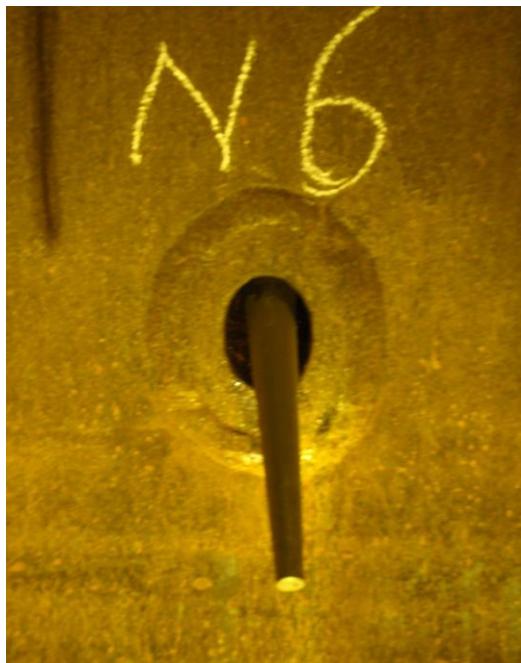
3. Check all man-ways, nozzles and connections for distortion, cracks, corrosion, wall loss and other type of defects or failures. If any defects are noted, specify type, extent and location.	<input checked="" type="checkbox"/>	<input type="checkbox"/>	<input type="checkbox"/>	<input type="checkbox"/>	Nozzles in bottom of vessels inspected via CVI. MPI also used to verify good condition and absence of discontinuity. See Photos 13-16

Photo 13 – Nozzle N6 – Thermowell south end.

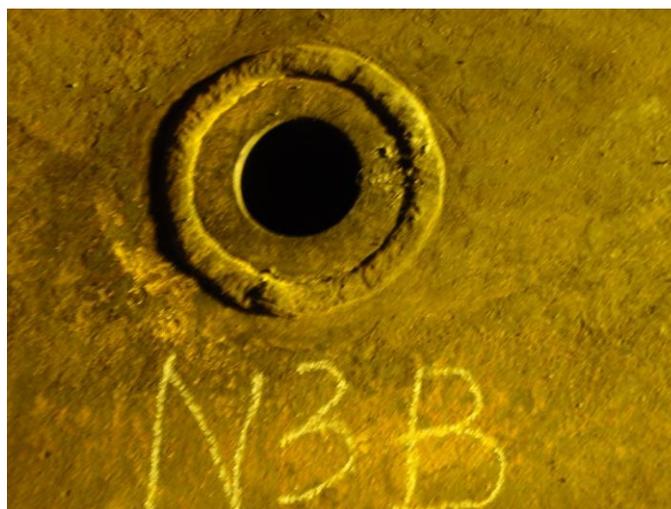
Photo 14 – Nozzle N3B (3" Level control).

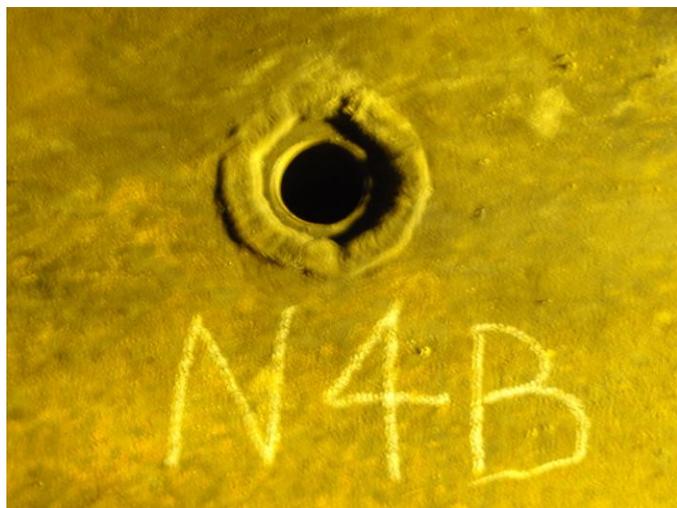
Photo 15 – Nozzle N4B (2" Level Indication).

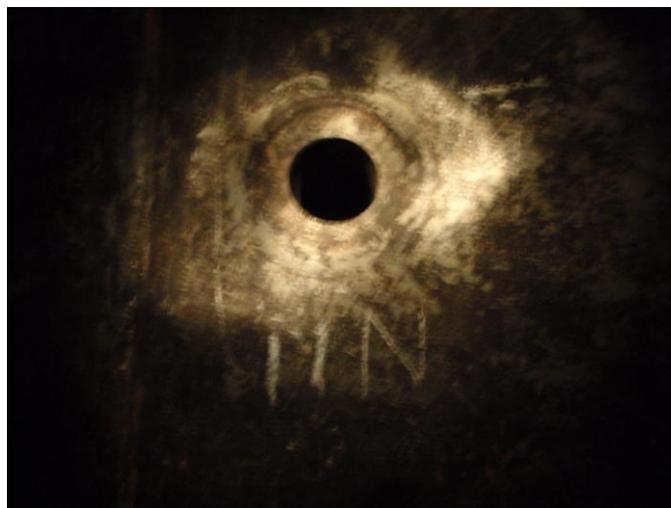
Photo 16 – Nozzle N11 (3" Purge C/W Blind).

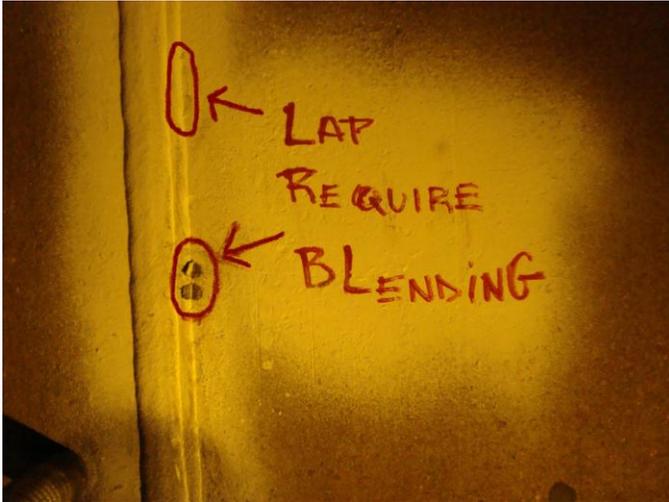
Two 1" indications were located on the 3rd seam from the south header of the vessel in about the 4 o'clock position when facing north. The two indications were located at the edge of the weld head. They appeared to be a "surface non-fusion" discontinuity related to either a cold lap or a bit of weld metal spatter. These indications were repaired by blending with a grinder as an inspection of these areas post grinding revealed no such indications. This repaired did not exceed the corrosion allowance. A measurement of this area confirmed a wall loss of 1mm.

Photo 1 – Two indications circled in red (pre-repair).

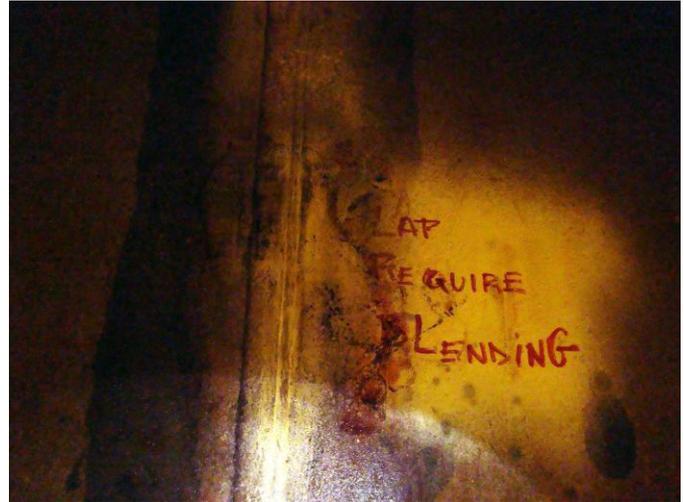
Photo 2 – No indications post-repair.
