INSPECTION REPORT

Pressure Vessel Survey			
Location:	Point Tupper	EM&I J Report No.:	PT-D-2100A-090305-DL-R0
Client Name:		Client Ref No.:	PT-11573612-001-D2100A
Client Rep.:		Inspector Name:	Daniel Lewis
WO No.:		Inspection Date:	May 03, 2009
SPO No.:		System:	Propane
Workscope No.:	PT-2008-VESSEL-EXT-03	EM&I J Job No:	EMJ0132.33
Tag No.:	D-2100A	Equipment Description:	Propane Storage Vessel D-2100A
Date of Last Inspection:	NA	Previous Records Seen:	NA
Drawing No.:	LA-B23-F-22-8050-01-Z5, 98-CA-399735B

Item Name: **PROPANE STORAGE VESSELS** Item No.: **D2100A/B/C**

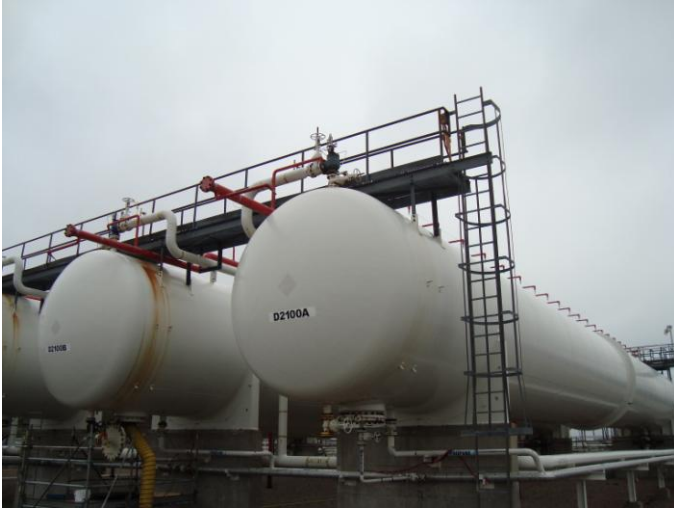
Inspection Summary					
Item	Condition				Comments
External Ladders, Access and Support Structure	Good	Fair	Poor	NA	
1. If applicable, check ladders, stairways, platforms and walkways that are connected to, or bearing on the vessel for signs of corrosion, missing components, or deterioration.	<input type="checkbox"/>	<input checked="" type="checkbox"/>	<input type="checkbox"/>	<input type="checkbox"/>	Supports for accessway allow a lot of movement. This could possibly be placing stress on the re-enforcement plates

Photo 1 – View of North end of vessel showing access platform

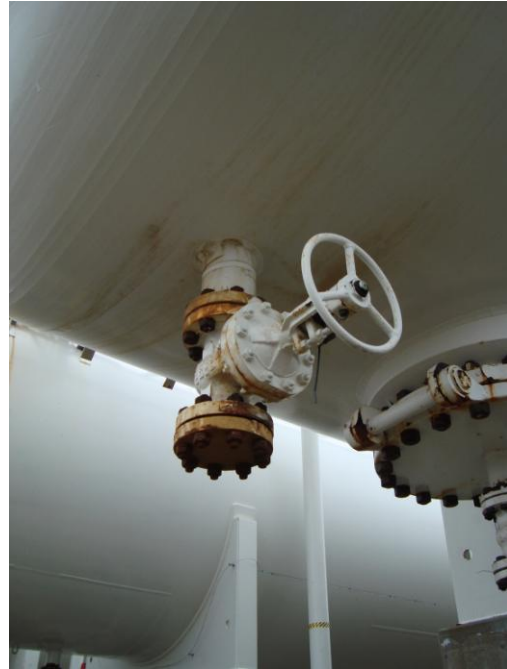
Photo 2 – (N10) Studs and nuts CAT II, 20% coating breakdown with surface corrosion on flange

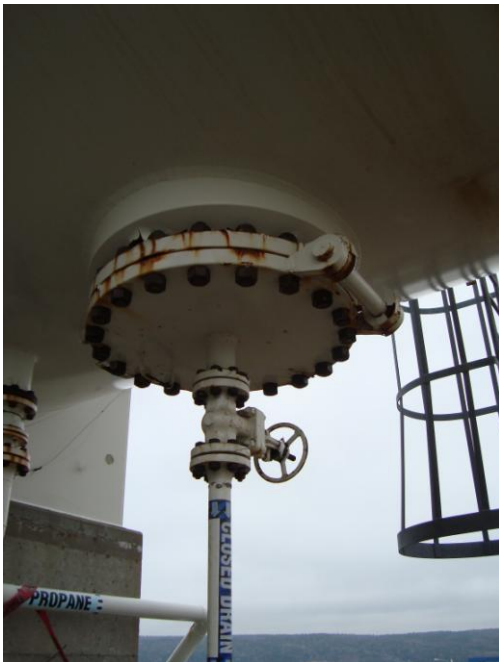
Photo 3 – (M) Studs and nuts CAT II, 20% coating breakdown with surface corrosion on flange

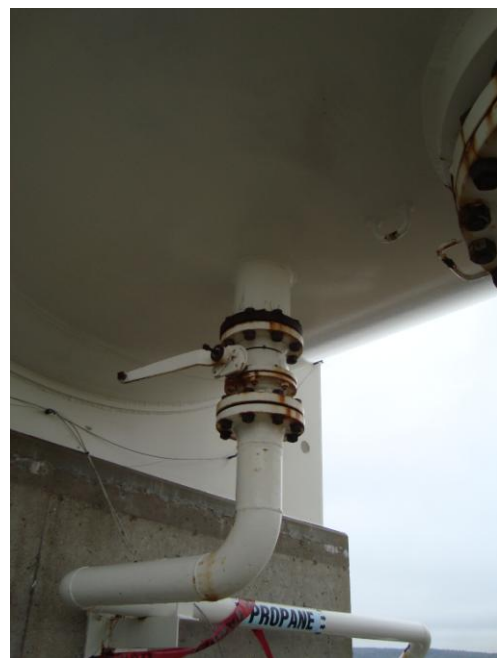
Photo 4 – (N5) Studs and nuts CAT II, 100% coating breakdown with surface corrosion on flange

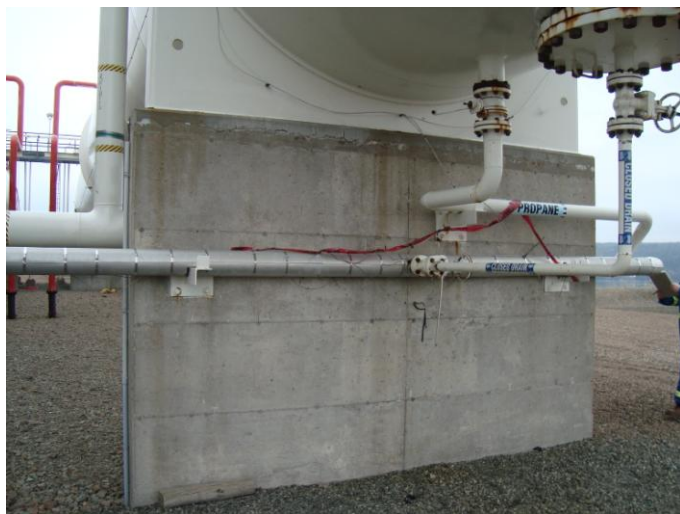
2. If applicable, check vessel supports for signs of deterioration, settlement, deflection, and/or corrosion.	<input checked="" type="checkbox"/>	<input type="checkbox"/>	<input type="checkbox"/>	<input type="checkbox"/>	Vessel supports are in good condition. Small cracks at the top of the concrete legs

Photo 5 – General view of vessel support leg

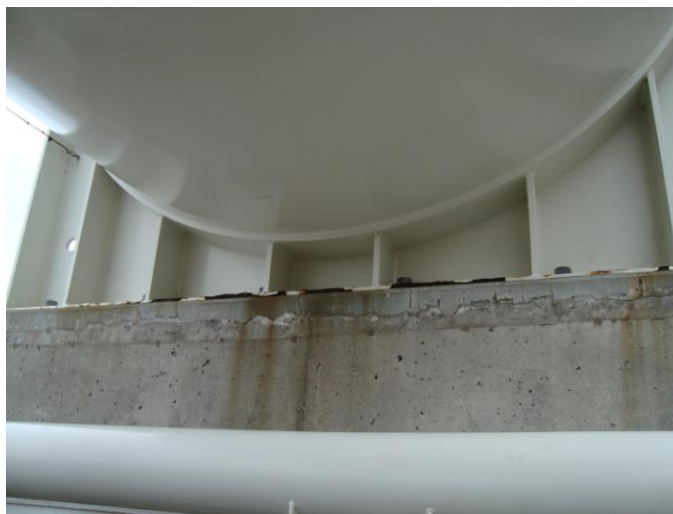
Photo 6 – Coating breakdown with surface corrosion occurring at foot of saddle support leg. This appears to be common of all propane storage vessels in this location

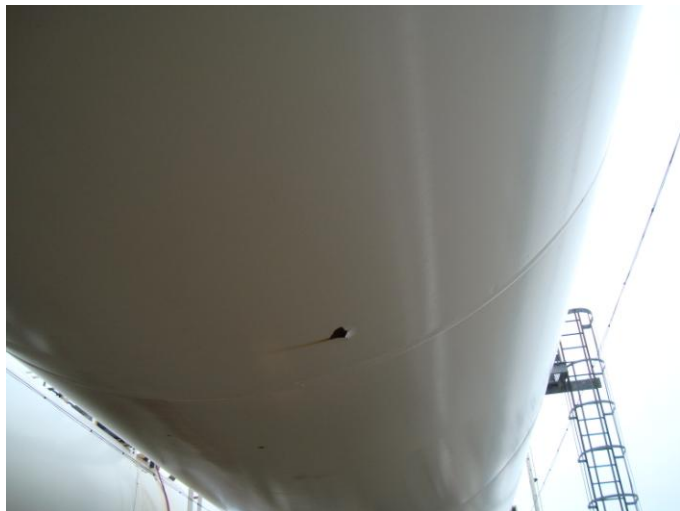
Inspection Summary					
Item	Condition				Comments
					Small isolated areas of coating breakdown occurring over the vessel shell (see Photos #7 & 11)
8. If applicable, check weep holes in reinforcement plates are not plugged.	<input checked="" type="checkbox"/>	<input type="checkbox"/>	<input type="checkbox"/>	<input type="checkbox"/>	
External Piping / Instrument Attachments	Good	Fair	Poor	NA

Photo 7 – Isolated area of coating breakdown with surface corrosion on shell of vessel. Does not appear to be any significant material loss

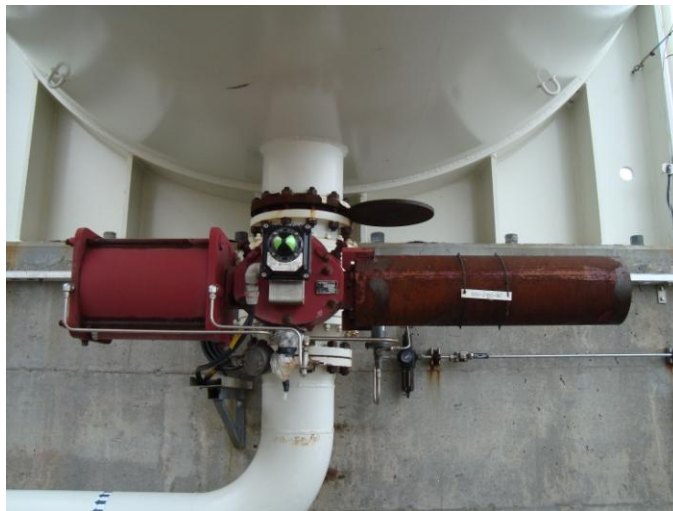
Photo 8 – (SDV2100) 50% coating breakdown with surface corrosion of valve. 90% coating breakdown with surface corrosion on flange of N2. Studs and nuts CAT II

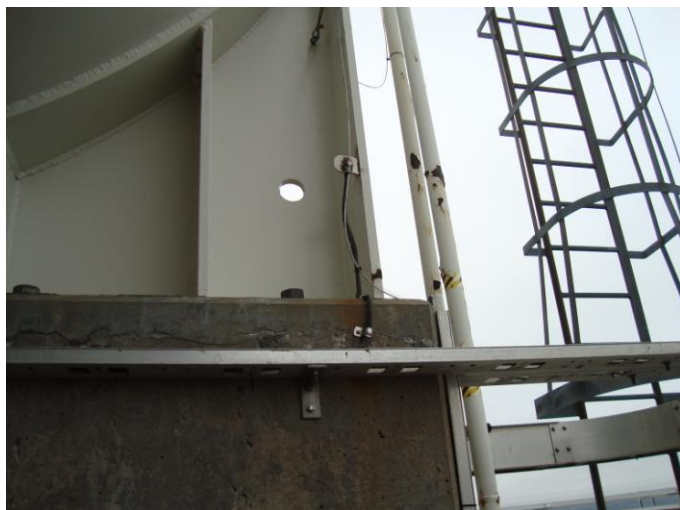
Photo 9 – Grounding cable installed and in good condition

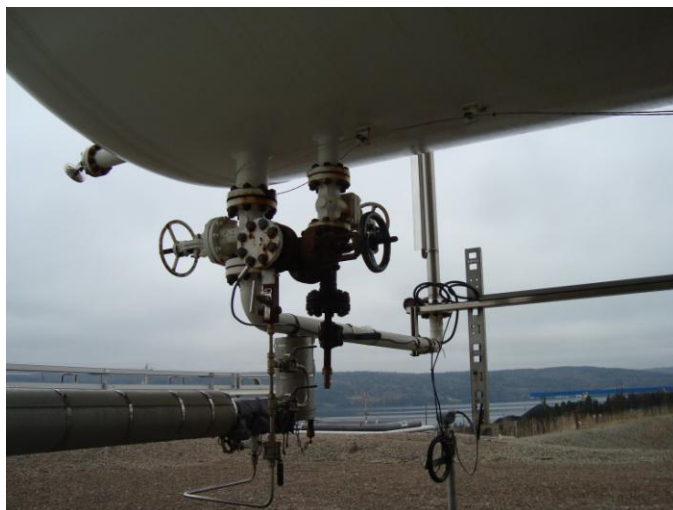
1. If applicable, check vessel trim, such as gauges, sight glasses, valves and other appurtenances, show signs of deterioration, or missing components, etc.	<input type="checkbox"/>	<input checked="" type="checkbox"/>	<input checked="" type="checkbox"/>	<input type="checkbox"/>	The vessel level gauge is Stainless Steel. This is connected to a Carbon Steel flange. The gauges on this vessel are in good condition. There is 50% coating breakdown with surface corrosion occurring on the SDV of this vessel. The trim attached to N4B has 100% coating breakdown and light surface corrosion

Photo 10 – (N3B, N4B) Trim attached to N4B has 100% coating breakdown with surface corrosion. 60% coating breakdown with surface corrosion on flanges, studs and nuts CAT II

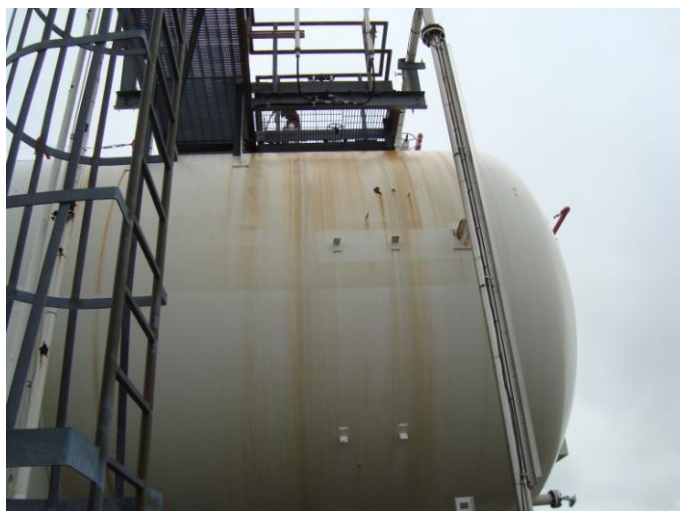
Photo 11 – View of South-West end of vessel. Isolated areas of coating breakdown with surface corrosion. There does not appear to be any significant material loss

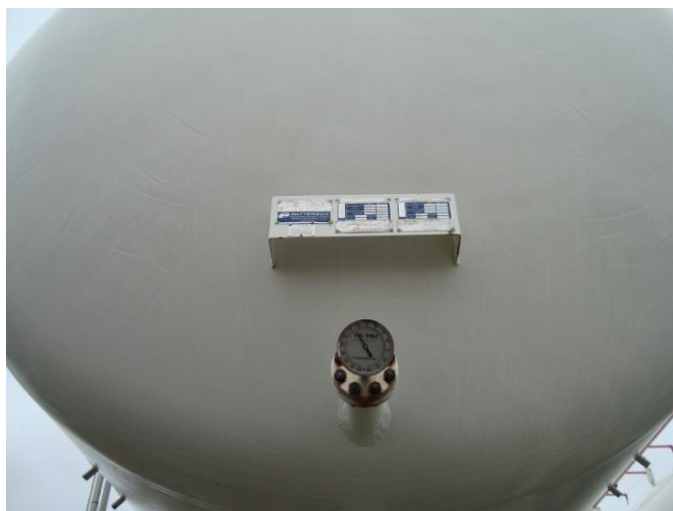
Photo 12 – (N6) Note: Use of dissimilar metals. Gauge in good condition, studs and nuts CAT II. Note: Grind marks/scores on dome end of vessel

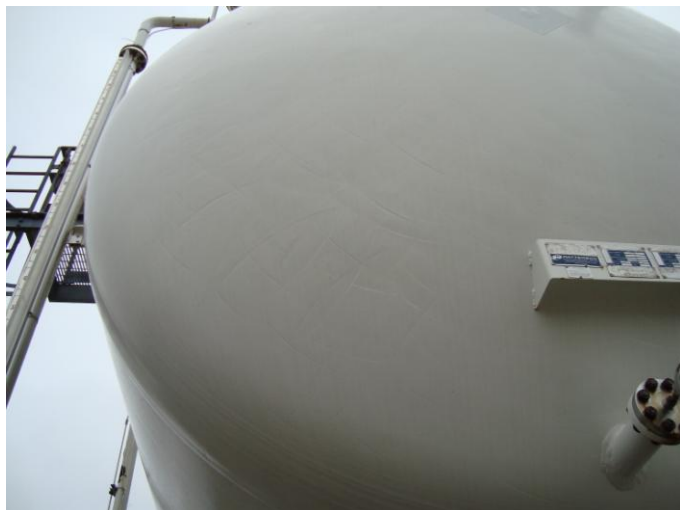
Photo 13 – Note: Grind marks/scores on dome end of vessel

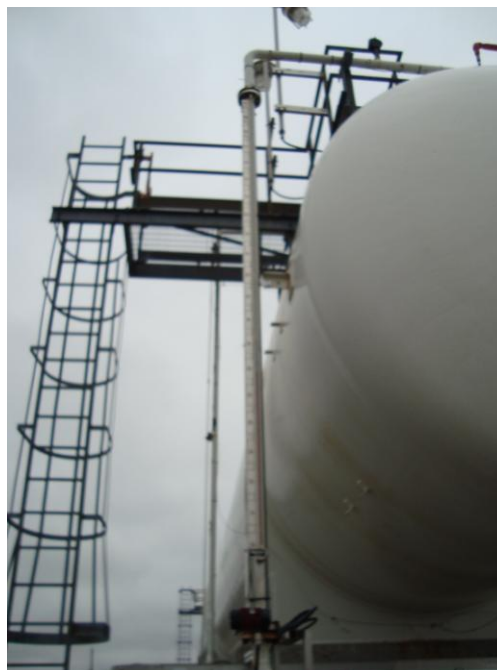
Photo 14 – Vessel level gauge in good condition, Dissimilar metals, studs and nuts CAT II

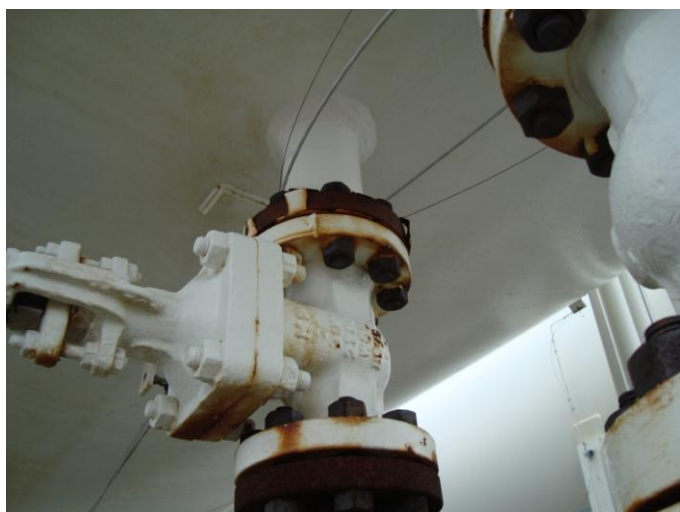
Photo 15 – (N4B) 60% coating breakdown with surface corrosion on flange. Studs and nuts CAT II

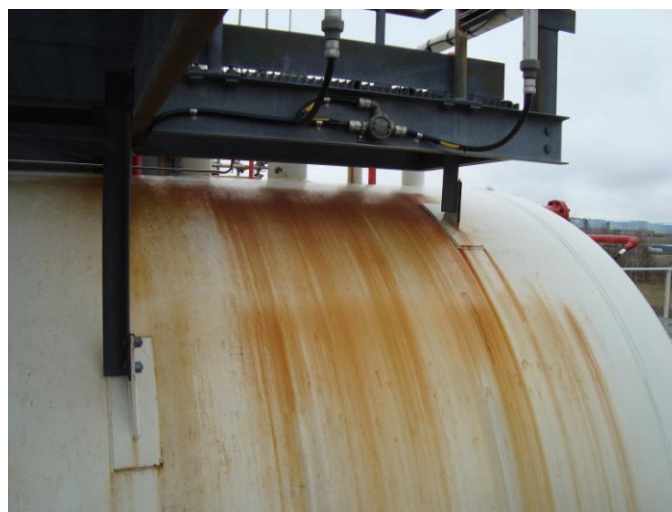
3. If applicable, check coatings for signs of deterioration, rusts spots, cracks, blistering, and/or coating disbondment.	<input checked="" type="checkbox"/>	<input type="checkbox"/>	<input type="checkbox"/>	<input type="checkbox"/>	Small areas of coating breakdown. The access way appears to be the source of some of the rust staining on the vessel ends

Photo 16 – Rust staining on vessel. Appears to be stemming from light rusting occurring on access way

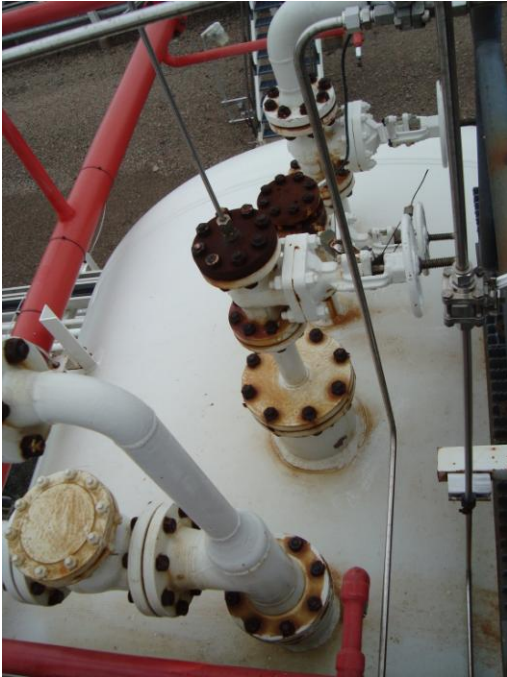
Photo 17 – (N1, N8, N4A, N3A) Studs and nuts CAT II. 100% coating breakdown with surface corrosion of blank flanges. Small amount of coating breakdown with surface corrosion occurring on nozzles

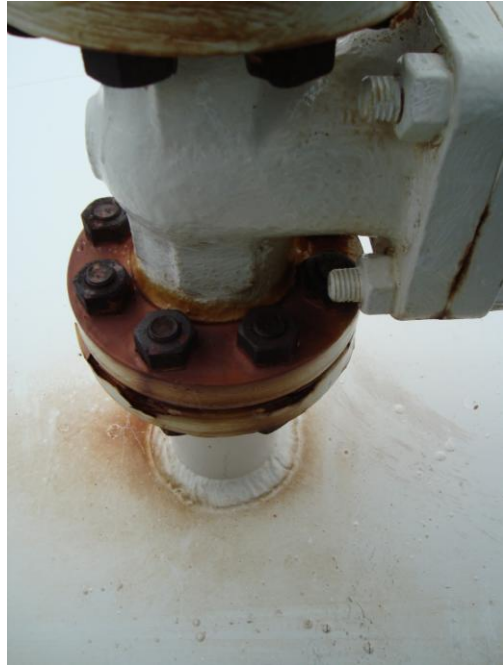
Photo 18 – (N9) Studs and nuts CAT II. 60% coating breakdown with surface corrosion occurring on flanges

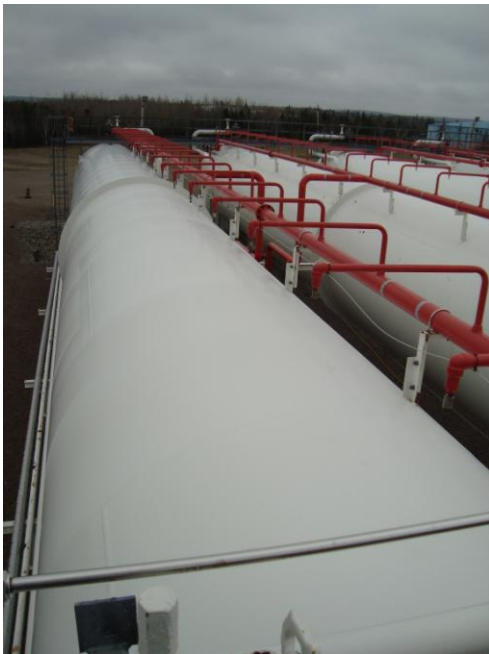
Photo 19 – General view of top of vessel, in good condition

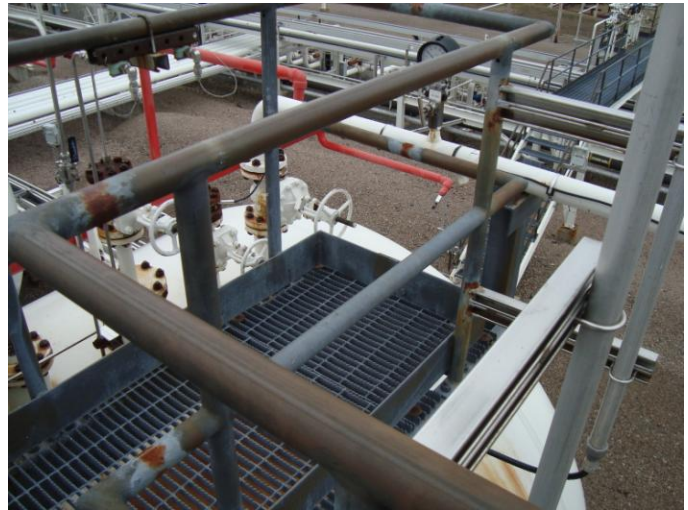
Photo 20 – Isolated areas of coating breakdown with surface occurring on access way

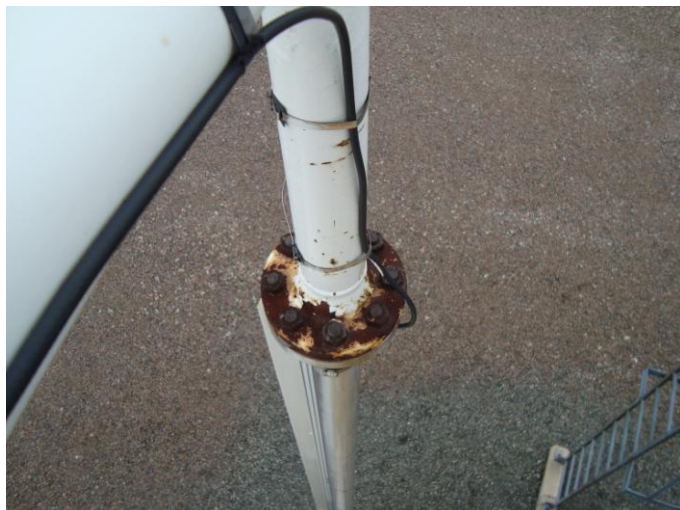
Photo 21 – Vessel level gauge as viewed from above.
Note: Use of dissimilar metals. 80% coating breakdown with surface corrosion on flange. Studs and nuts CAT II

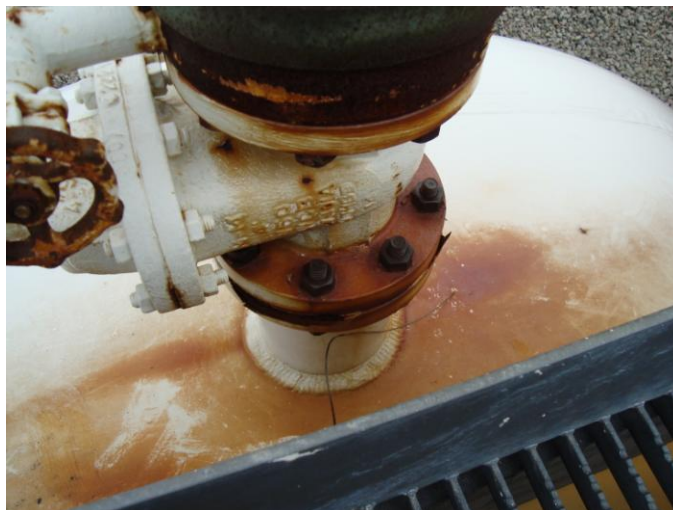
Photo 22 – (N7) 70% coating breakdown with surface corrosion of flange. Studs and nuts CAT II

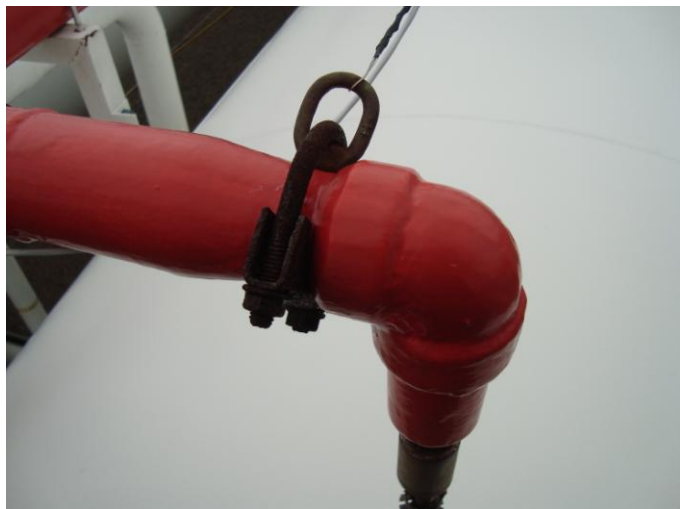
Photo 23 – Corroded u-bolt holding linear heat

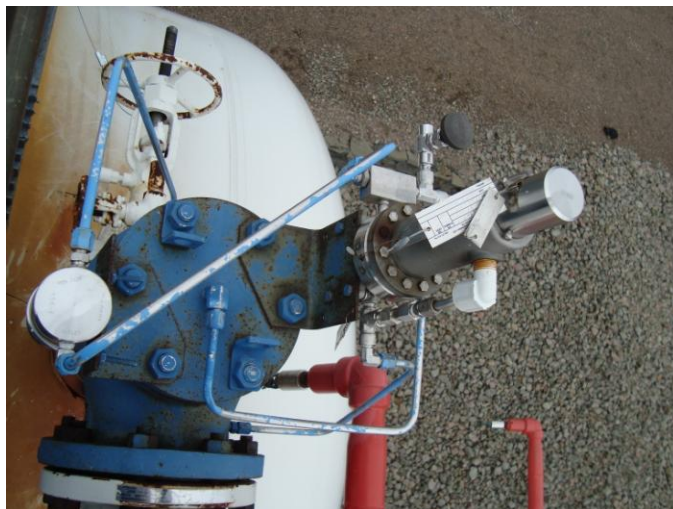
Condition: Good condition, 20% coating breakdown with surface corrosion. Studs and nuts CAT II

Photo 24 – Condition of PSV

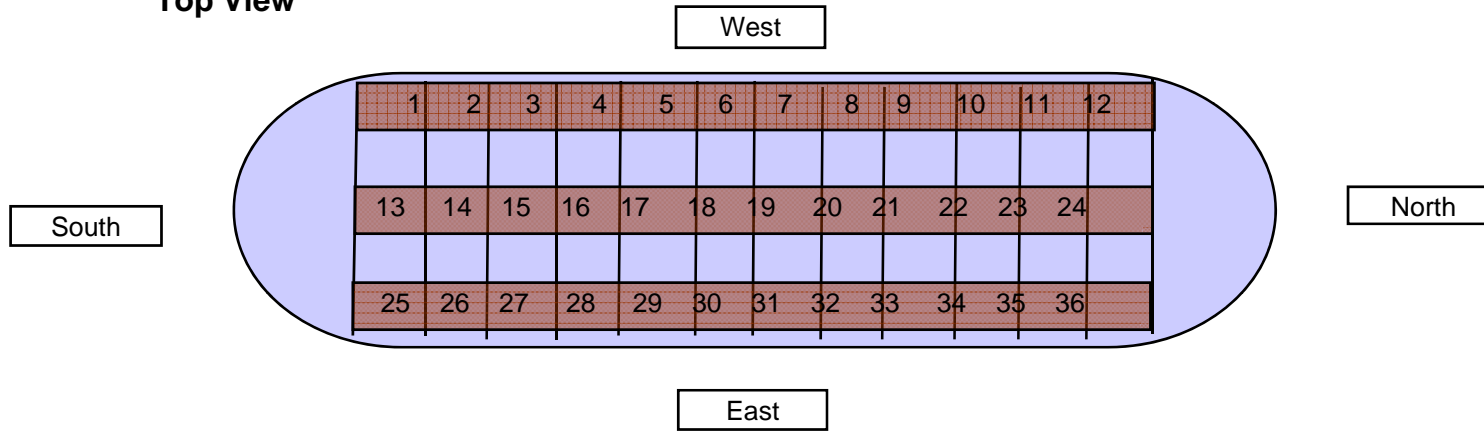
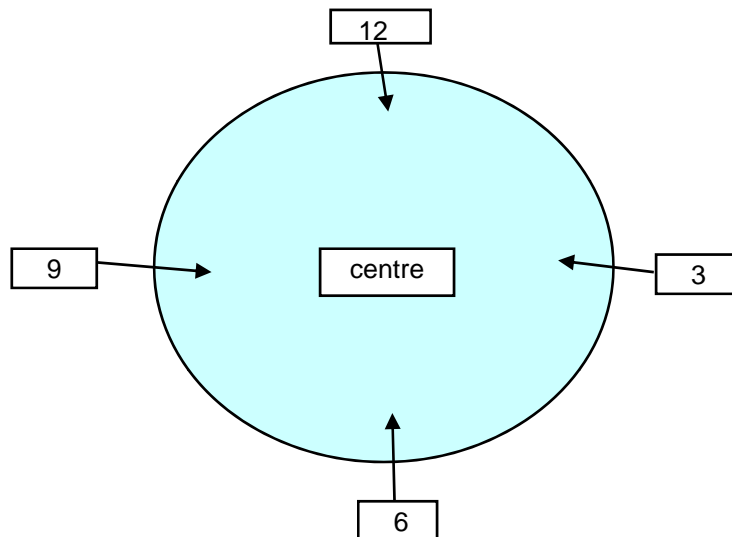
Top View

Three UT readings were taken on each plate. One on the East, one top center, and one on West side. The areas are numbered and readings were recorded on the UT report. Only the lowest readings were reported

UT readings were taken on vessel end caps at the centre and at 12,3,6 & 9 o'clock positions. Lowest readings were recorded
