INSPECTION REPORT

| Pressure Vessel Survey | | | |
| Location: | Point Tupper | EM&I S Report No.: | PT-D2100A-090805-JT-R0 |
| Tag No.: | D-2100A | Equipment Description: | Propane Storage Vessel D-2100A |

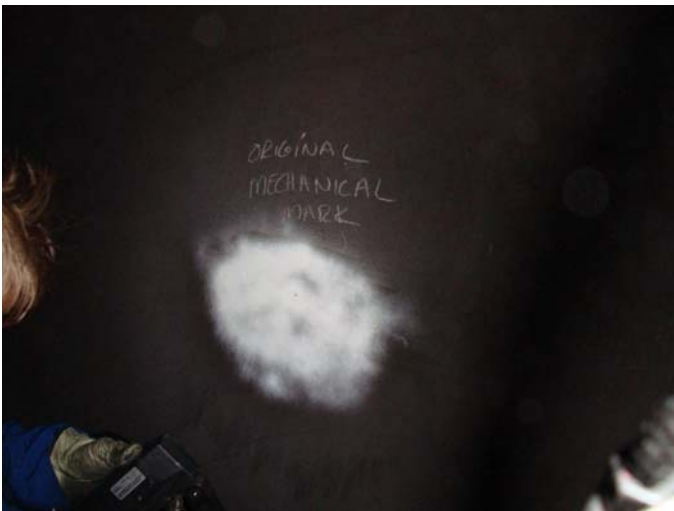
An isolated mechanical indication found on West wall between circ.weld #3 and #4 created during 1999 fabrication of vessel (having a crescent shape) has a depth of 2.5mm, width approx: 3.0mm and 1cm in length. No signs of corrosion/erosion in the immediate area.

Magnetic particle examination was performed on and around this indication but no other evidence of discontinuities present. See Photos #3 and 4 after MPI performed. See Photo #19 before MPI.

Photo 3 – Original mechanical mark

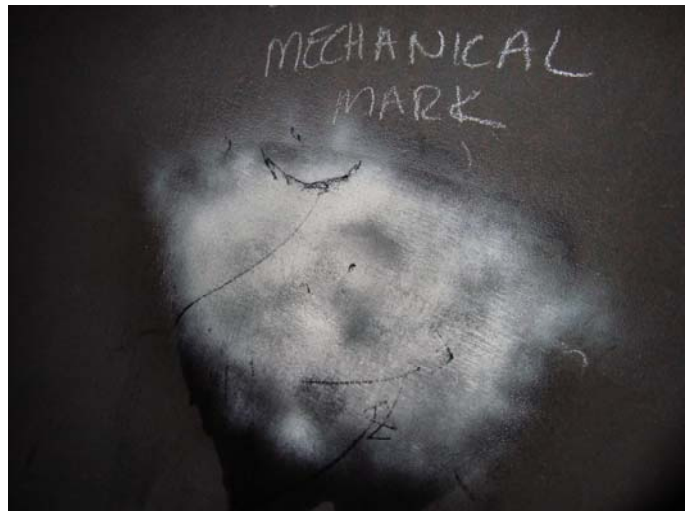
Photo 4 – Close-up of mechanical mark

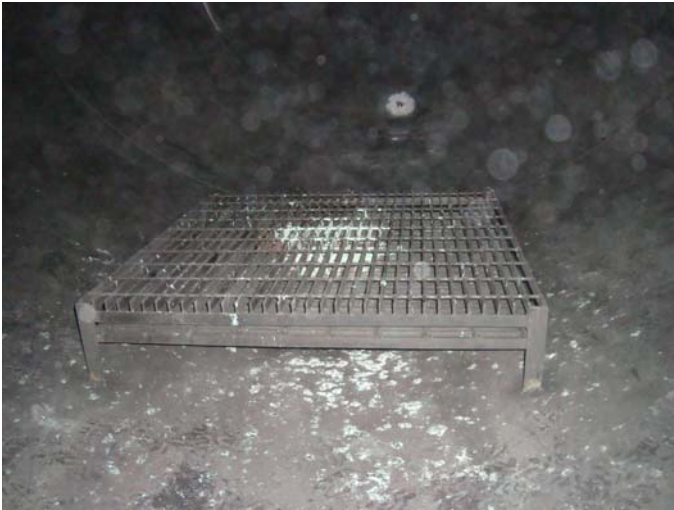
No evidence of corrosion, distortion, missing components or any deterioration on vortex breaker for nozzle #N2.

Photo 5 – Side view of vortex breaker, looking South

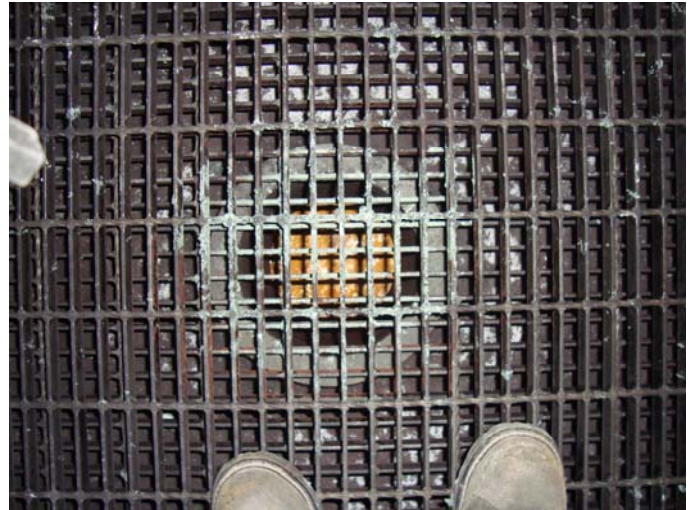
Photo 6 – Top view of vortex breaker looking down at nozzle

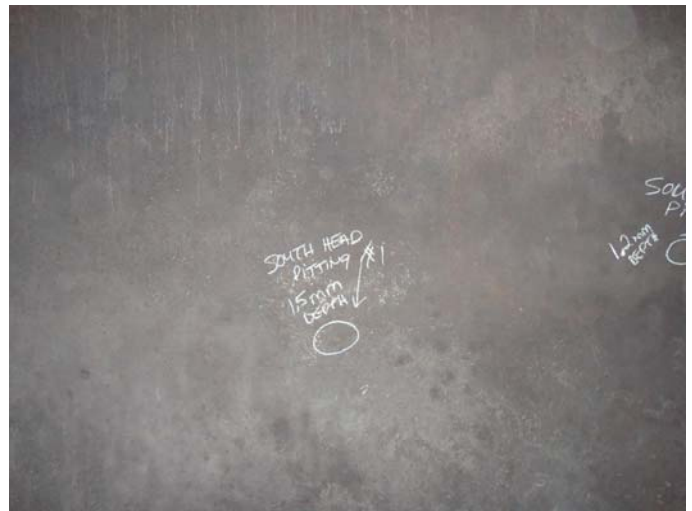
- South Head Pit #1= 1.5mm depth - see Photo #8
- South Head Pit #2= 1.2mm depth - see Photo #9
- North Head Pit #1= 1.2mm depth - see Photo #22
- North Head Pit #2= 2.0mm depth - see Photo #22
- North Head Pit #3= 2.0mm depth- see Photo #23

Photo 8 –South head pitting

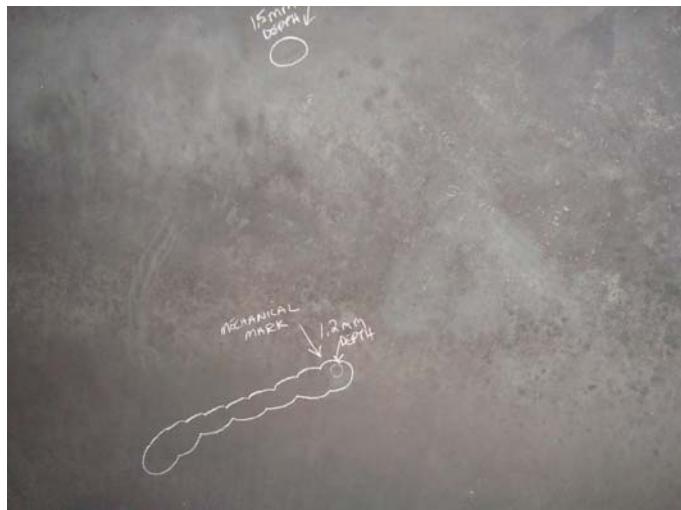
- Mechanical gouge on South head has a length of approx: 60cm and max. depth of 1.2mm. See Photo #9
- Mechanical mark on East wall between circ. weld #9 and #10 has a depth of 1.4mm. See Photo #16
- Mechanical mark on West wall between circ. weld #9 and #10 has a depth of 1.0mm. See Photo #17
- Mechanical mark on West wall between circ. weld #2 and #3 has a depth of approx: 0.7mm. No photo

Photo 9 – Mechanical mark

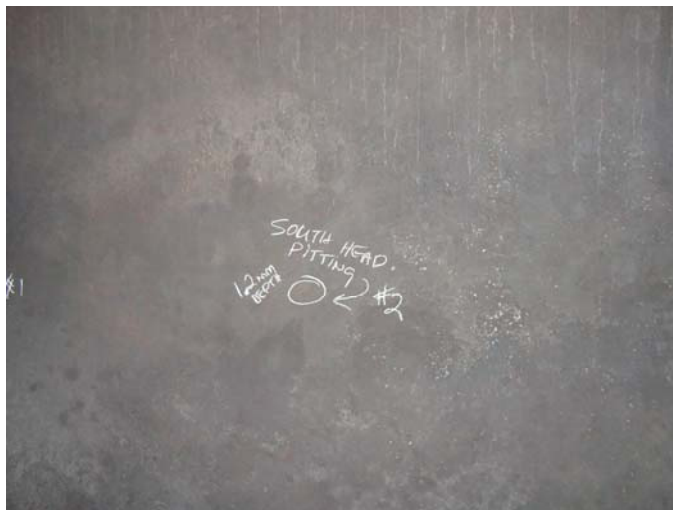
Photo 10 – South head pitting

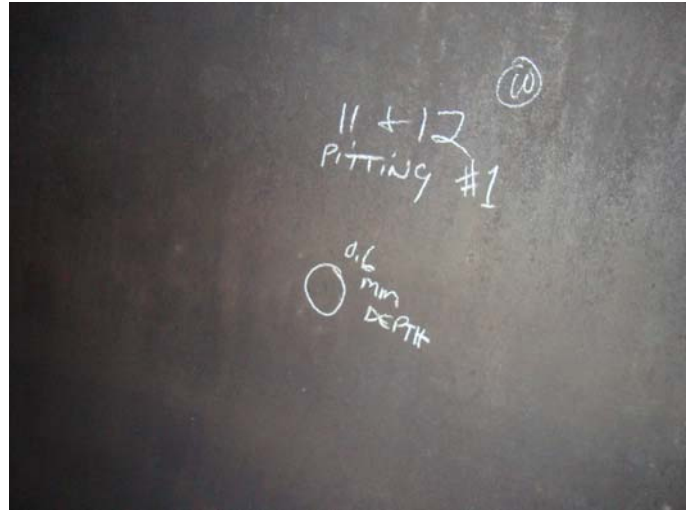
- West side between circ. #2 and #3 = 0.7mm depth - see Photo #21
- West side between circ. #11 and #12 - Pit #1 = 0.6mm depth - see Photo #14 and Pit #2 = 1.2mm depth - see Photo #15
- East side between circ. #12 and #13 - corrosion pit #1 = 1.0mm depth; corrosion pit #2 = 1.2mm depth; corrosion pit #3 = 1.2mm depth.

Photo 14 – Pitting

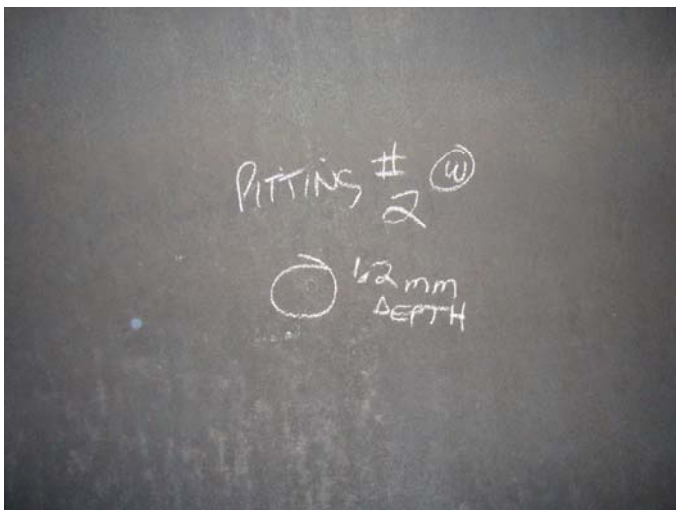
Photo 15 – Pitting

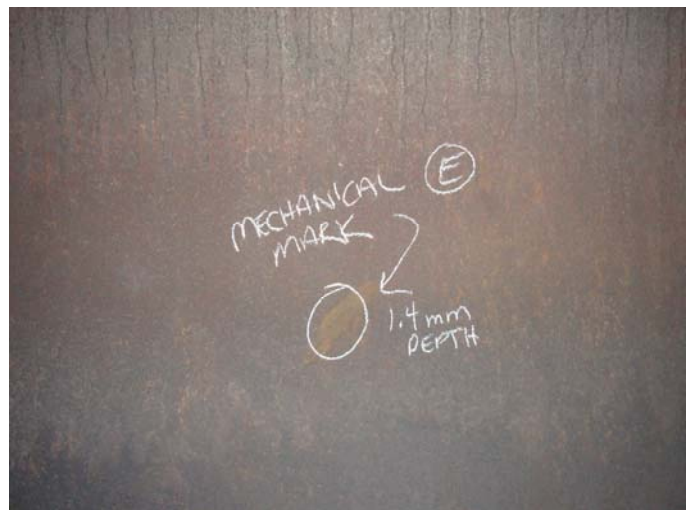
Photo 16 – Mechanical mark

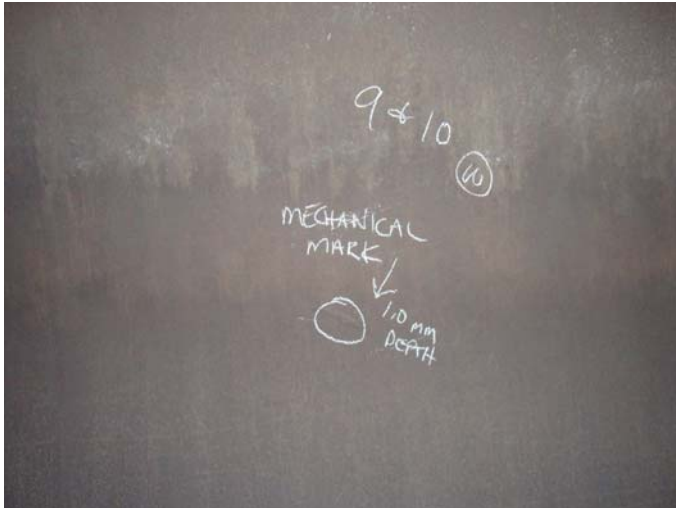
Photo 17 – Mechanical mark

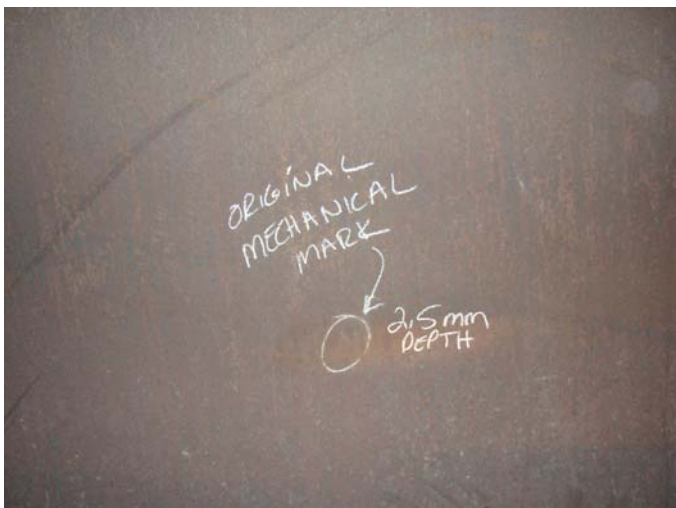
Photo 19 – Original mechanical mark

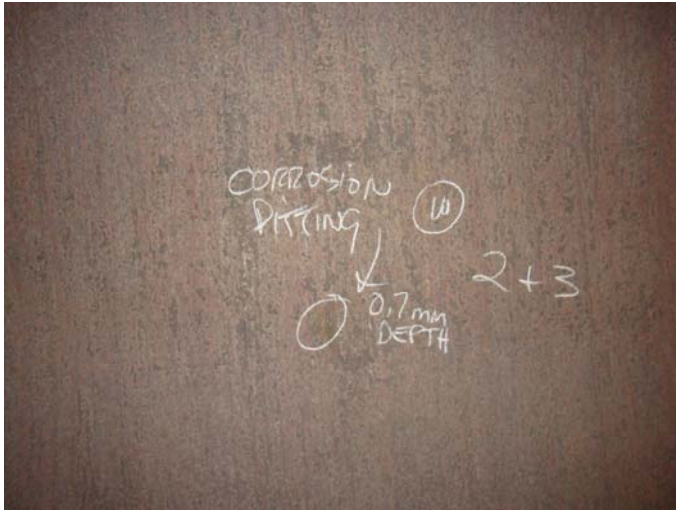
Photo 21 – Corrosion pitting

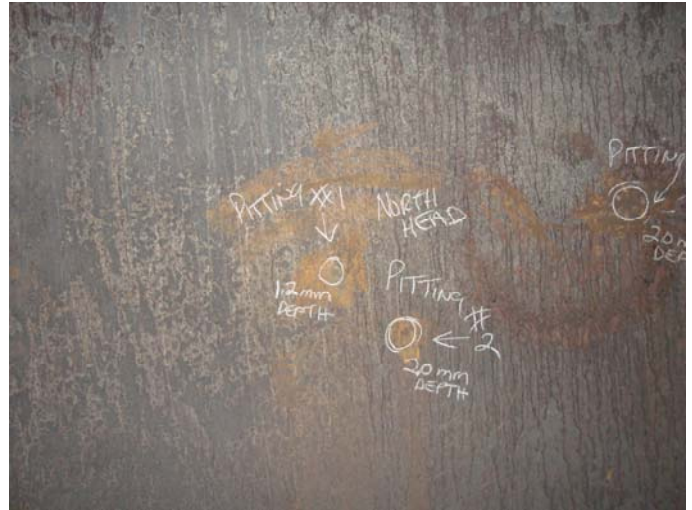
Photo 22 – North head pitting

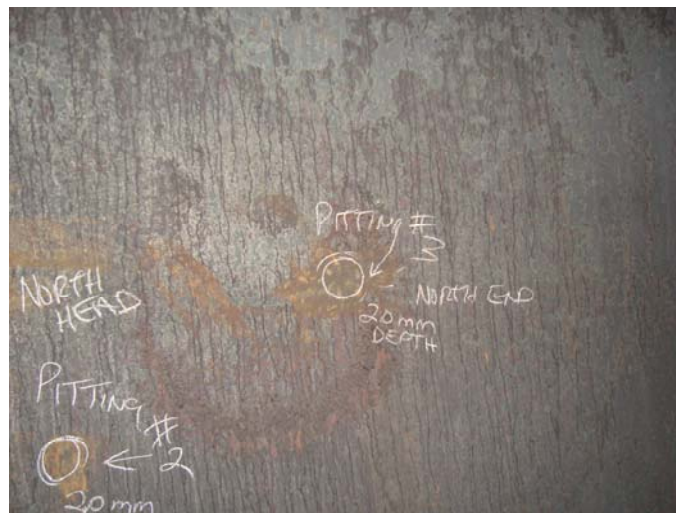
Photo 23 – North end pitting
