INSPECTION REPORT

Pressure Vessel Survey			
Location:	Point Tupper	EM&I J Report No.:	PT-D2100B-090320-BR-R1
Client Name:		Client Ref No.:	PT-11573613-001-D2100B
Client Rep.:		Inspector Name:	Barry Ritchie
WO No.:		Inspection Date:	March 20, 2009
SPO No.:		System:	Propane
Workscope No.:	PT-2008-VESSEL-EXT-03	EM&I J Job No:	EMJ0132.33
Tag No.:	D-2100B	Equipment Description:	Propane Storage Vessel D-2100B
Date of Last Inspection:	NA	Previous Records Seen:	NA
Drawing No.:	LA-B23-F-22-8050-01-Z5, 98-CA-399735-1B-5, 98-CA-399735-4B-0

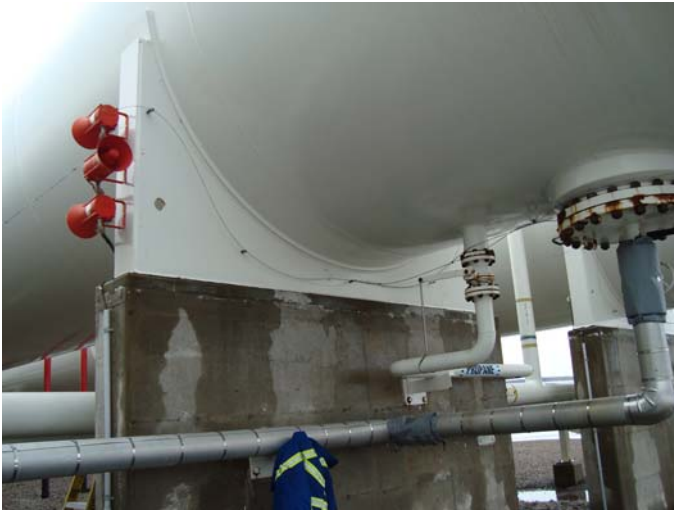
Photo 1 – Showing North face of North vessel support, paint coating in good condition

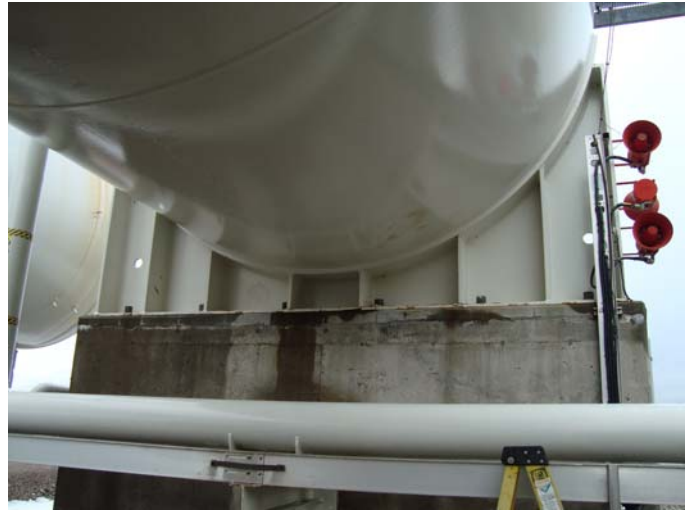
Photo 2 – Showing South face of North vessel support, coating breakdown and corrosion only on lower flange connection to concrete

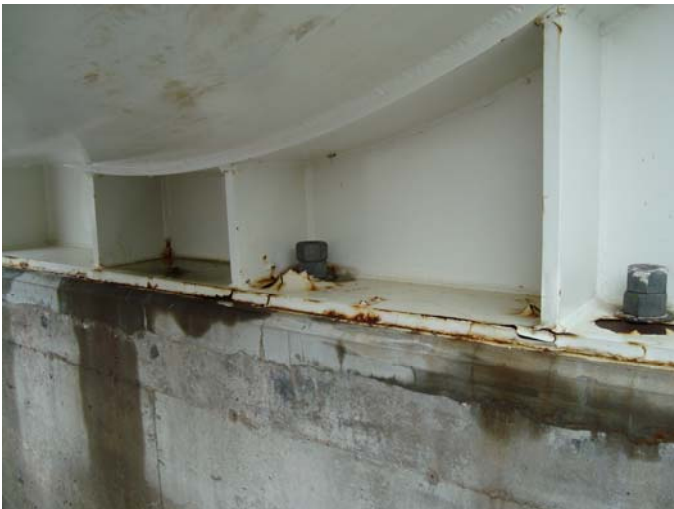
2. If applicable, check vessel supports for signs of deterioration, settlement, deflection, and/or corrosion.	<input checked="" type="checkbox"/>	<input type="checkbox"/>	<input type="checkbox"/>	<input type="checkbox"/>	See Photo #3

4. a) For horizontally mounted vessels, check for signs of trapped moisture, resulting in corrosion between cradle support and vessel shell.	<input checked="" type="checkbox"/>	<input type="checkbox"/>	<input type="checkbox"/>	<input type="checkbox"/>	See Photo #3 & 6

Photo 3 – Steel to concrete connection, coating breakdown mainly on edges

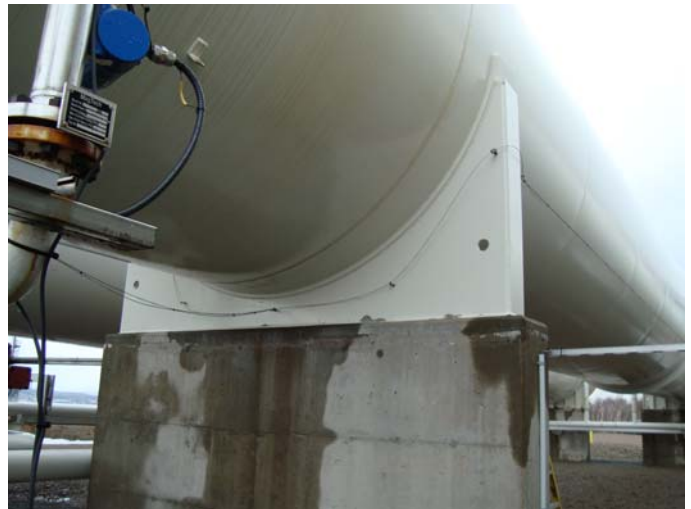
Photo 4 – South face of South vessel support, paint in good condition

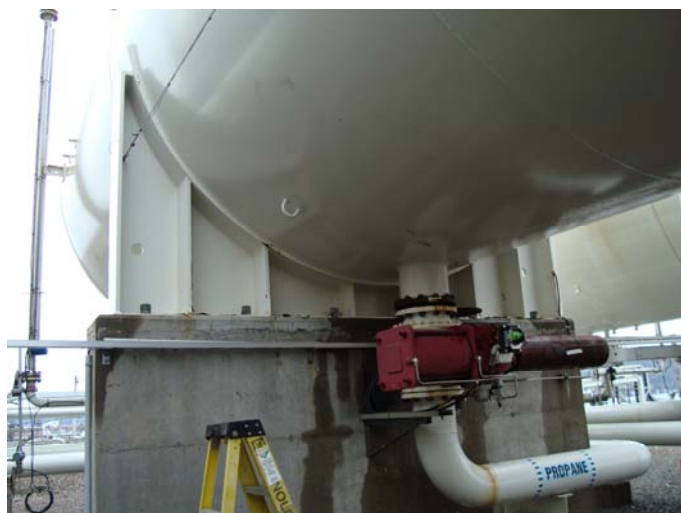
Photo 5 – North face of South vessel support, paint coating in good condition. Coating breakdown on lower flange mainly

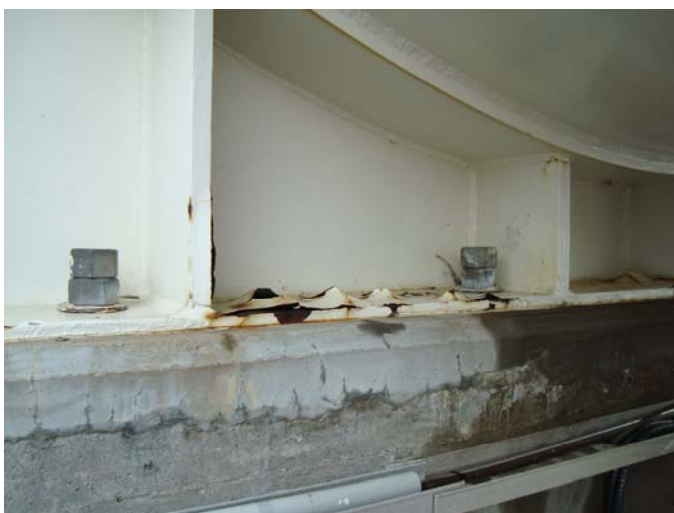
Photo 6 – Close-up of lower flange, no water damage or trapped moisture, paint coating flaking

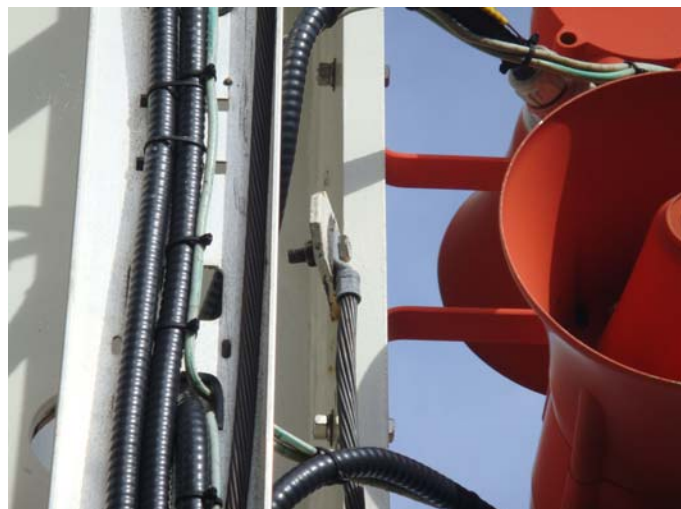
5. Check the grounding connection is correctly installed, with cable connections tight and ground wires in good condition.	<input checked="" type="checkbox"/>	<input type="checkbox"/>	<input type="checkbox"/>	<input type="checkbox"/>	See Photos #7-10

Photo 7 – Earthing strap connection North vessel support

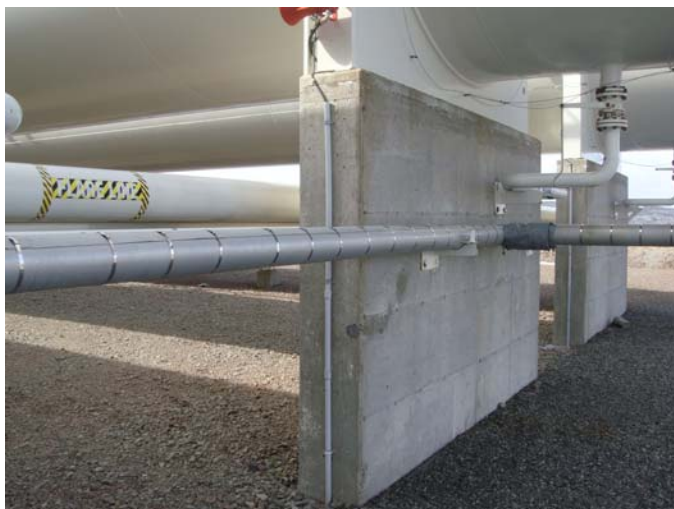
Photo 8 – Earthing strap and connections on North vessel support

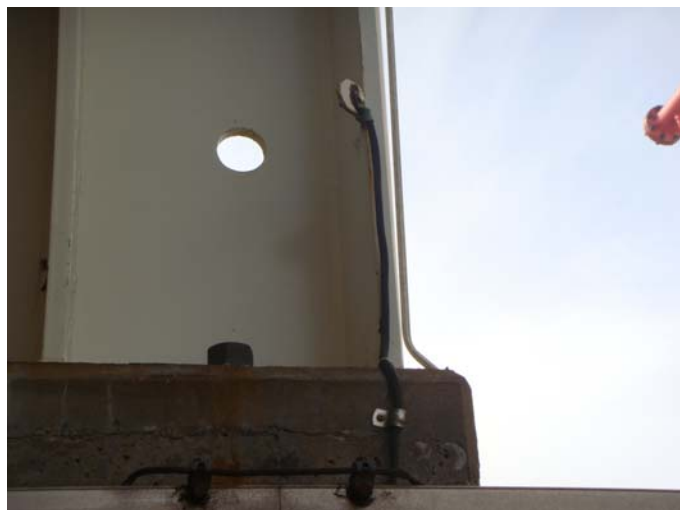
Photo 9 – Earthing strap connection on South vessel support

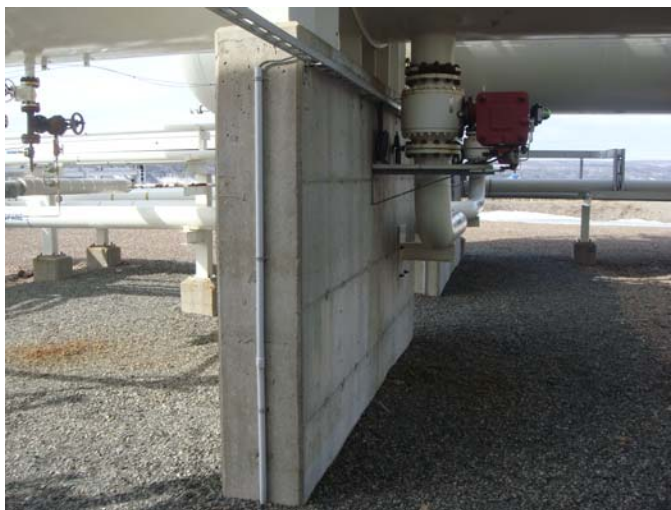
Photo 10 – Earthing strap on vessel support South side, general photo

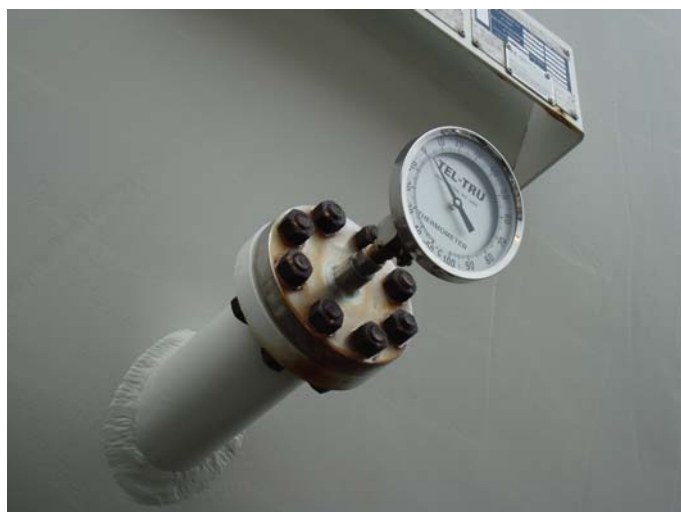
Photo 15 – Nozzle N6, in generally good condition, no areas of concern. Studs and nuts CAT III

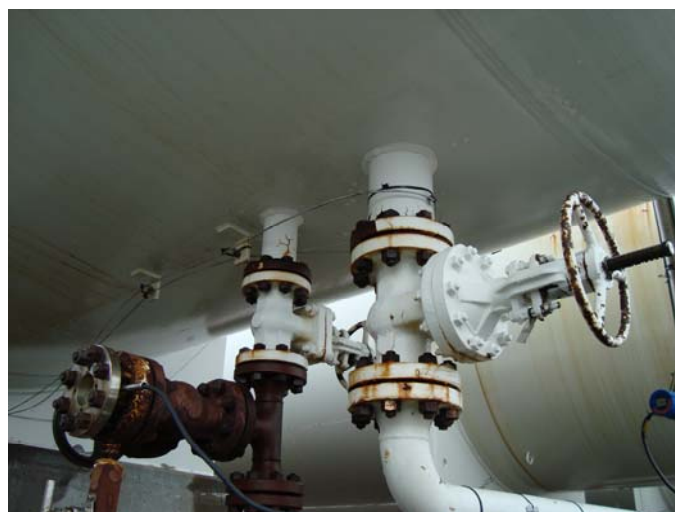
Photo 16 – Nozzles N3B & N4B, coating breakdown and light corrosion located on nozzle body and flange, studs and nuts CAT III

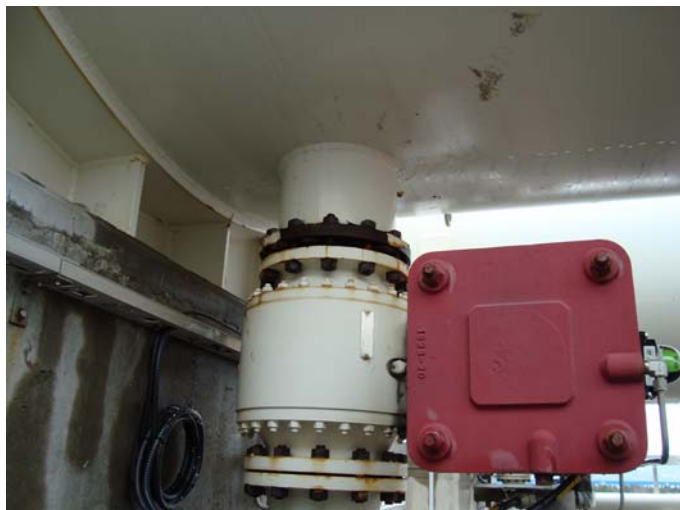
Photo 17 – Nozzle N2, coating breakdown only on flange connection. Studs and nuts uncoated but in good condition, CAT III

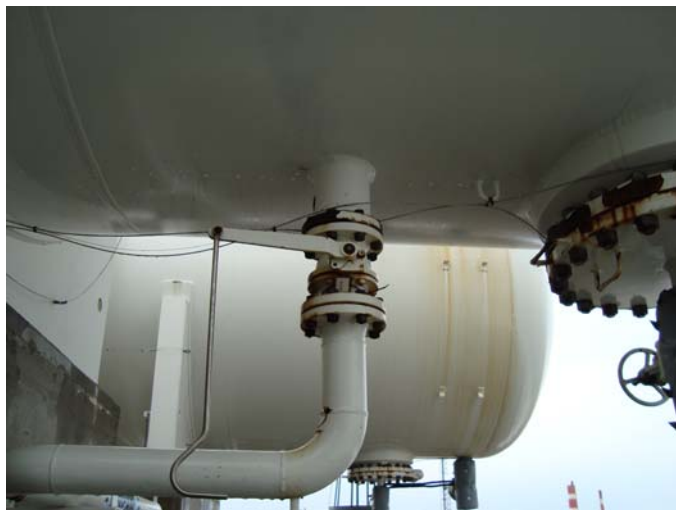
Photo 18 – Nozzle N5, coating breakdown only located on flange connection. Studs and nuts CAT III

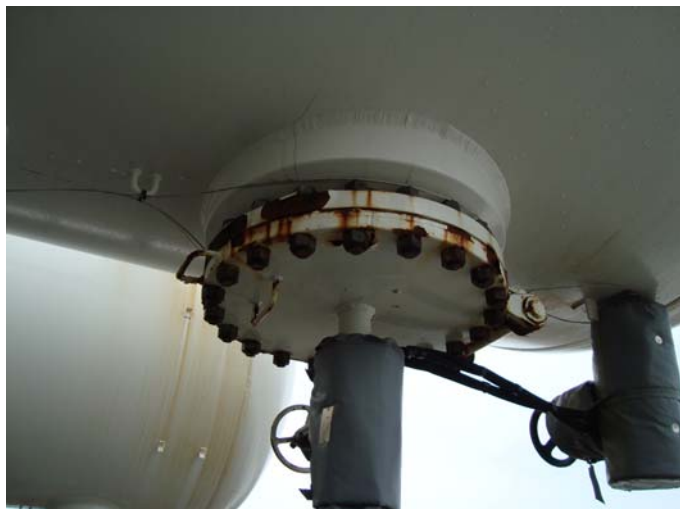
Photo 19 – Manhole, coating breakdown on flanges only, studs and nuts uncoated, CAT III

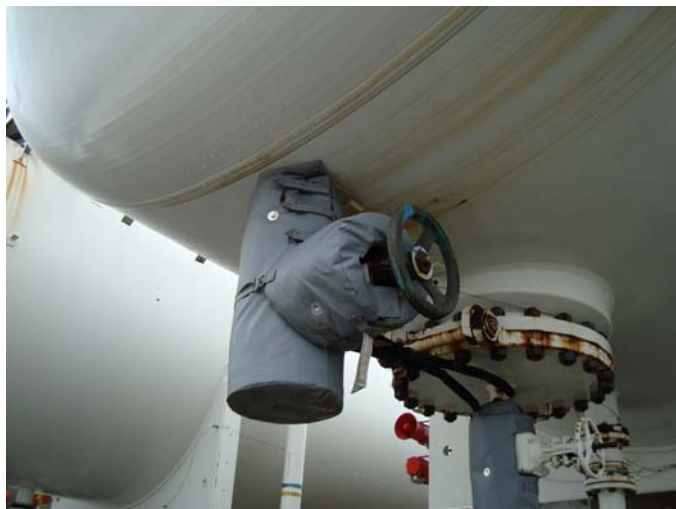
Photo 20 – N10, insulation bag in good condition, studs and nut CAT III

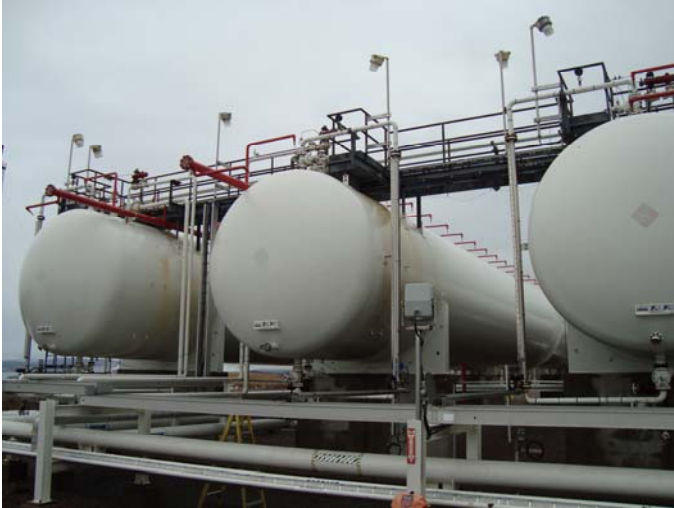
7. Carry out visual inspection of the exterior surface of the vessel, including coatings for any signs of leaks, cracks, deformation, distortion, pitting, corrosion or other forms of deterioration. If so, specify type, location and extent.	<input checked="" type="checkbox"/>	<input type="checkbox"/>	<input type="checkbox"/>	<input type="checkbox"/>	See Photos #21-27

Photo 21 – General condition of East side shell, good condition

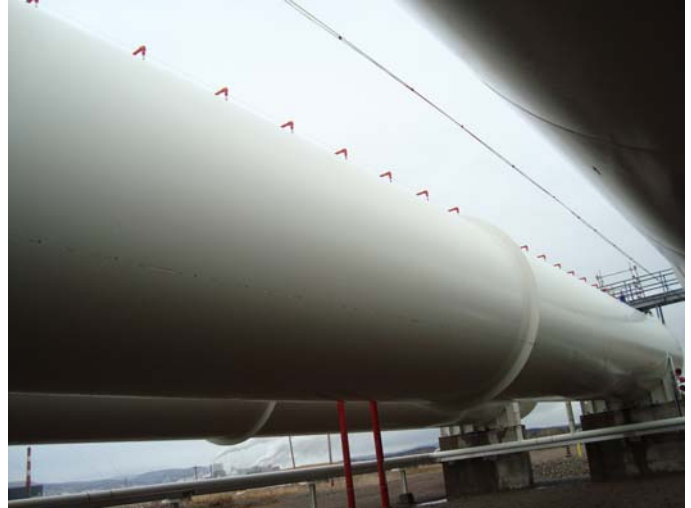
Photo 22 – General condition of East side shell, good condition

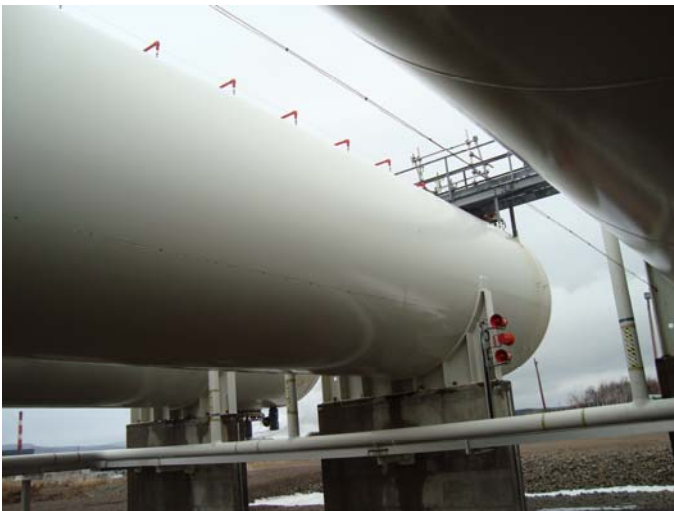
Photo 23 – General condition of East side shell, good condition

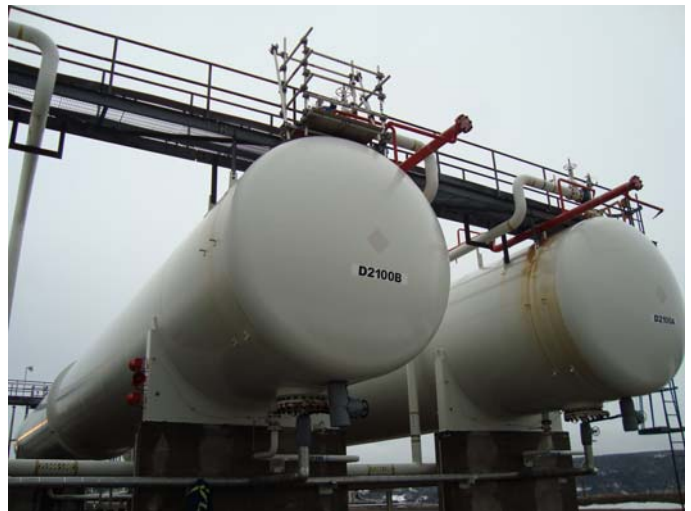
Photo 24 – General good condition of North dome end, photo taken facing South

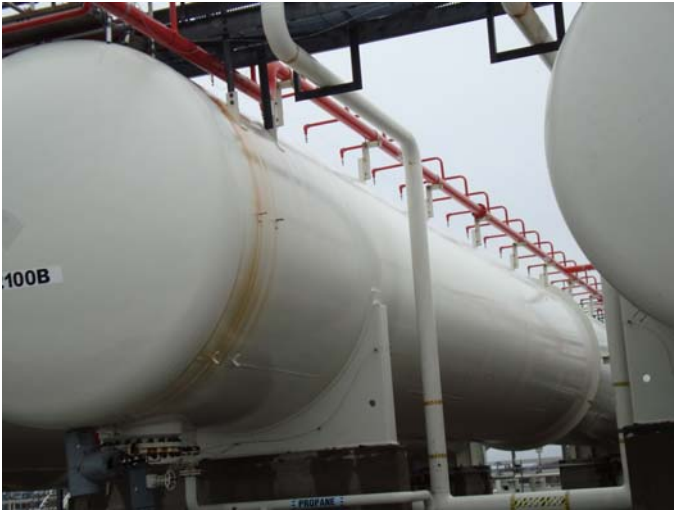
Photo 25 – West side shell generally in good condition

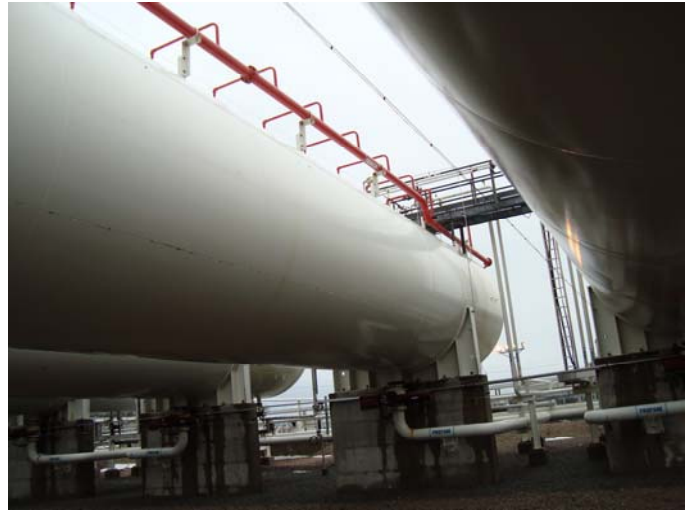
Photo 26 – West side shell generally in good condition

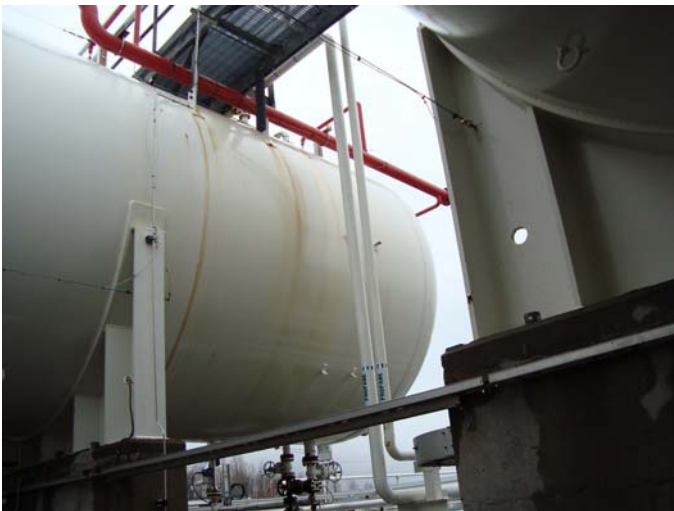
Photo 27 – West side shell generally in good condition

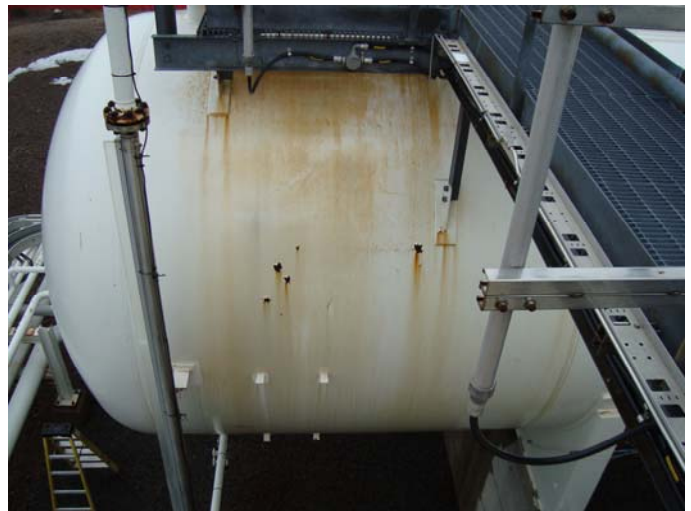
Photo 28 – Showing 4 small isolated patches of coating breakdown and light corrosion on the upper South-East side shell Dome end

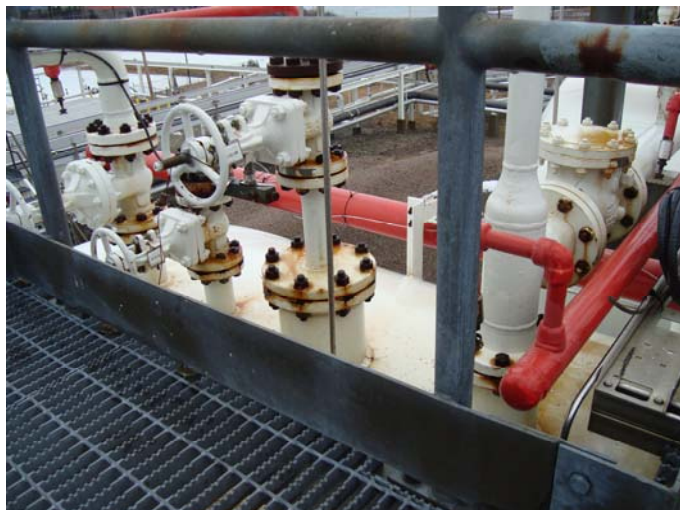
Photo 29 – Nozzles N3A/N4A/N8/N1, coating breakdown and light to moderate corrosion located only on flange edges. All studs and nuts are uncoated but in good condition, CAT III

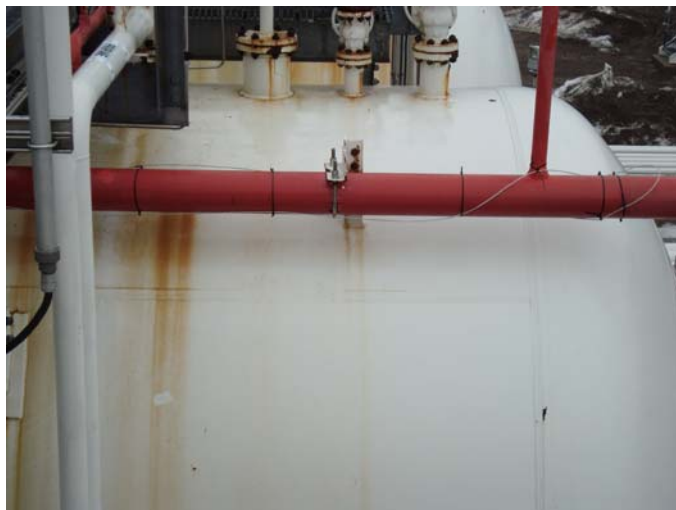
Photo 30 – South-West upper side shell, water staining only good condition

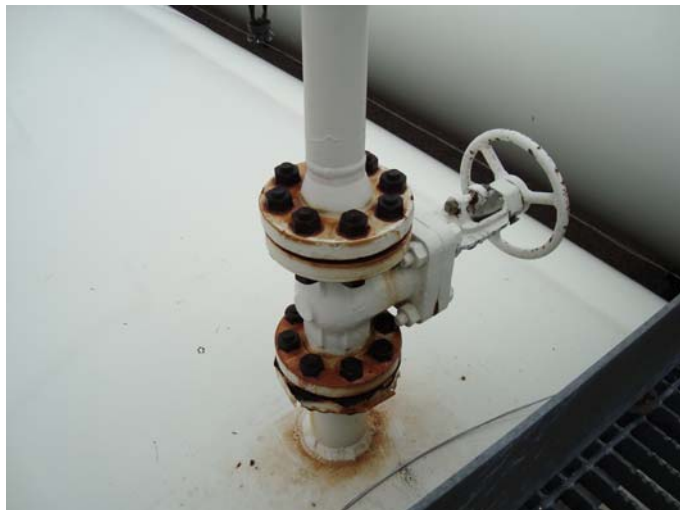
Photo 31 – Nozzle N9, coating breakdown on flange connection, only studs and nuts have lost paint coating but are still in good condition, CAT III

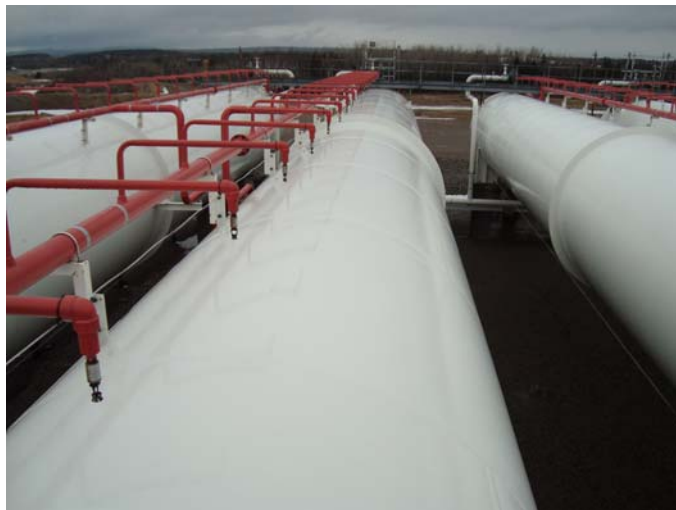
Photo 32 – Generally good condition on top section of vessel, photo taken facing North

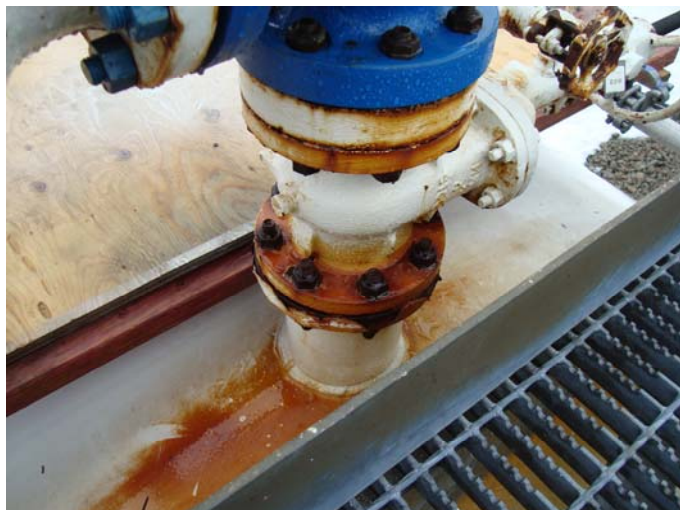
Photo 33 – Nozzle N7, coating breakdown only on flange connection, studs and nuts CAT II

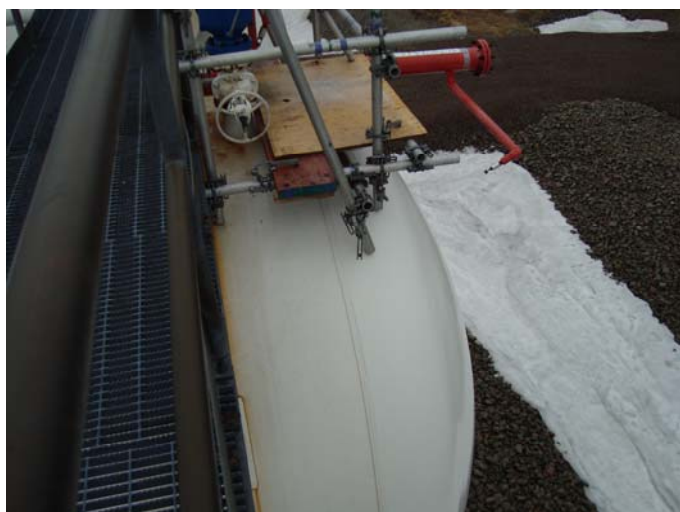
Photo 35 – East top side of North dome, good condition

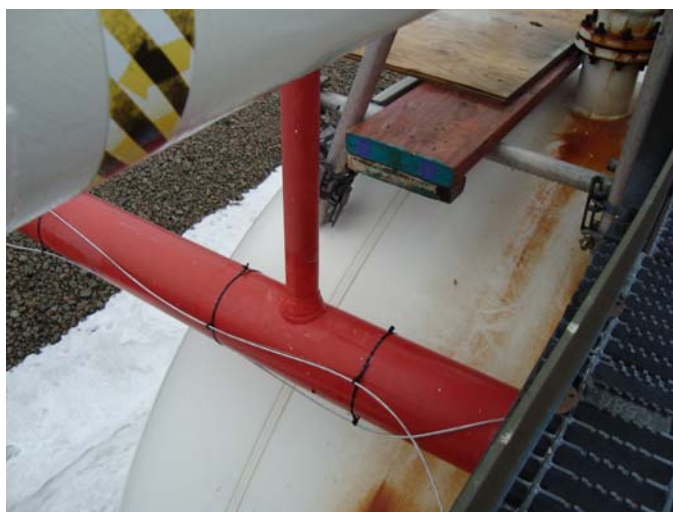
Photo 36 – Condition of top West side of North dome

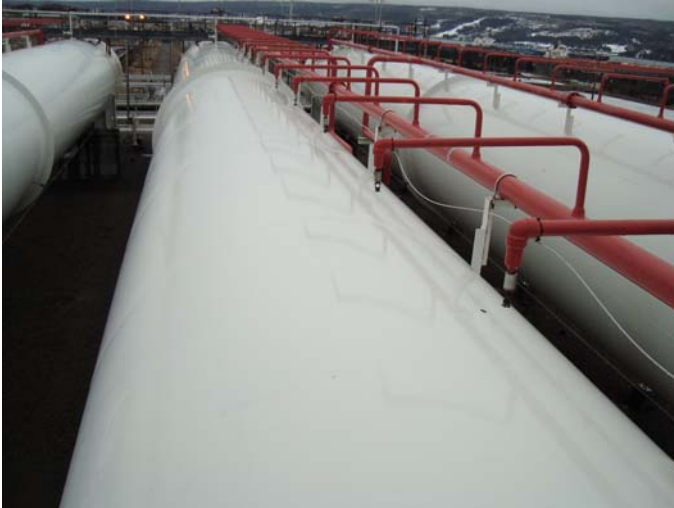
Photo 37 – General view of top section of vessel in good condition

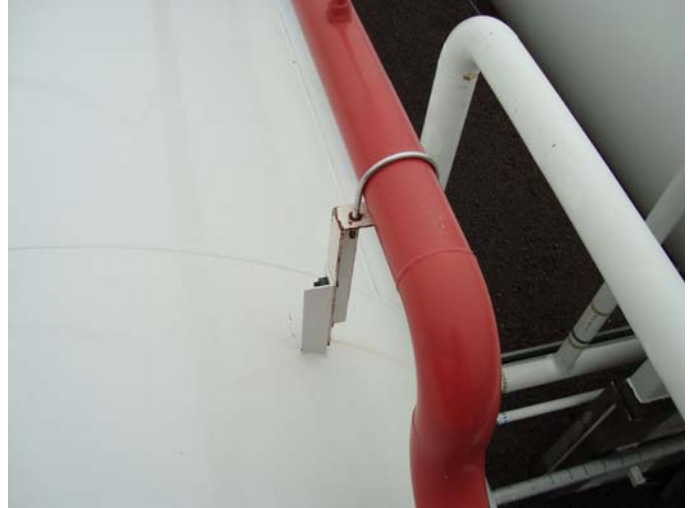
Photo 38 – Typical condition of deluge pipe support

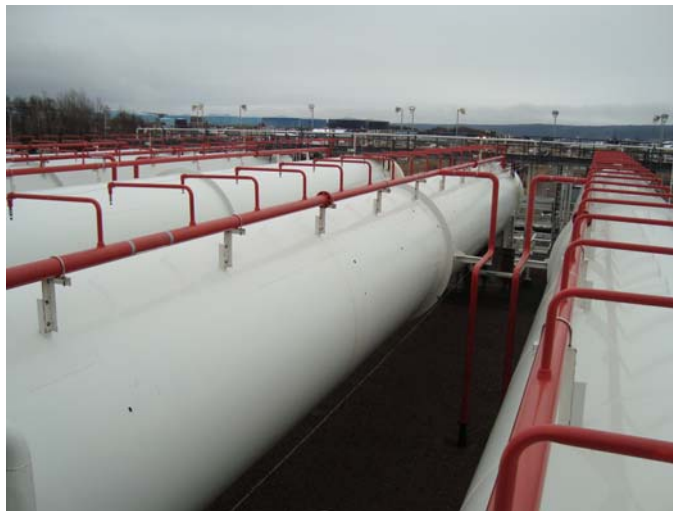
Photo 39 – General view of upper side shell West side, six very small areas of coating breakdown and light corrosion, photo taken facing South

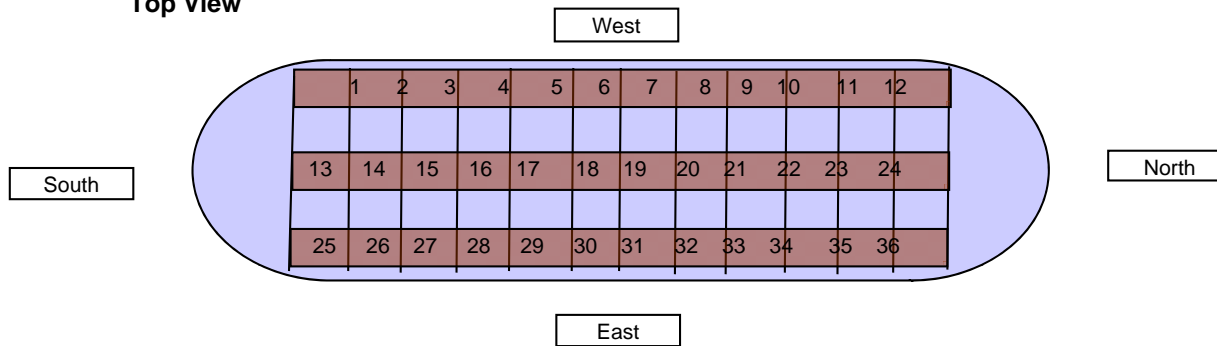
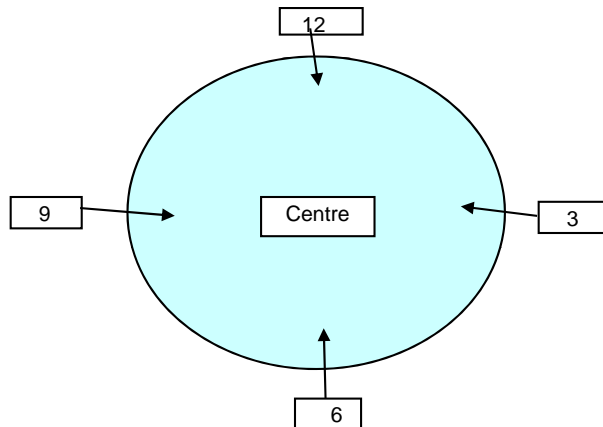
Top View

Three UT readings were taken on each plate.
One on the East, one top Center, and one on
the West side. The areas are numbered and
readings were recorded on the UT report.
Only the lowest readings were reported.

UT readings were taken on vessel end caps
at the Centre and at 12,3,6 & 9 O'clock
positions. Lowest readings were recorded.
