# INSPECTION REPORT

Pressure Vessel Survey			
<b>Location:</b>	Point Tupper	<b>EM&amp;I J Report No.:</b>	PT-D2100B-090506-CR-R0
<b>Client Name:</b>		<b>Client Ref No.:</b>	PT-11564781-002-D2100B
<b>Client Rep.:</b>		<b>Inspector Name:</b>	Colin Robinson
<b>WO No.:</b>		<b>Inspection Date:</b>	May 06, 2009
<b>SPO No.:</b>		<b>System:</b>	Propane
<b>Workscope No.:</b>	PT-2009-D-2100B-INT-01	<b>EM&amp;I J Job No:</b>	EMJ0132.43
<b>Tag No.:</b>	D-2100B	<b>Equipment Description:</b>	Propane Storage Vessel D-2100B
<b>Date of Last Inspection:</b>	NA	<b>Previous Records Seen:</b>	NA
<b>Drawing No.:</b>	LA-B23-F-22-8050-01-Z5, 98-CA-399735-1B-5

### Technical Characteristic of D-2100B:

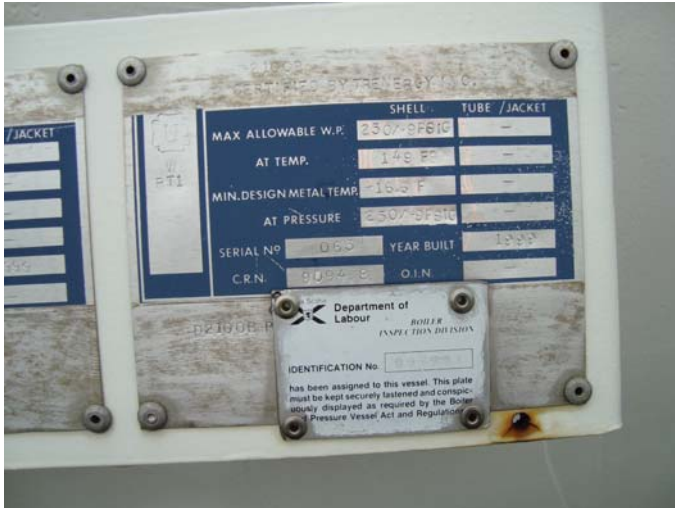
- Certified By: Patterson Industries (Canada) Ltd
- The maximum allowable working pressure (MAWP): 250 & -9 PSI @ 149°F (1724 & -62Kpa @65 °C)
- The minimum design metal temperature (MDMT): -16.6°F @ 250 & -9 PSI (-27°C @1724 & -62Kpa)
- Serial No.: 063
- Year Built: 1998
- C.R.N.: 9094.8

Photo 1 – Name Plate Details

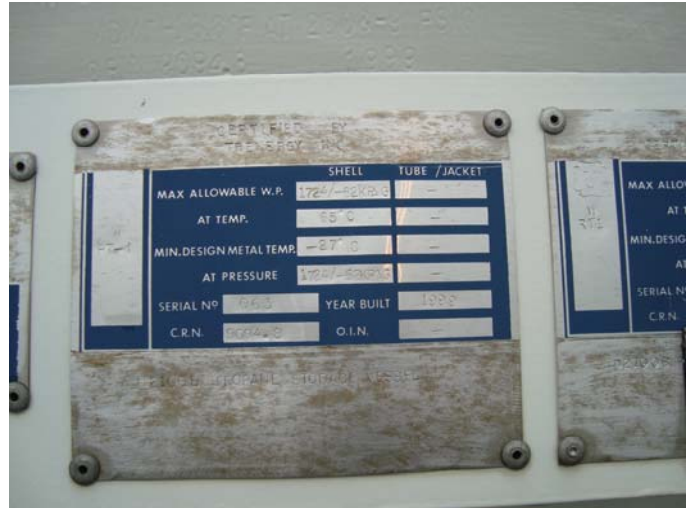
Photo 2 – Name Plate Details

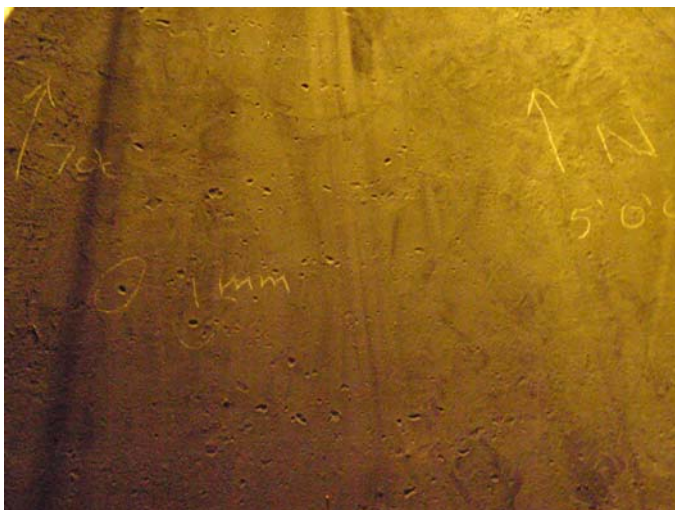
**Note 3:** Isolated areas of pitting were noted; approx. 1% - 2% by density located between 5 and 7 O'clock position; maximum depth 1mm with an average depth 0.5mm; please see Photo #3 and the attached drawing for locations.

Photo 3 – Close view of internal pitting

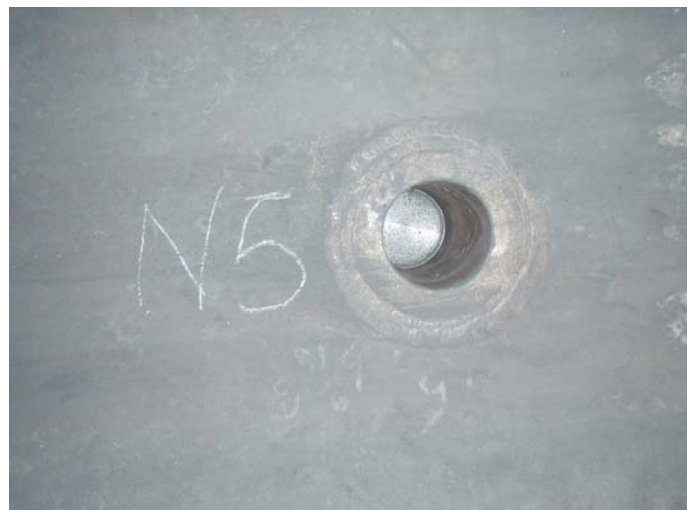
3. Check all man-ways, nozzles and connections for distortion, cracks, corrosion, wall loss and other type of defects or failures. If any defects are noted, specify type, extent and location.	<b>Good</b>	All nozzles in good condition (see Photo 4-10). MPI carried out on N3B, N4B, N5, N6, N10 and Manway M

Photo 4 – General View of Nozzle N5 in good condition

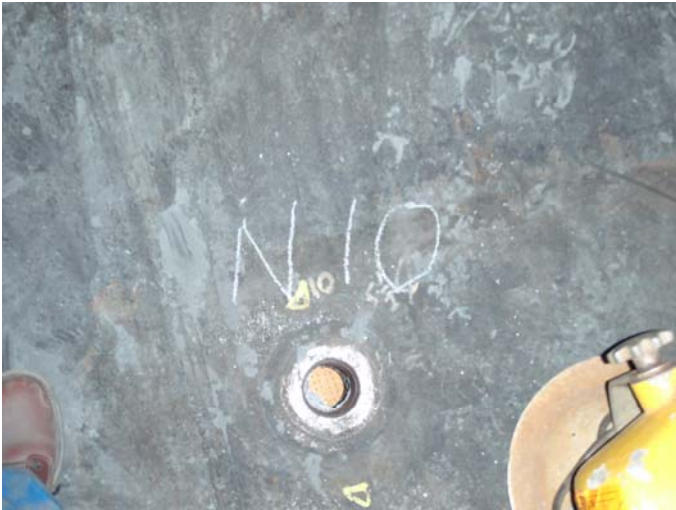
Photo 5 – General View of Nozzle N10 in good condition

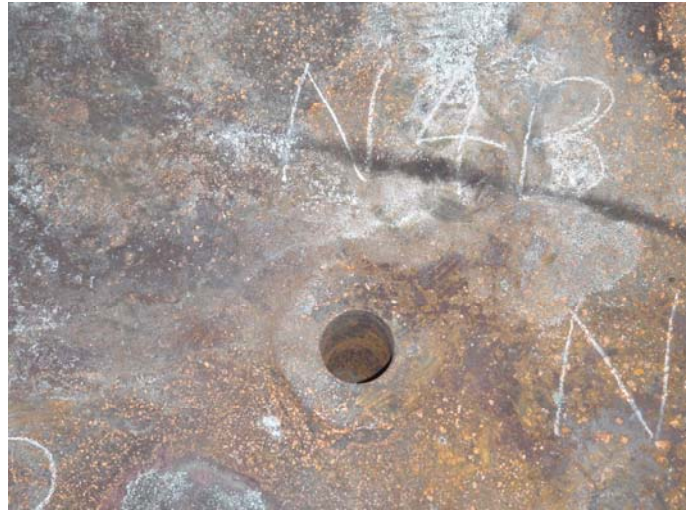
Photo 6 – General View of Nozzle N4B in good condition

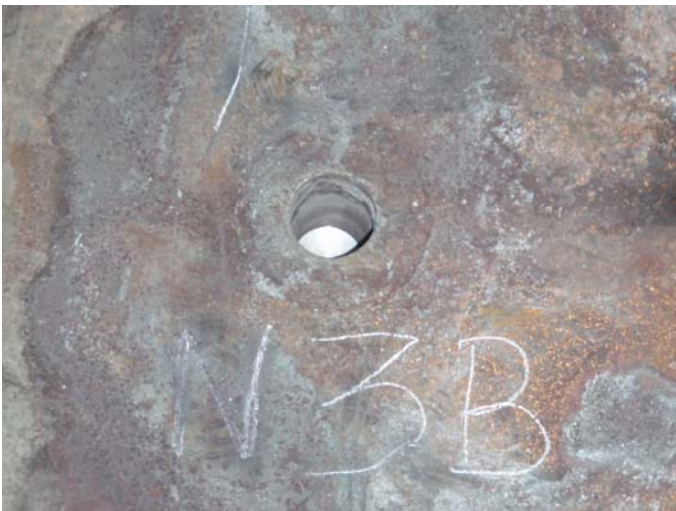
Photo 7 – General View of Nozzle N3B in good condition

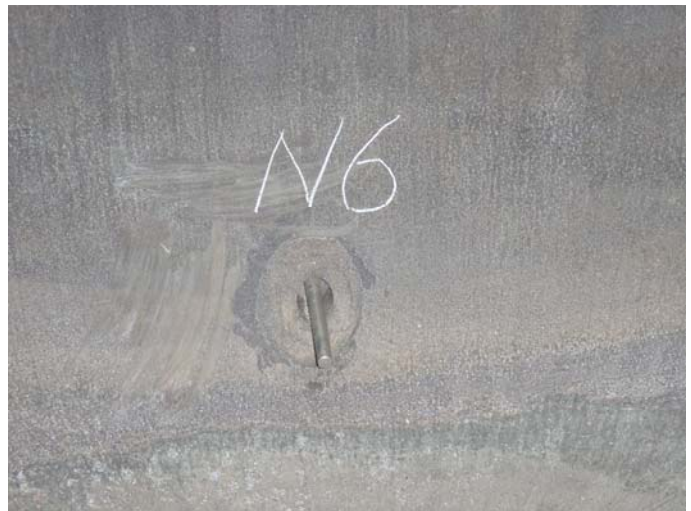
Photo 8 – General View of Nozzle N6 in good condition

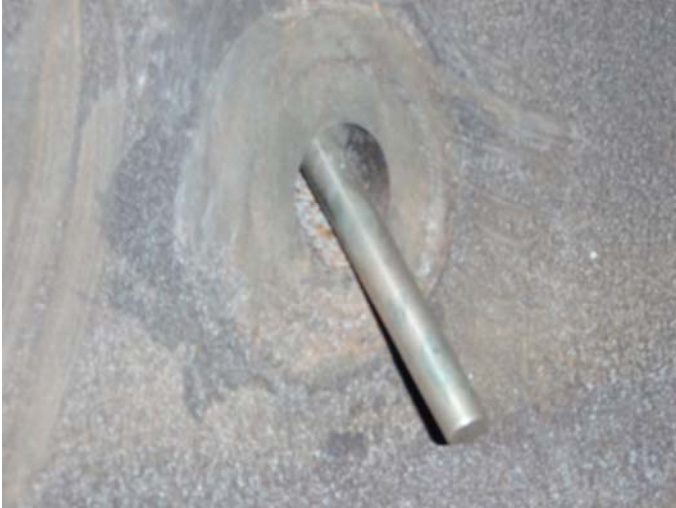
Photo 9 – Thermowell on Nozzle N6

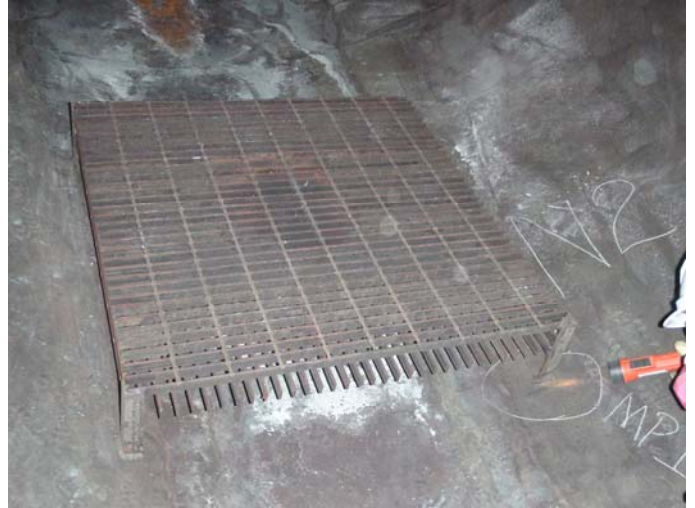
3. If applicable, check if bolted connections are in full contact with connected elements and connections are free from rust or other deleterious material that may prohibit full contact.	<b>NA</b>	Welded internal Vortex Breaker (see Photo #10 & 11)

Photo 10 – General View of Nozzle N2 with Vortex Breaker in good condition

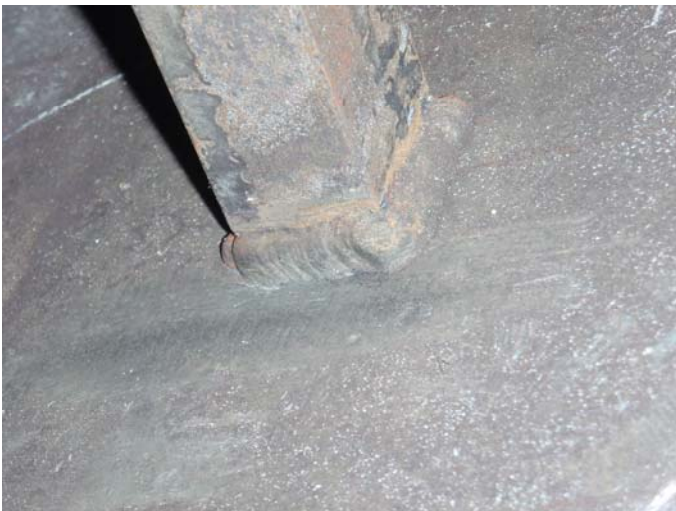
**Note 6:** MPI was carried out on the Vortex Breaker on N2 to vessel shell weld; no indication was noted. Slight undercut was noted on the vortex breaker to vessel shell weld; MPI was carried out to confirm the integrity of the weld – No cracking noted.

Photo 11 – Close view of the weld for Vortex breaker to shell

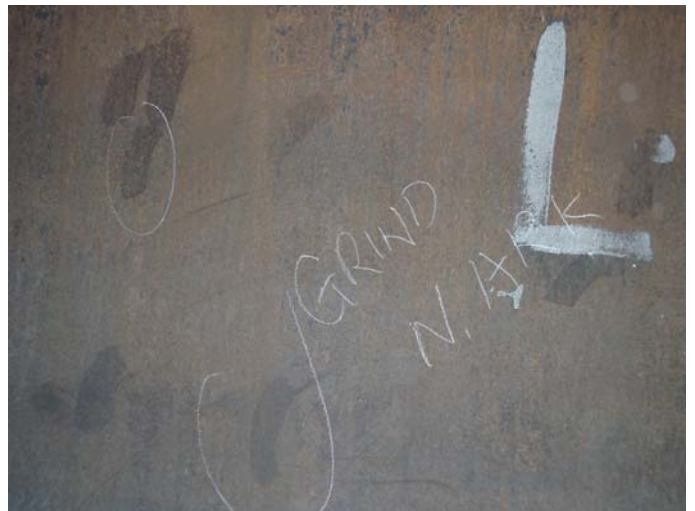
Photo 12 - Grinding Marks on shell

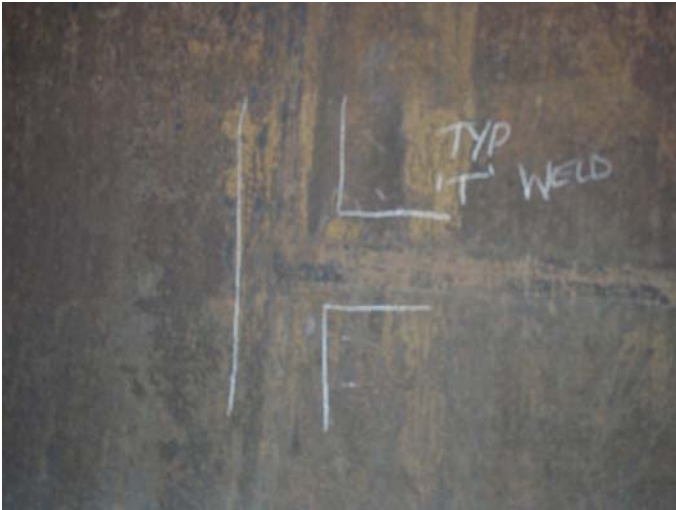
Photo 13 – Typical 'T' Weld

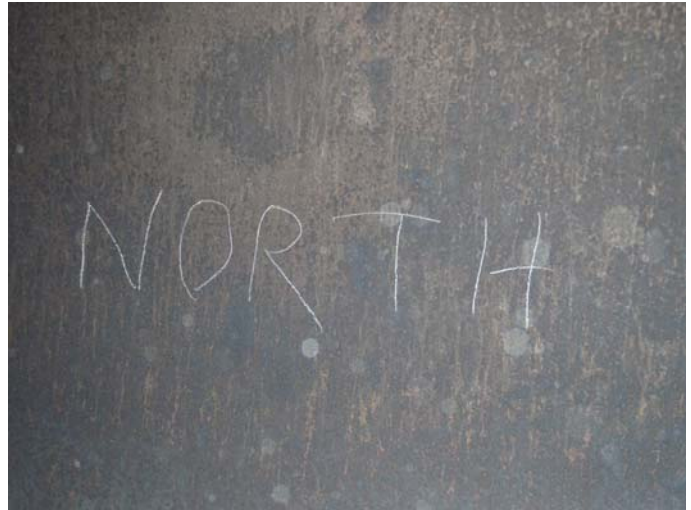
Photo 14 – General View of North Head

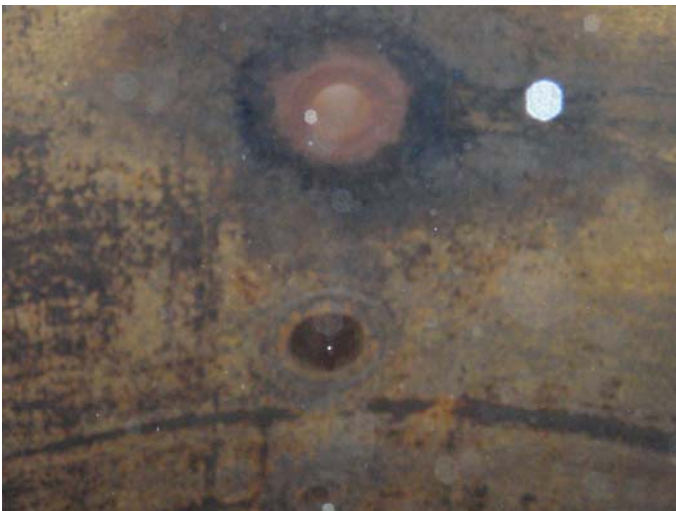
Photo 15 – General View of Nozzle N4A &amp; N3A in good condition

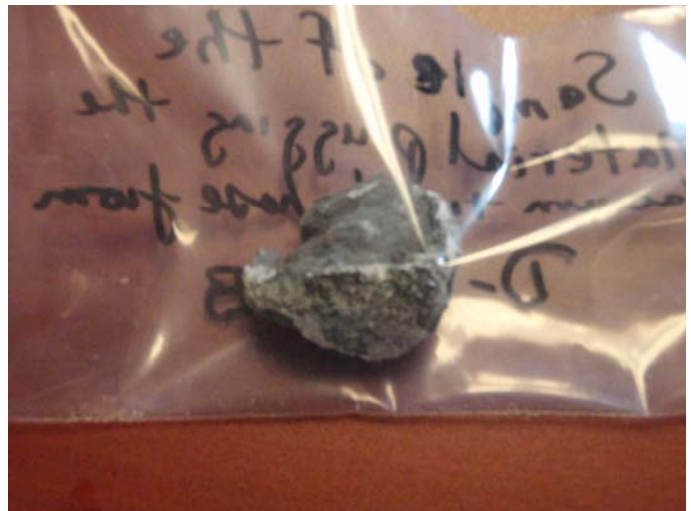
**Note 2:** A thorough internal inspection of D-2100B was carried out in accordance with API 510 and API 572 by entering the vessel. The Vessel was found generally to be in good condition. Light surface scaling and roughness on the vessel shell and head was noted. Residue was removed from the vessel during vessel cleaning process and sent for analysis, see Photo #16 & 17.

Photo 16 – Residue removed from D-2100B

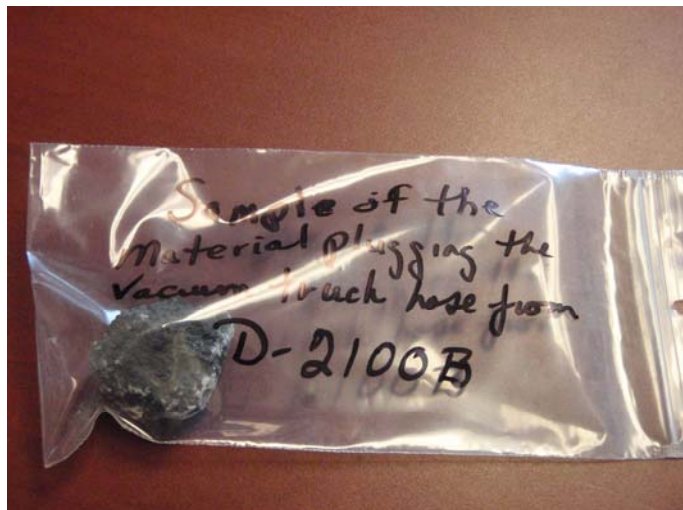
Photo 17 – Residue removed from D-2100B

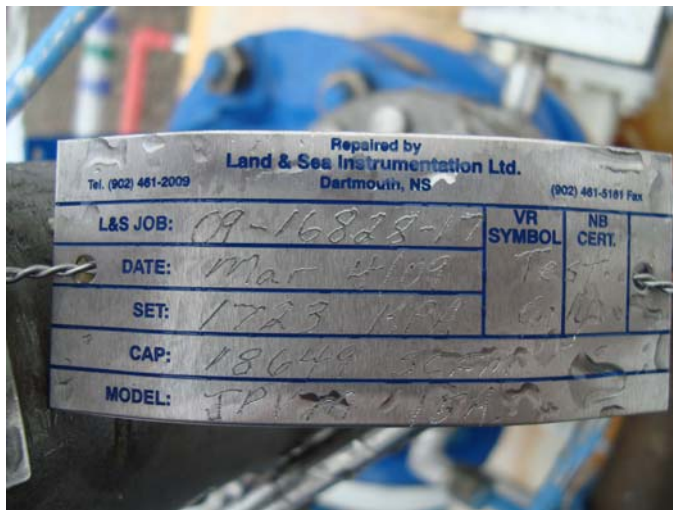
- Certified By: Land & Sea Instrumentation Ltd. Job No. 09-16828-17
- Date: March 4<sup>th</sup>, 2009
- Set Pressure: 1723Kpa
- Capacity: 18649 SCFM
- Model: JPVm – 15A

Photo 18 – PSV Details
