INSPECTION REPORT

Pressure Vessel Survey			
Location:	Point Tupper	EM&I J Report No.:	PT-D2100C-090319-BR-R1
Client Name:		Client Ref No.:	PT-11573614-001-D2100C
Client Rep.:		Inspector Name:	Barry Ritchie
WO No.:		Inspection Date:	March 19, 2009
SPO No.:		System:	Propane
Workscope No.:	PT-2008-VESSEL-EXT-03	EM&I J Job No:	EMJ0132.33
Tag No.:	D-2100C	Equipment Description:	Propane Storage Vessel D-2100C
Date of Last Inspection:	NA	Previous Records Seen:	NA
Drawing No.:	LA-B23-F-22-8051-01-Z3, 98-CA-399735-1B-5, 98-CA-399735-4B-0

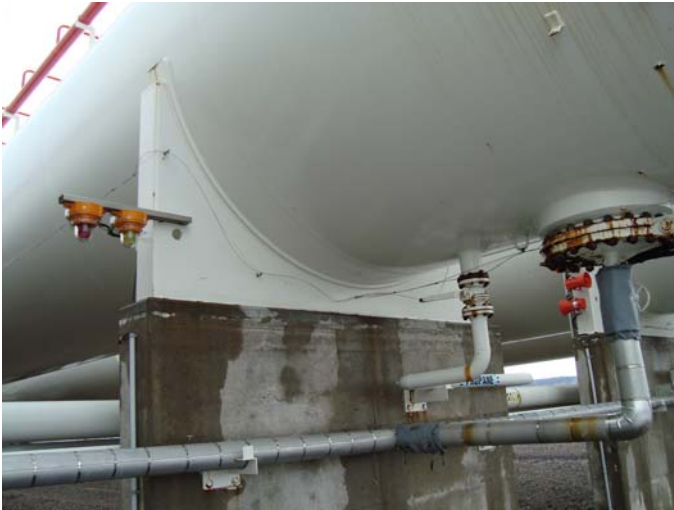
Photo 1 – North face of North vessel support, paint coating in good condition

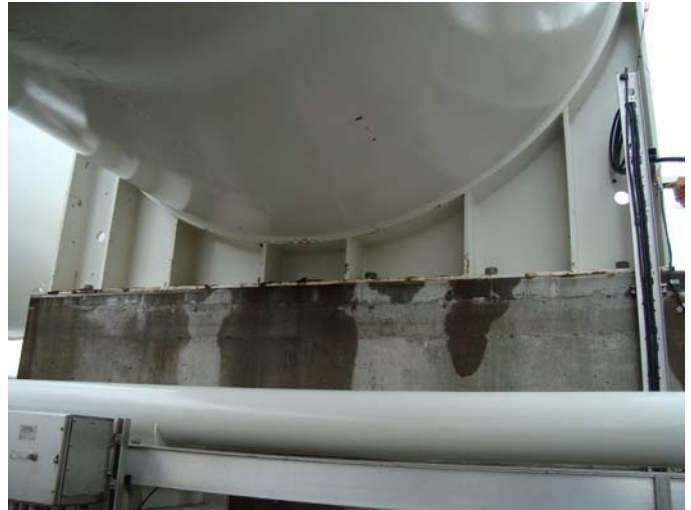
Photo 2 – South face of North vessel support, coating breakdown and corrosion only on lower flange connection to concrete

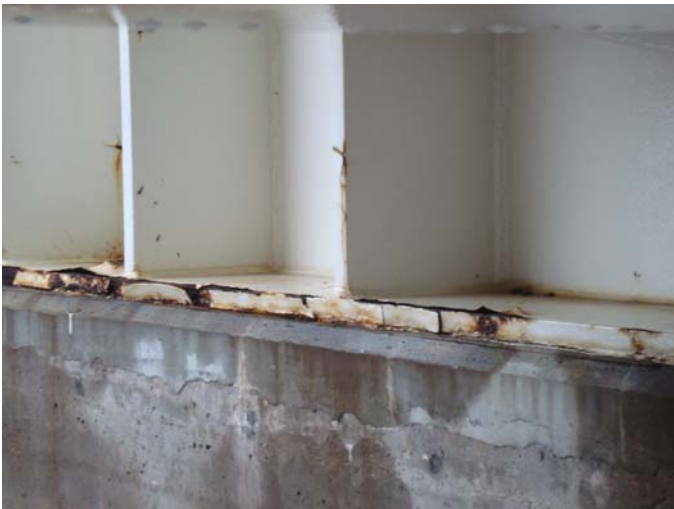
2. If applicable, check vessel supports for signs of deterioration, settlement, deflection, and/or corrosion.	<input checked="" type="checkbox"/>	<input type="checkbox"/>	<input type="checkbox"/>	<input type="checkbox"/>	See Photo #3

Photo 3 – Steel to concrete connection, coating breakdown mainly on edges

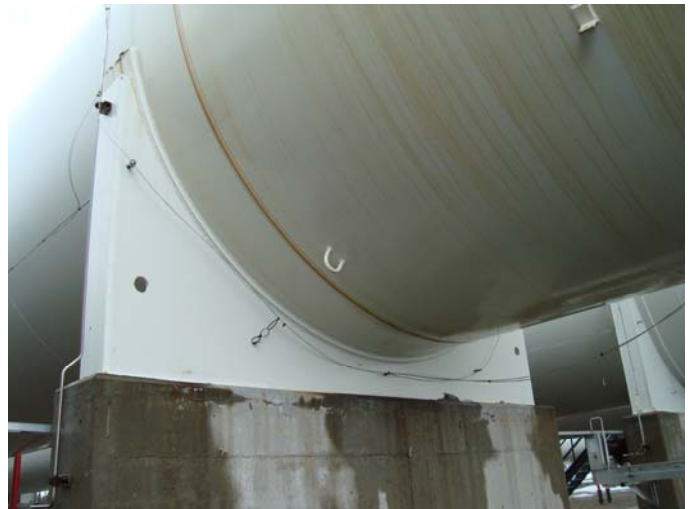
Photo 4 – South face of South vessel support, paint in good condition

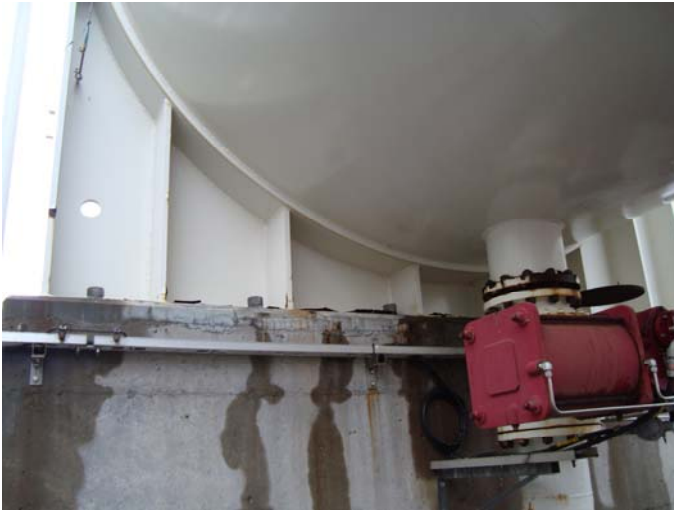
Photo 5 – North face of South vessel support, paint coating in good condition. Coating breakdown on lower flange mainly

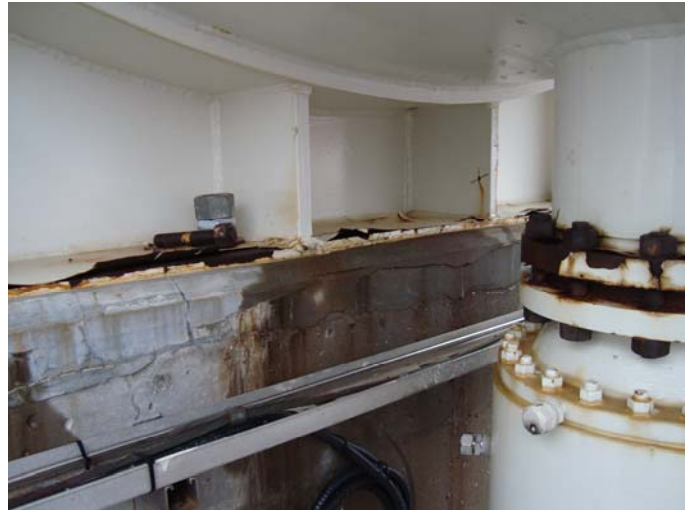
4. a) For horizontally mounted vessels, check for signs of trapped moisture, resulting in corrosion between cradle support and vessel shell.	<input type="checkbox"/>	<input checked="" type="checkbox"/>	<input type="checkbox"/>	<input type="checkbox"/>	Crack on South support See Photo #3 & 6

Photo 6 – Close-up of lower flange and horizontal crack along top edge of concrete

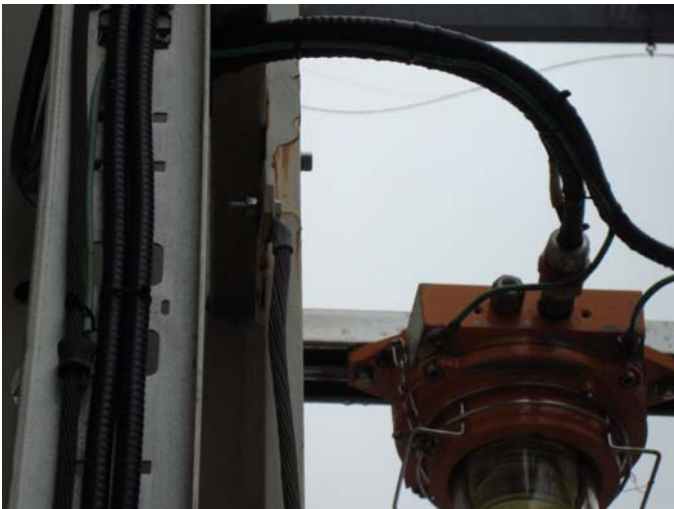
Photo 7 – Earthing strap connection North vessel support

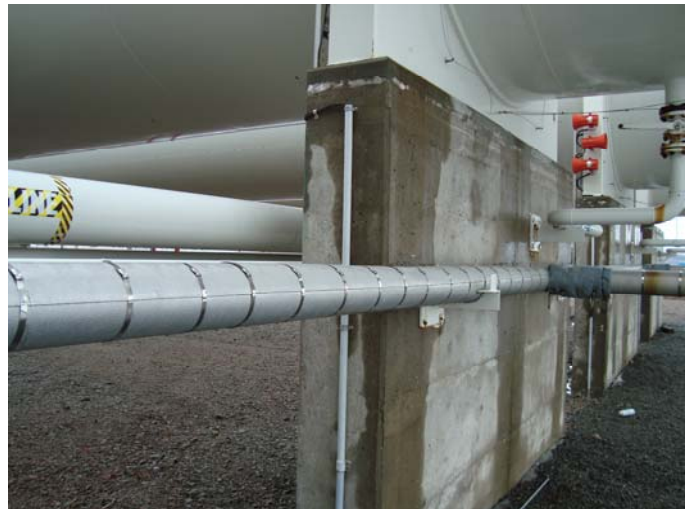
Photo 8 – Earthing strap and connections on North vessel support

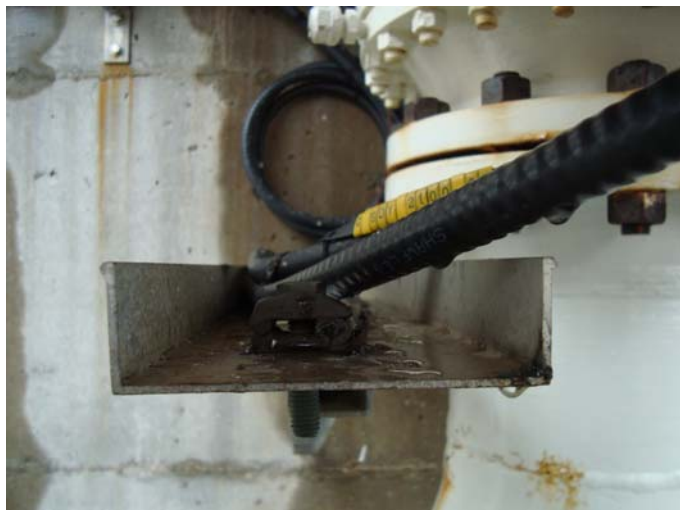
Photo 9 – Earthing strap connection on South vessel support

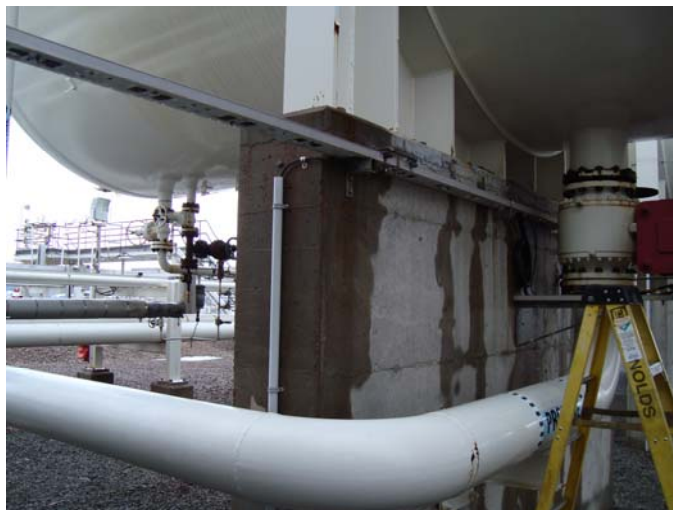
Photo 10 – Earthing strap on vessel support South side, general photo

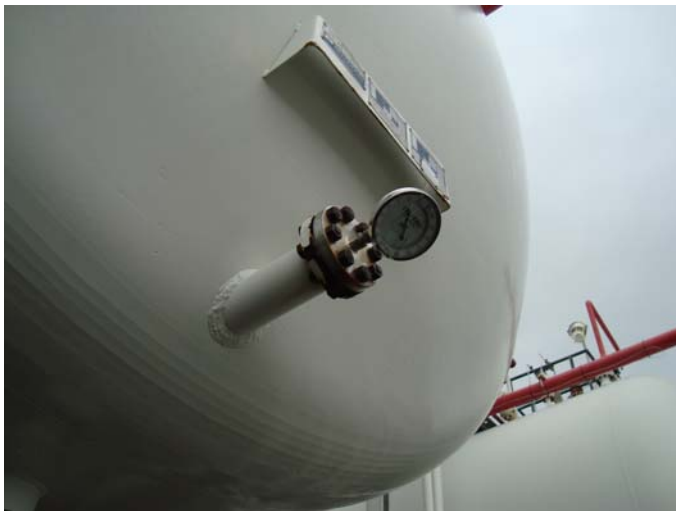
Photo 15 – Nozzle N6, in generally good condition, no areas of concern

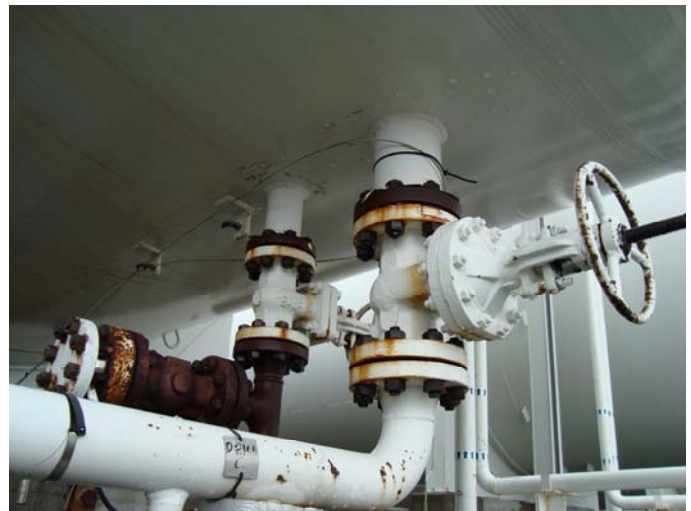
Photo 16 – Nozzles N3B & N4B, coating breakdown and light corrosion located only on flange connection, studs and nuts CAT III

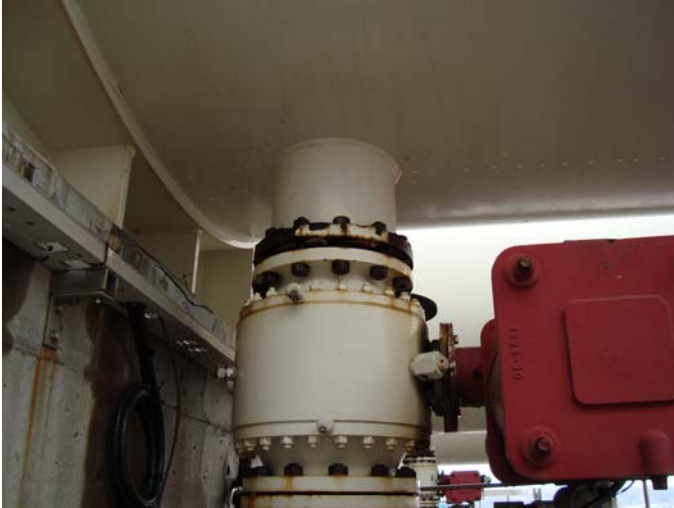
Photo 17 – Nozzle N2, coating breakdown only on flange connection. Studs and nuts uncoated but in good condition, CAT III

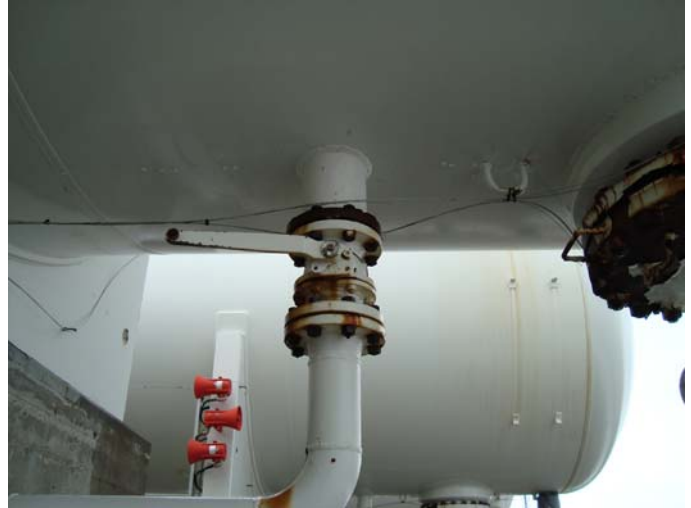
Photo 18 – Nozzle N5, coating breakdown only located on flange connection, studs and nuts CAT III

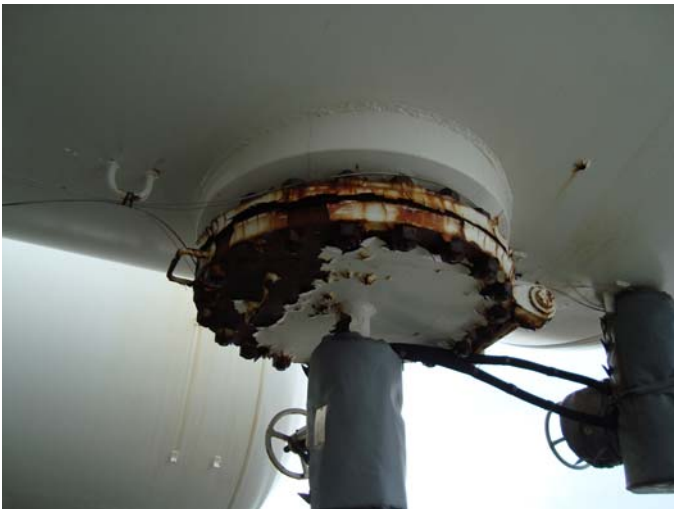
Photo 19 – Manhole, coating breakdown on flanges only. Studs and nuts uncoated, CAT III

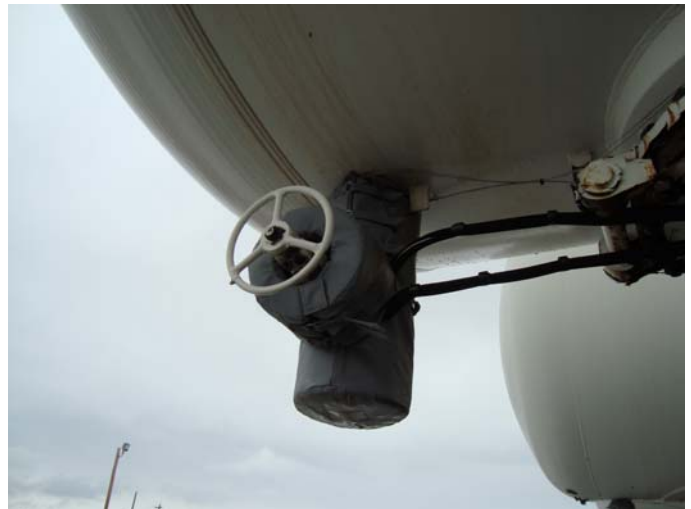
Photo 20 – N10, insulation bag in good condition, studs and nuts CAT III

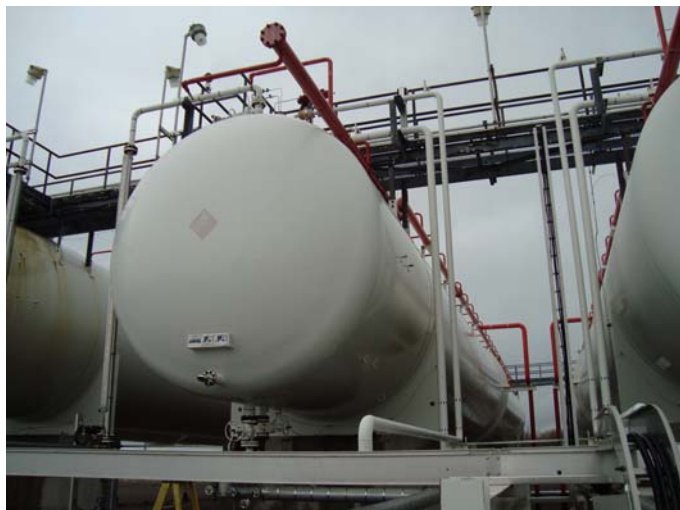
Photo 21 – General condition of East side shell, only a few small isolated patches of coating breakdown and light corrosion located on the upper section of shell

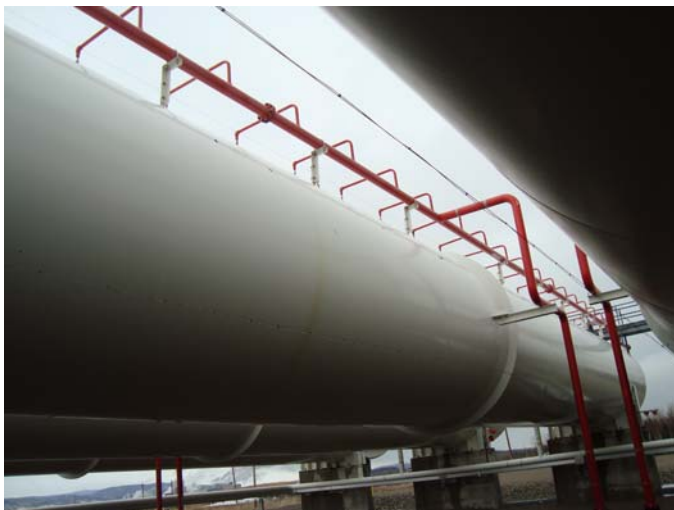
Photo 22 – General condition of East side shell, only a few small isolated patches of coating breakdown and light corrosion located on the upper section of shell

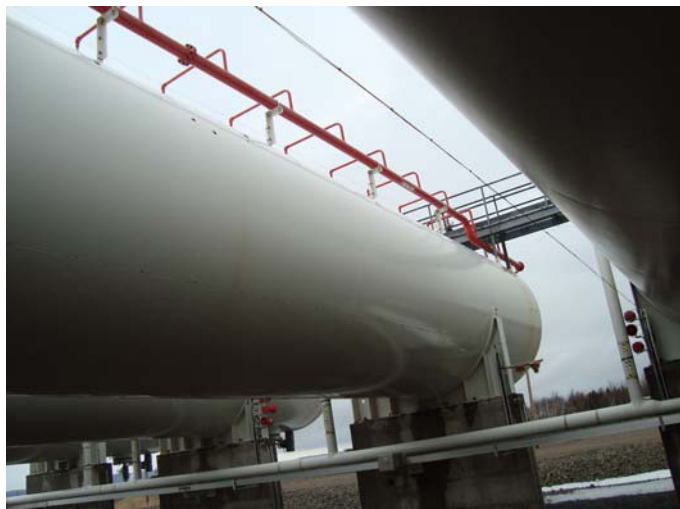
Photo 23 – General condition of East side shell, only a few small isolated patches of coating breakdown and light corrosion located on the upper section of shell

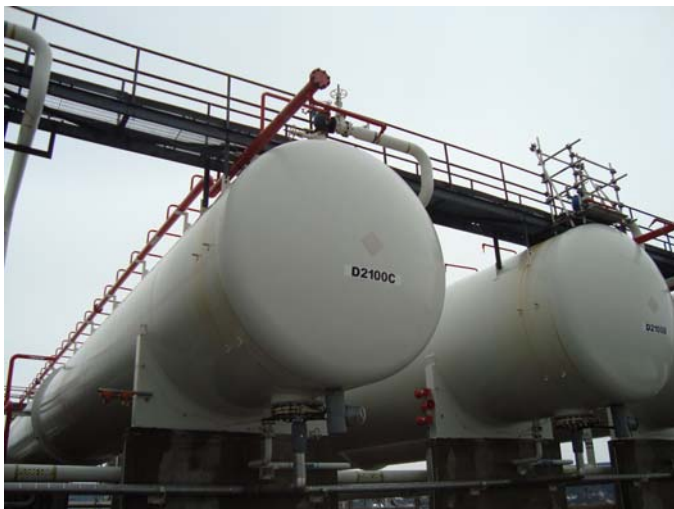
Photo 24 – General good condition of North dome end, photo taken facing South

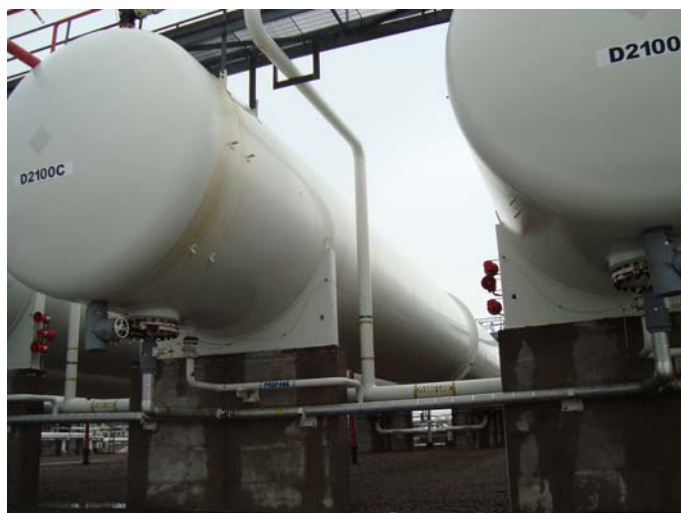
Photo 25 – West side shell in general condition, photo taken facing South

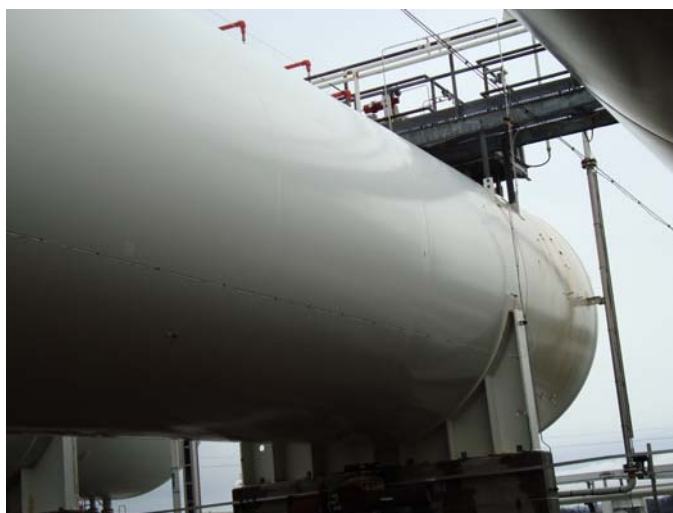
Photo 26 – West side shell in general condition, photo taken facing South

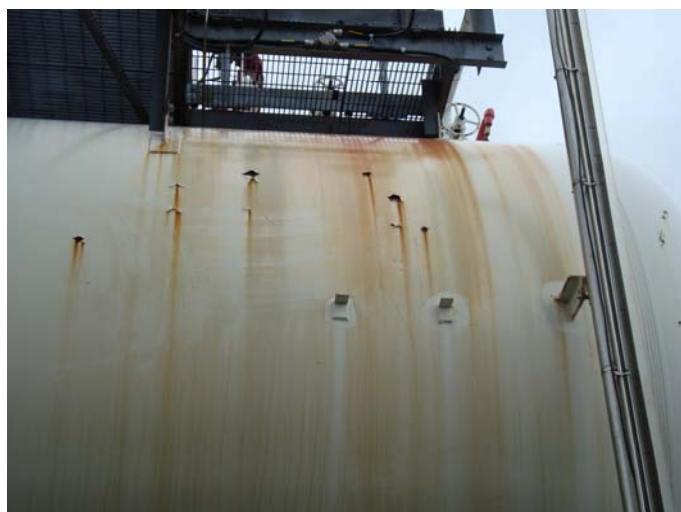
Photo 27 – West side shell in general condition. Showing small isolated patches of coating breakdown and light corrosion, largest patch measuring approx 50mm x 20mm all photos taken facing South

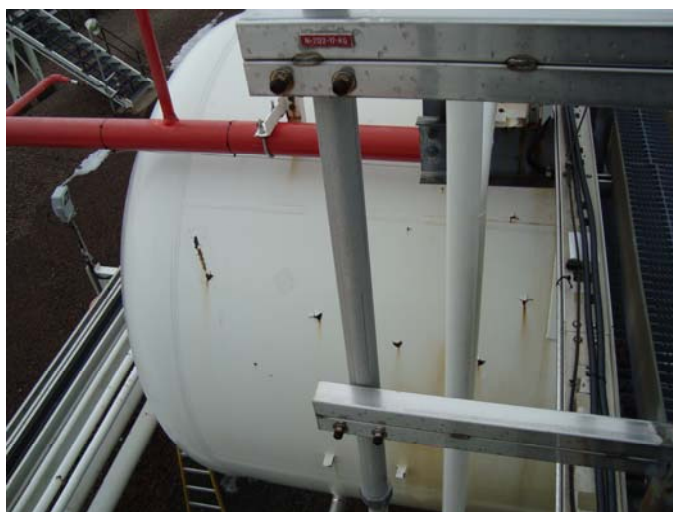
Photo 28 – Small isolated patches of coating breakdown and light corrosion on the upper South-East side shell Dome end

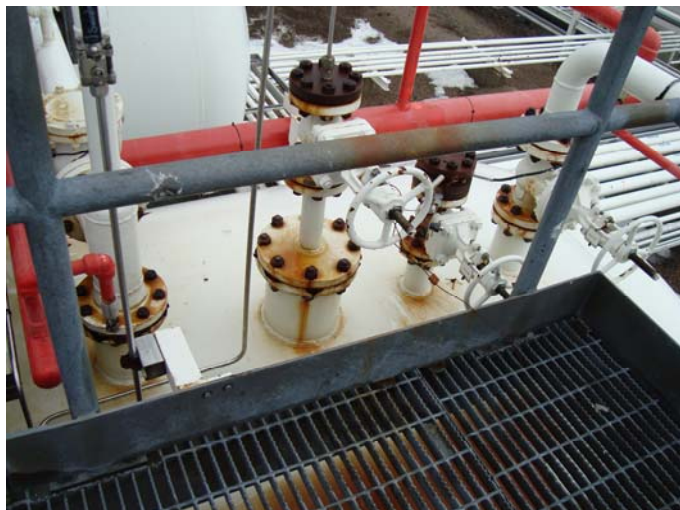
Photo 29 – Nozzles N3A/N4A/N8/N1, coating breakdown and light to moderate corrosion located only on flanges. All studs and nuts are uncoated but are in good condition, CAT III

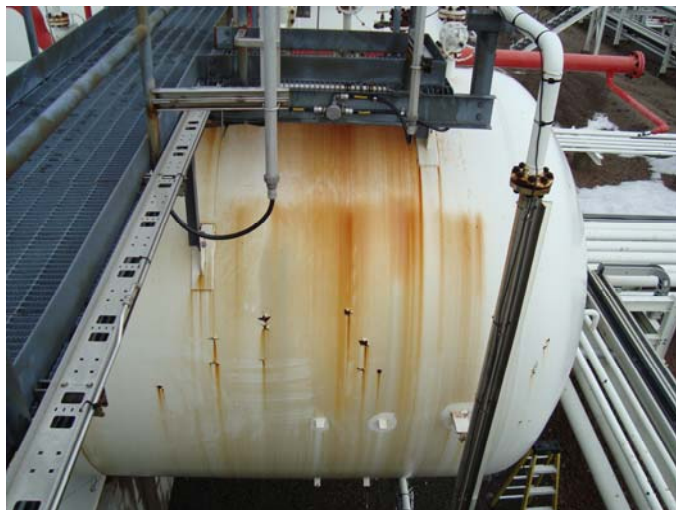
Photo 30 – South-West upper side shell, same as photo 27

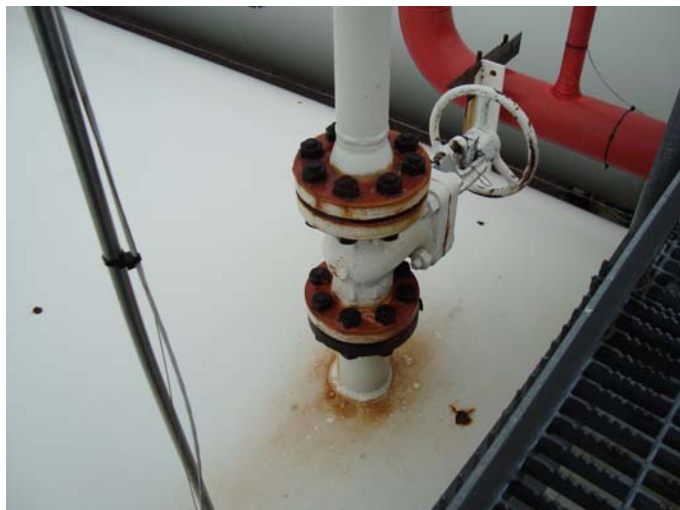
Photo 31 – Nozzle N9, coating breakdown on flange connection only studs and nuts have lost paint coating but are still in good condition, CAT III

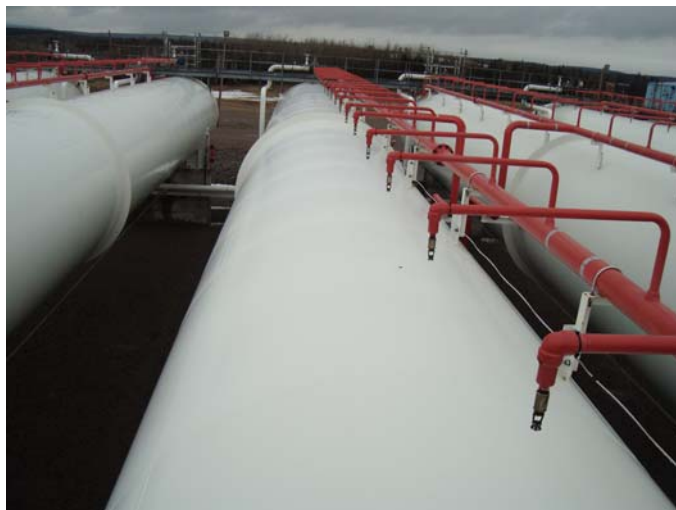
Photo 32 – General good condition of top section of vessel

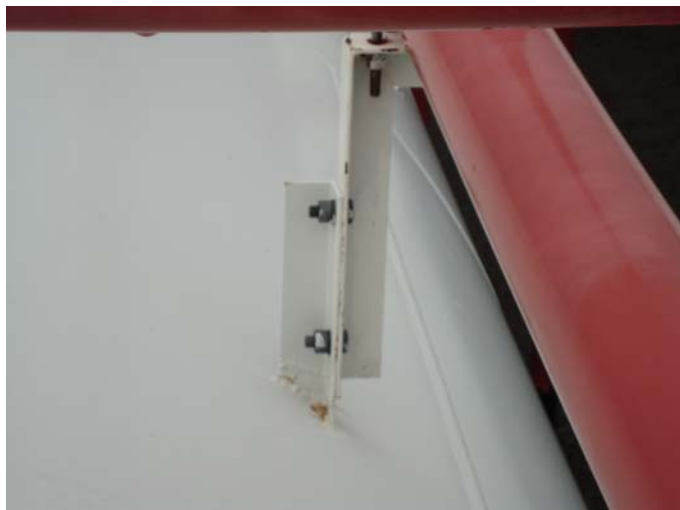
Photo 33 – Typical condition of deluge pipe support

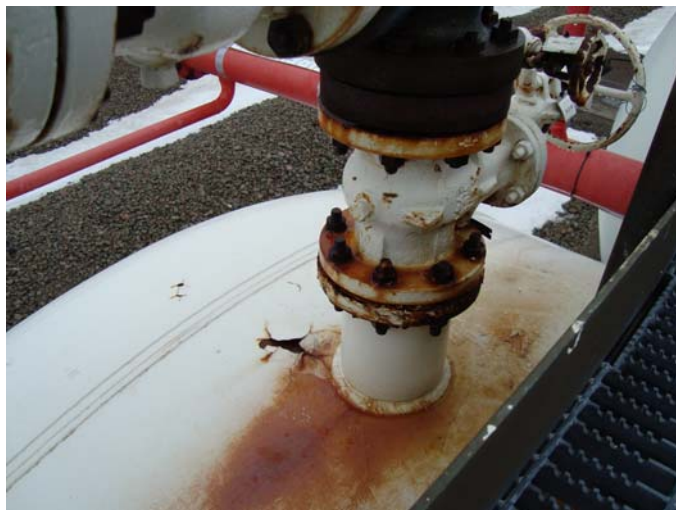
Photo 34 – Nozzle N7, coating breakdown only on flange connection. Studs and nuts CAT II

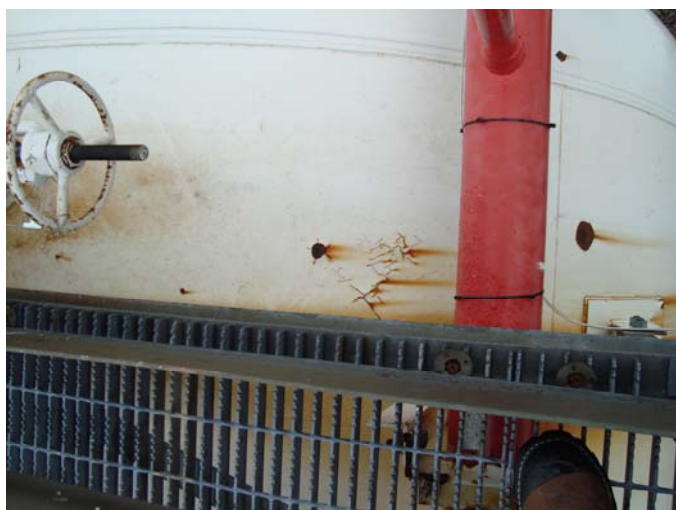
Photo 36 – Coating breakdown and light corrosion on top of North dome, East side

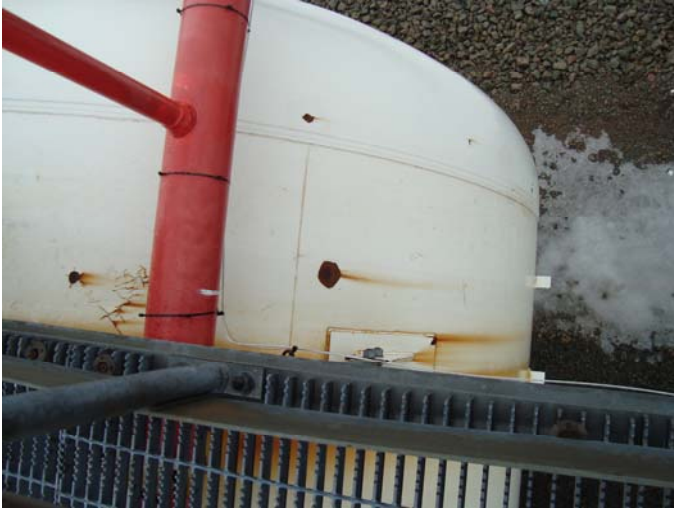
Photo 37 – Coating breakdown and light corrosion on top of North dome, East side

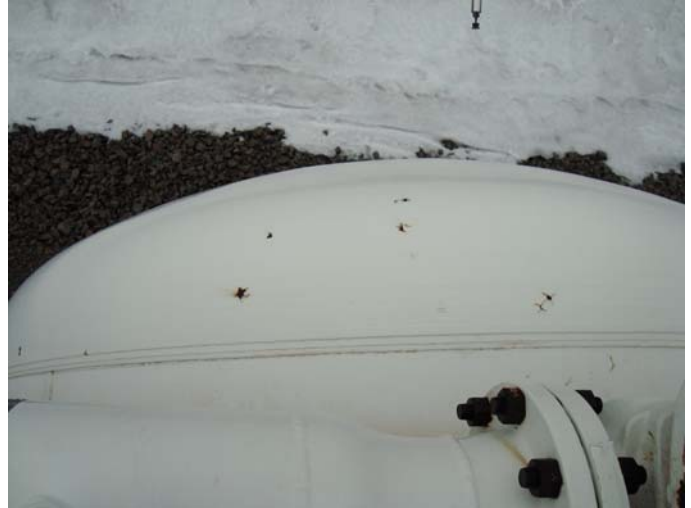
Photo 38 – Very small isolated patches of coating breakdown on North dome, top Centre

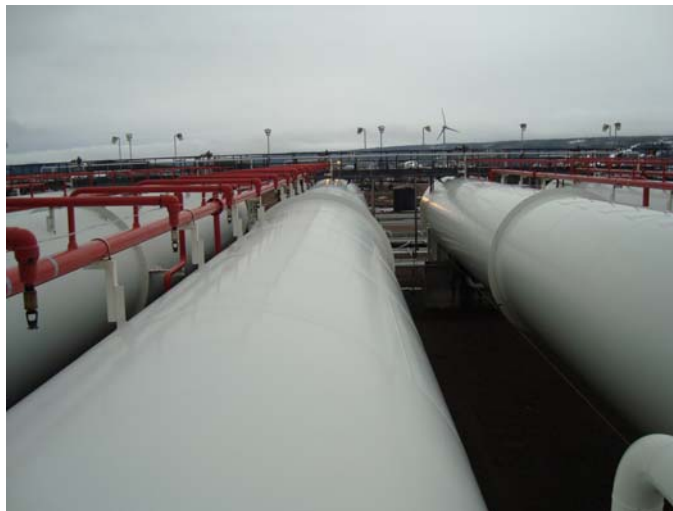
Photo 39 – General view along top section of vessel, all good condition, photo taken facing South
