INSPECTION REPORT

Pressure Vessel Survey			
Location:	Point Tupper	EM&I Report No.:	PT-D2100C-090715-JT-R0
Client Name:		Client Ref No.:	PT-11564782-002-D2100C
Client Rep.:		Inspector Name:	James Tulk
WO No.:		Inspection Date:	July 15, 2009
SPO No.:		System:	Propane
Workscope No.:	PT-2009-D2100C-INT-01	EM&I Job No:	EMJ0132.43
Tag No.:	D-2100C	Equipment Description:	Propane Storage Vessel D-2100C
Date of Last Inspection:	NA	Previous Records Seen:	NA
Drawing No.:	LA-B23-F-22-8051-01-Z3, 98-CA-399735-1B-5

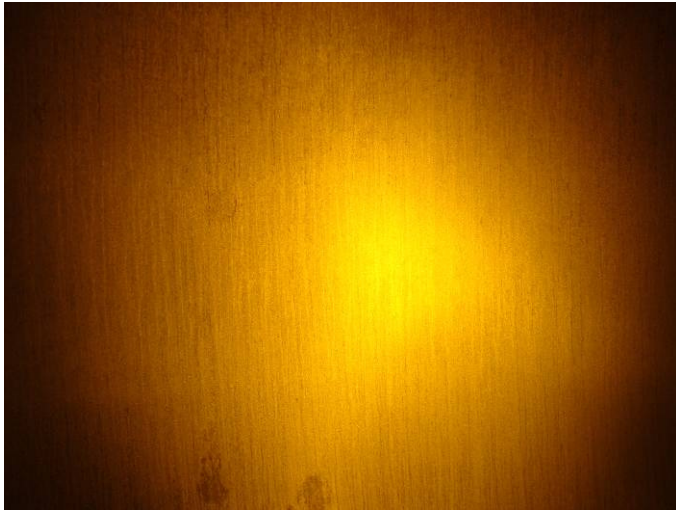
Photo 1 – Interior of north head

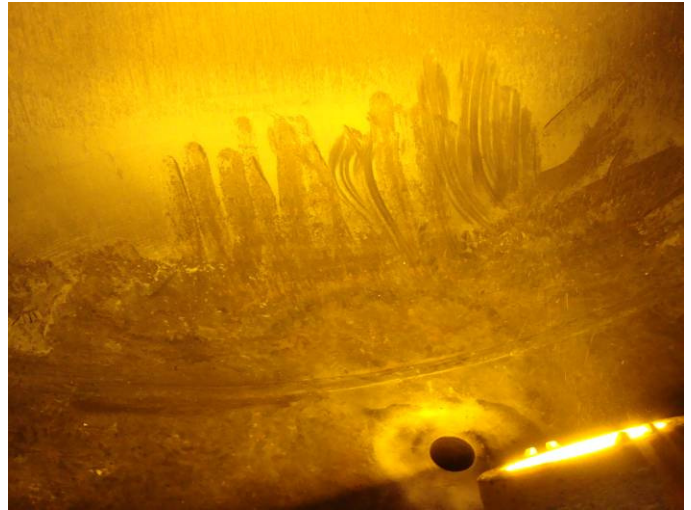
Photo 2 – Bottom section of north head circ seam and 3" nozzle N10

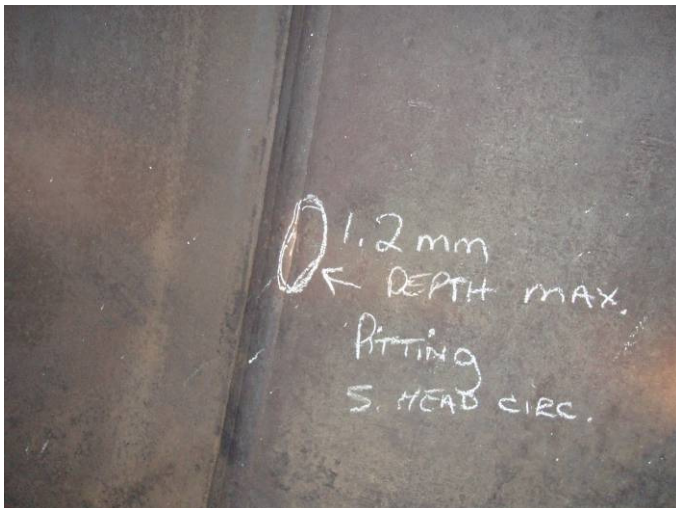
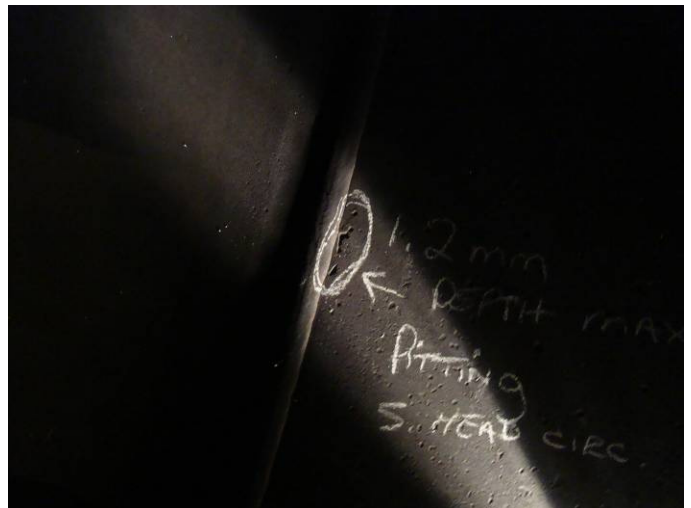
A localized pitting area was also found adjacent to south head circ seam 13 which was measured at its most significant depth and found to be approx 1.2mm deep and a length of 32mm. See photo 3 and 4.

Photo 3 – Area of pitting

Photo 4 – Area of pitting

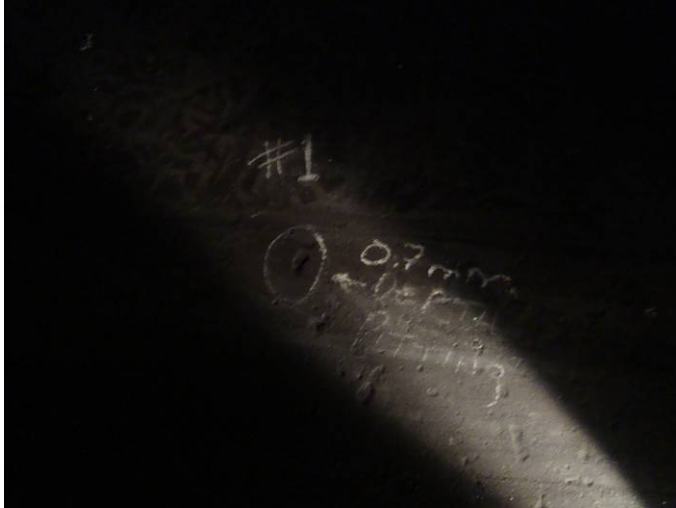
pit 1= 0.7mm depth - see photo 5 Acceptable for service

Photo 5 – Area of pitting

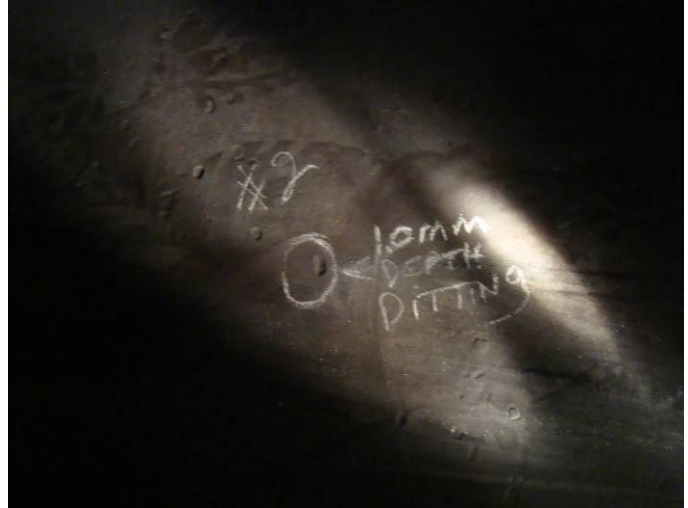
pit 2= 1.0mm depth - see photo 6 Acceptable for service

Photo 6 – Area of pitting

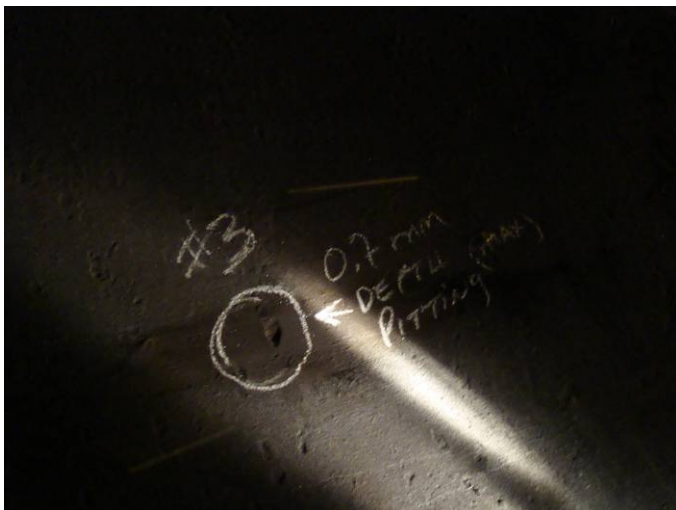
pit 3= 0.7mm depth - see photo 7 Acceptable for service

Photo 7 – Area of pitting

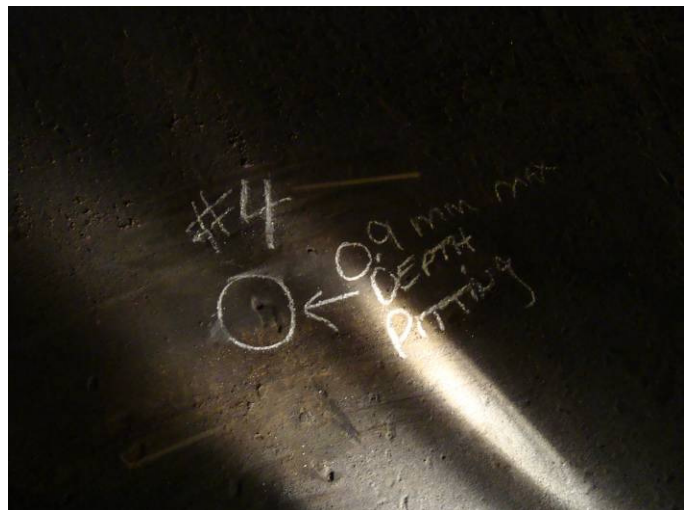
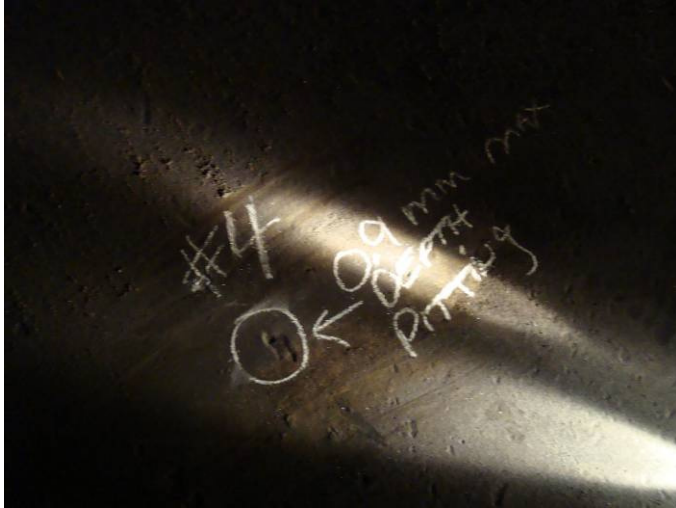
pit 4= 0.9mm depth - see photo 8 & 9 Acceptable for service

Photo 8 – Area of pitting

Photo 9 – Area of pitting

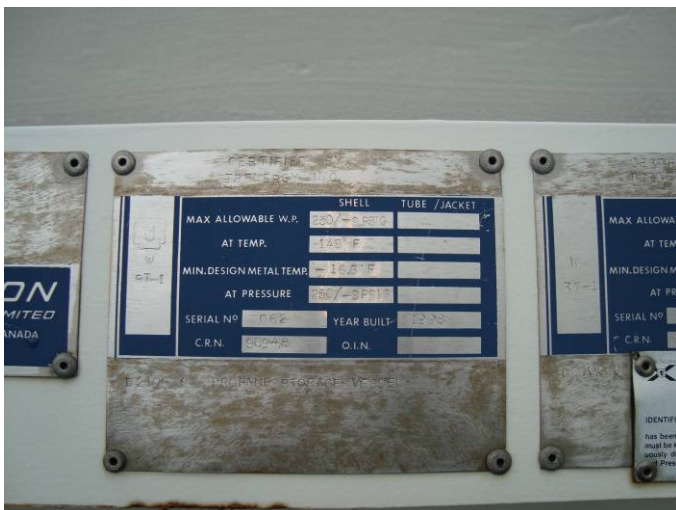
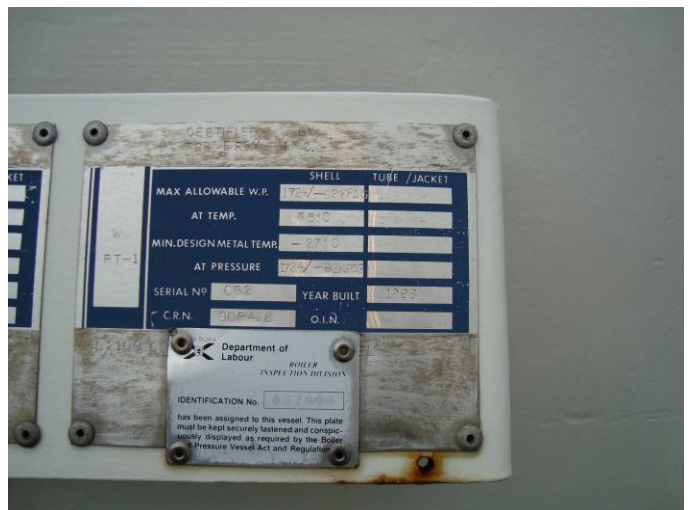
1. Check permanent identifying tags on vessel are legible and present the required information.	<input checked="" type="checkbox"/>	<input type="checkbox"/>	<input type="checkbox"/>	<input type="checkbox"/>	See Details of Findings and Photos 11 and 12

Photo 11 – Nameplate

Photo 12 – Nameplate

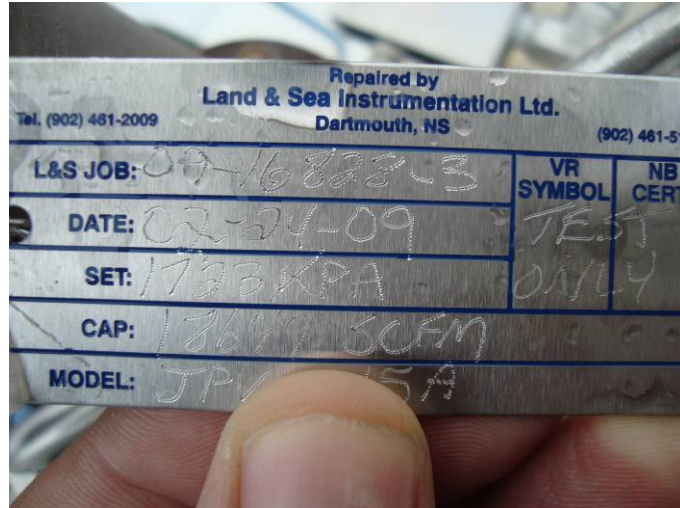
2. If applicable, check if the PSV on the vessel is in calibration. Record tag number of PSV and calibration date.	<input checked="" type="checkbox"/>	<input type="checkbox"/>	<input type="checkbox"/>	<input type="checkbox"/>	See Details of Findings and Photo 13

Photo 13 – PSV tag
