INSPECTION REPORT

Pressure Vessel Survey			
Location:	Point Tupper	EM&I J Report No.:	PT-D2100D-090319-BR-R1
Client Name:		Client Ref No.:	PT-11573615-001-D2100D
Client Rep.:		Inspector Name:	Barry Ritchie
WO No.:		Inspection Date:	March 19, 2009
SPO No.:		System:	Propane
Workscope No.:	PT-2008-VESSEL-EXT-03	EM&I J Job No:	EMJ0132.33
Tag No.:	D-2100D	Equipment Description:	Propane Storage Vessel D-2100D
Date of Last Inspection:	NA	Previous Records Seen:	NA
Drawing No.:	LA-B23-F-22-8052-01-Z4, 980047-4-2, 980047-2-4, 98-CA-399735-4B-0

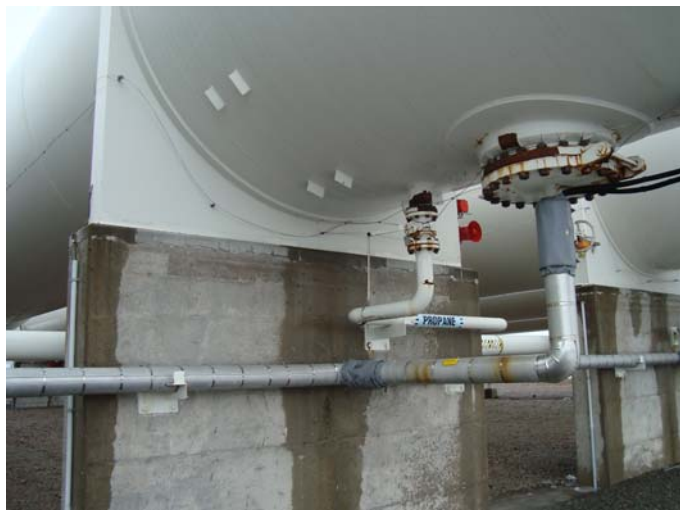
Photo 1 – North face of North vessel support, paint coating in good condition, photo taken facing South

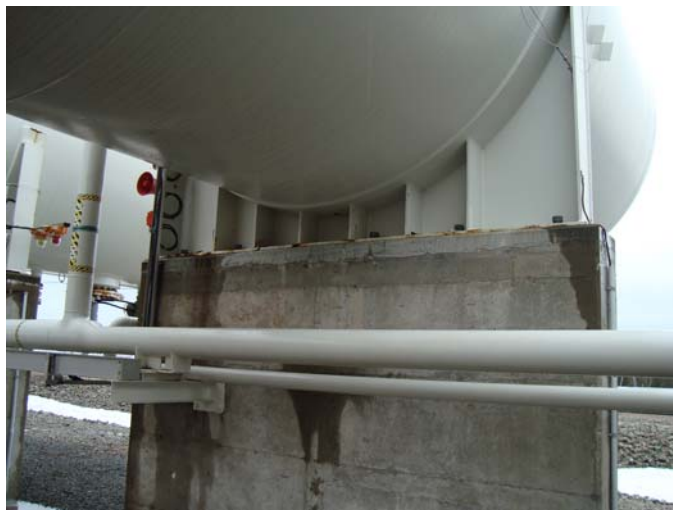
Photo 2 – South face of North vessel support , showing corrosion running along lower flange connection to concrete support, photo taken facing South

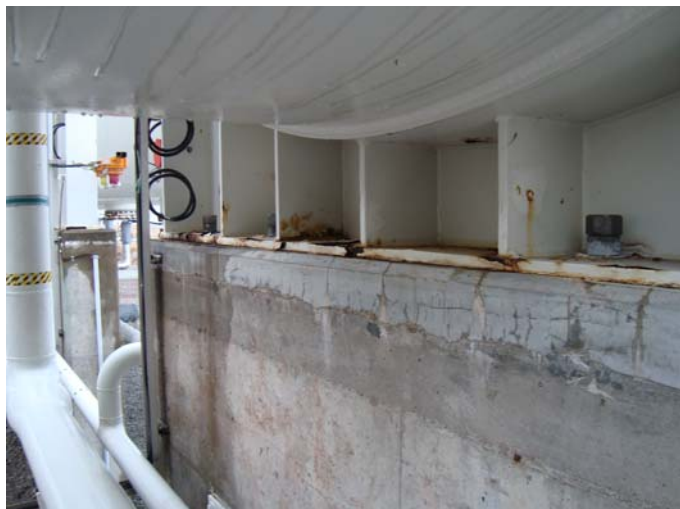
Photo 3 – South face of North vessel support , showing corrosion running along lower flange connection to concrete support, photo taken facing South

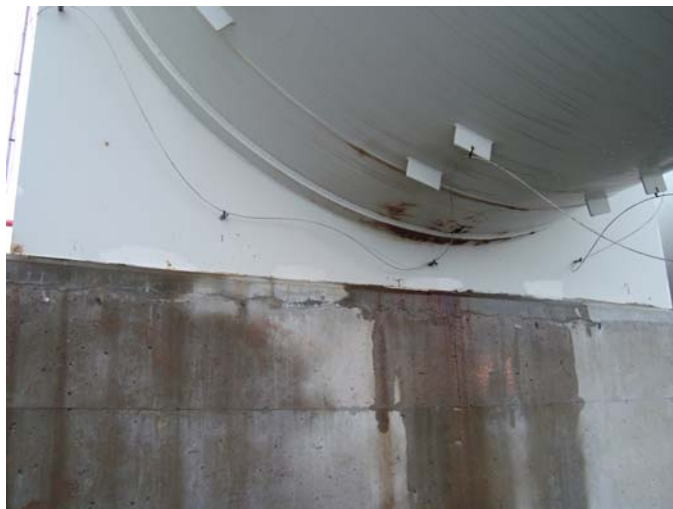
Photo 4 – South face of South vessel support showing coating breakdown on upper flange, photo taken facing North

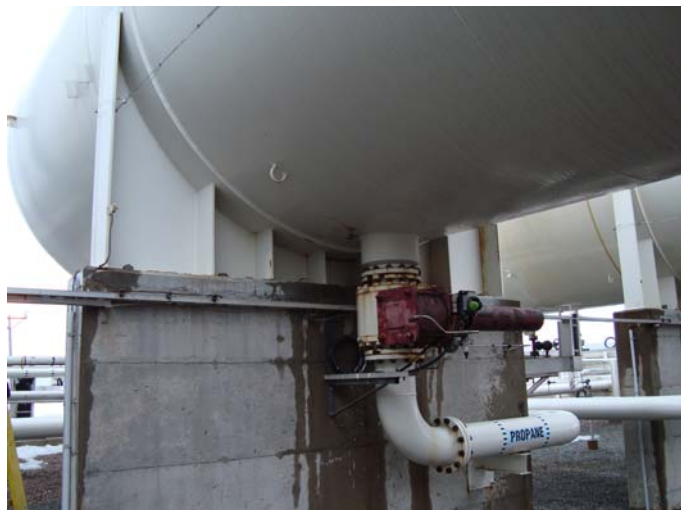
Photo 5 – North face of South vessel support , coating breakdown on lower flange with damage to top South-East vessel concrete support, taken facing West

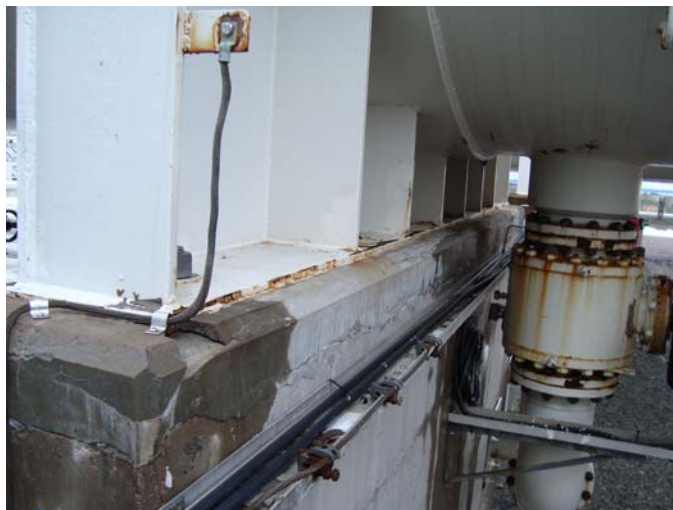
Photo 6– North face of South vessel support, coating breakdown on lower flange with damage to top South-East vessel concrete support, taken facing West

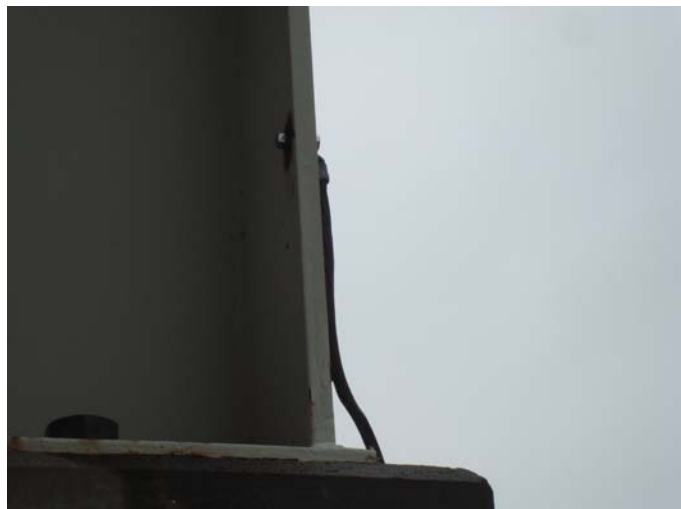
Photo 7 – Earth strap connections to be in good condition

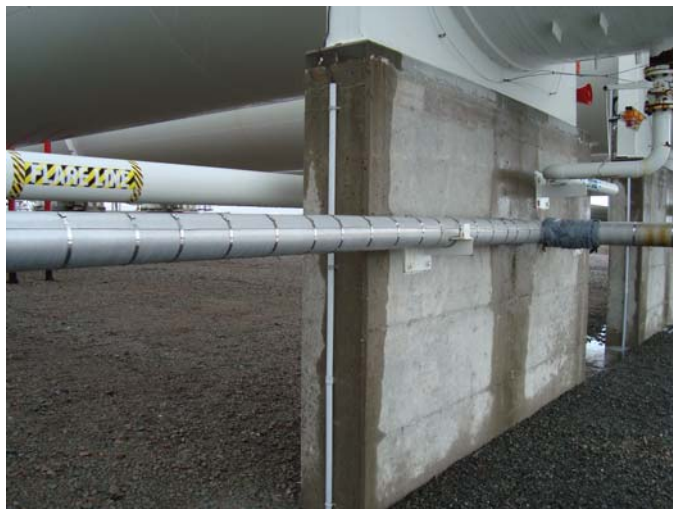
Photo 8 – Earth strap connections to be in good condition

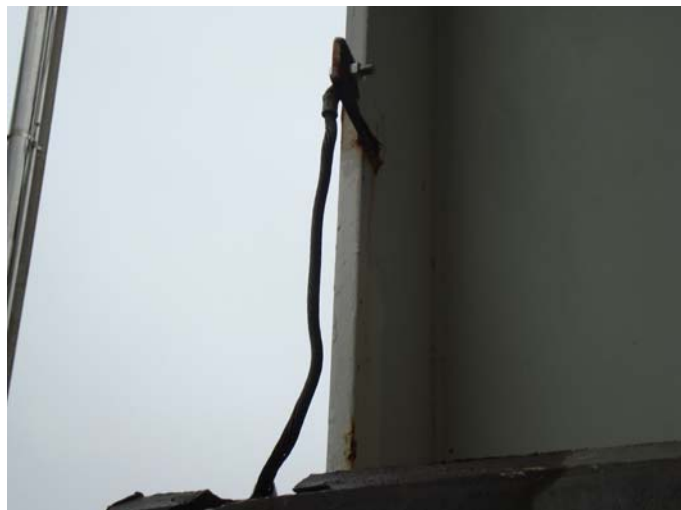
Photo 9 – Earth strap connections to be in good condition

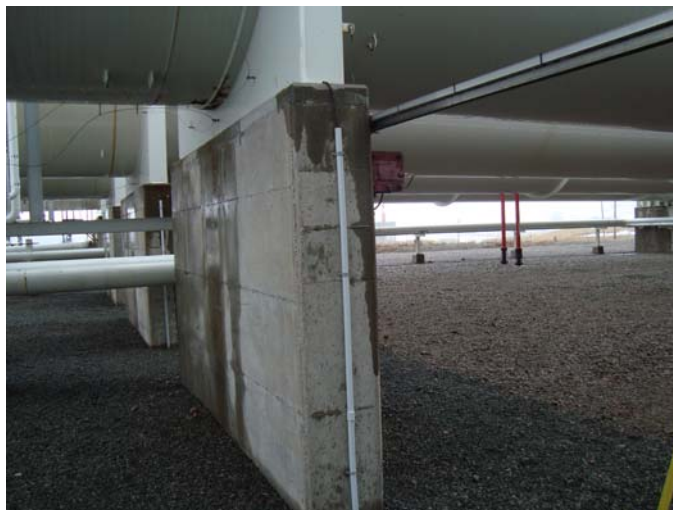
Photo 10 – Earth strap connections to be in good condition

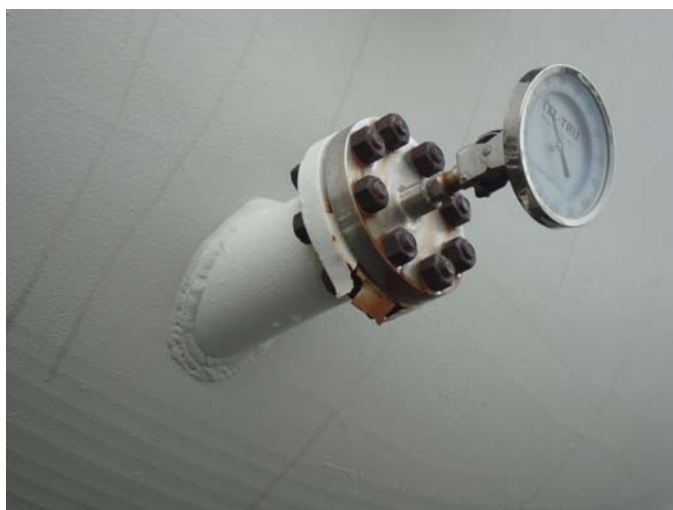
Photo 12 – Nozzle N6, in good condition, studs and nuts CAT III

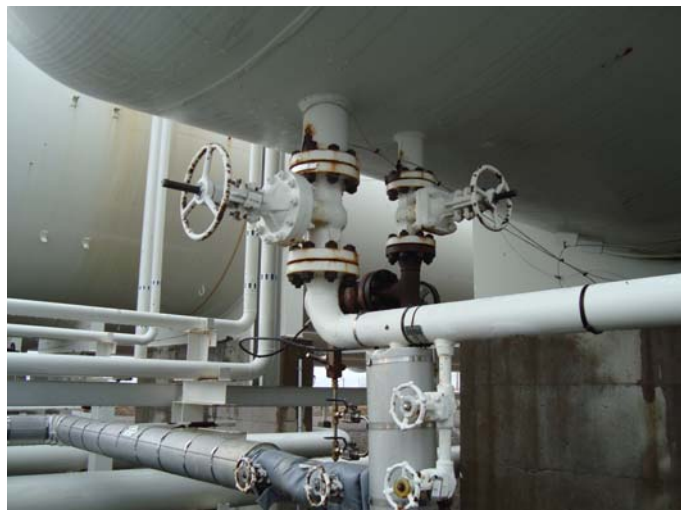
Photo 13 – Nozzles N3B & N4B, showing corrosion and coating breakdown, studs and nuts CAT III

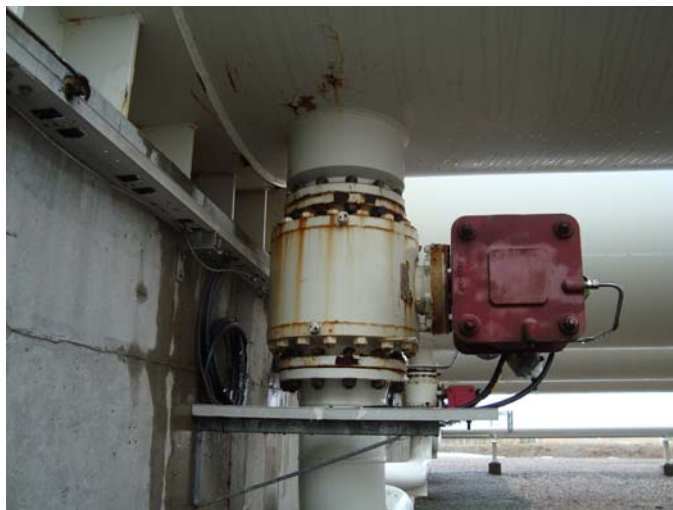
Photo 14 – Nozzle N2 with coating breakdown. Studs and nuts CAT III

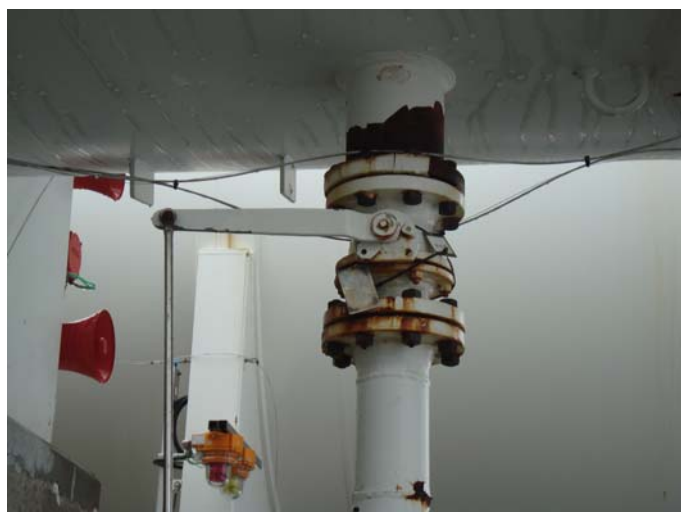
Photo 15 – Nozzle N5 with coating breakdown and light corrosion, studs and nuts CAT III

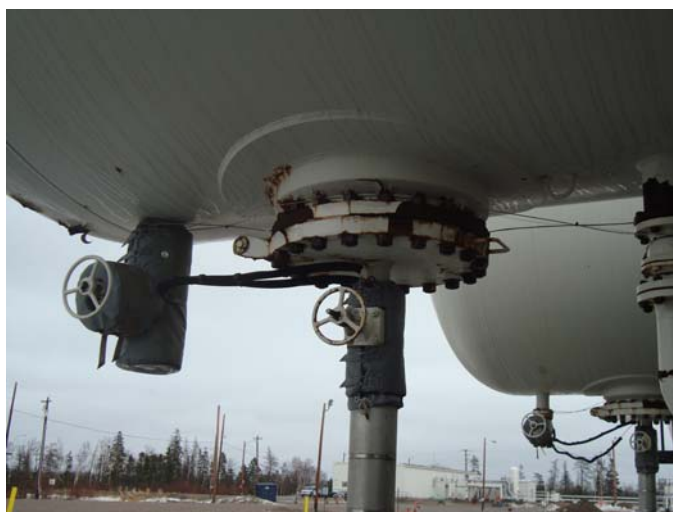
Photo 16 – Manhole with coating breakdown and light corrosion, studs and nuts CAT III

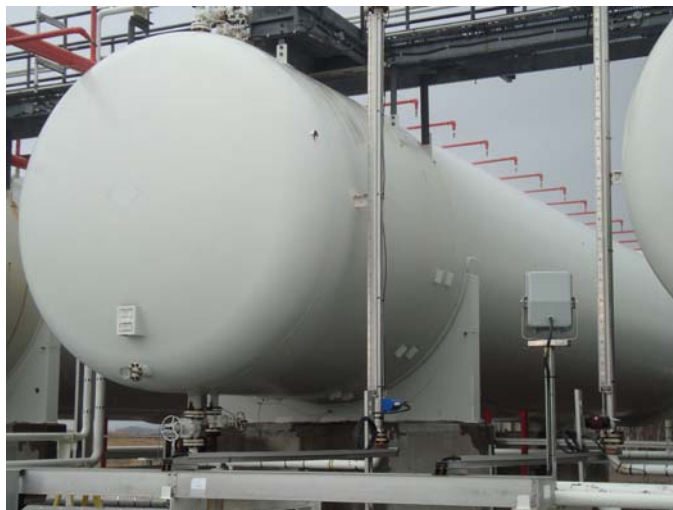
Photo 18 – General photo taken of the South end dome of vessel, showing one isolated patch of coating breakdown, photo taken facing North

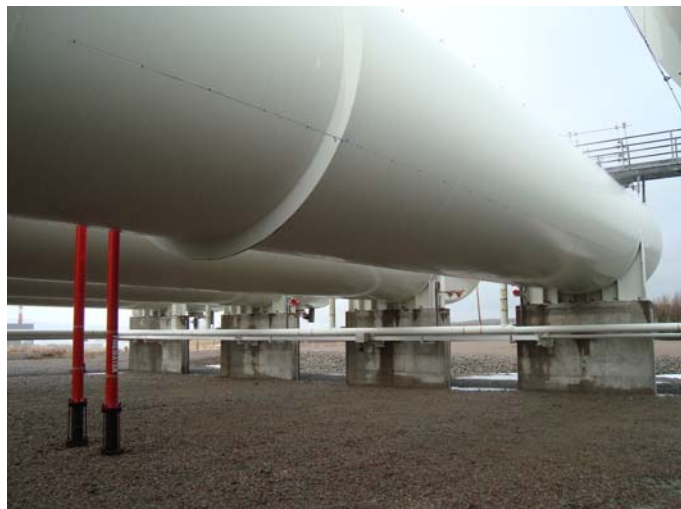
Photo 19 – General photo taken of the East side shell of vessel, shown to be in good condition, photo taken facing North

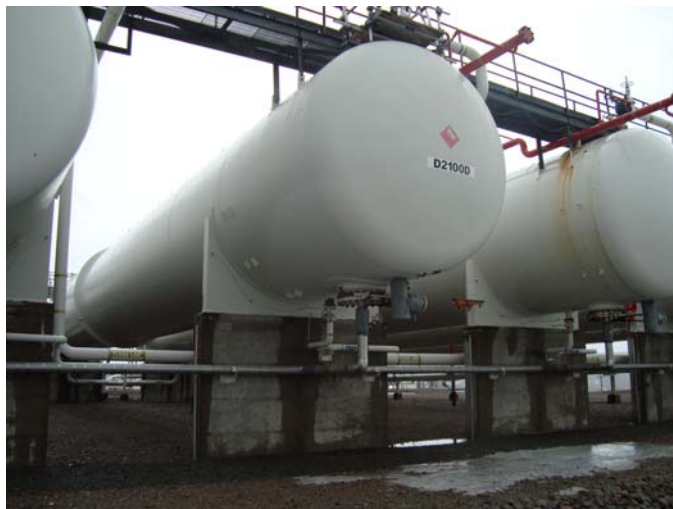
Photo 20 – General photos taken of North end dome of vessel, showing two isolated patches of coating breakdown on bottom centre of the dome end, photos taken facing South

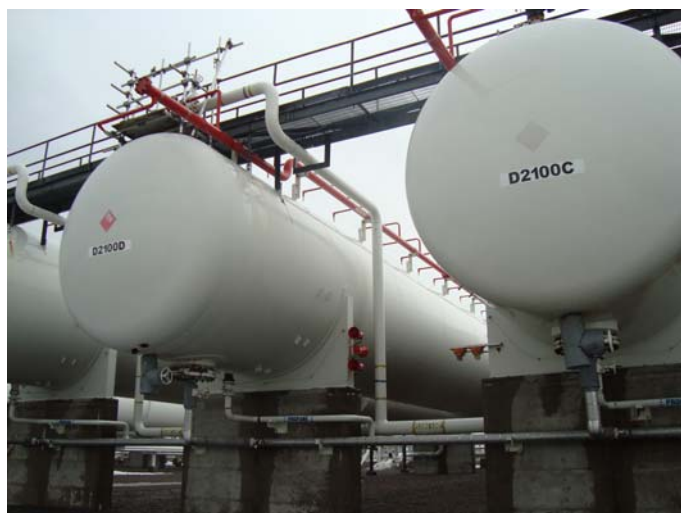
Photo 21 – General photos taken of North end dome of vessel, showing two isolated patches of coating breakdown on bottom centre of the dome end, photos taken facing South

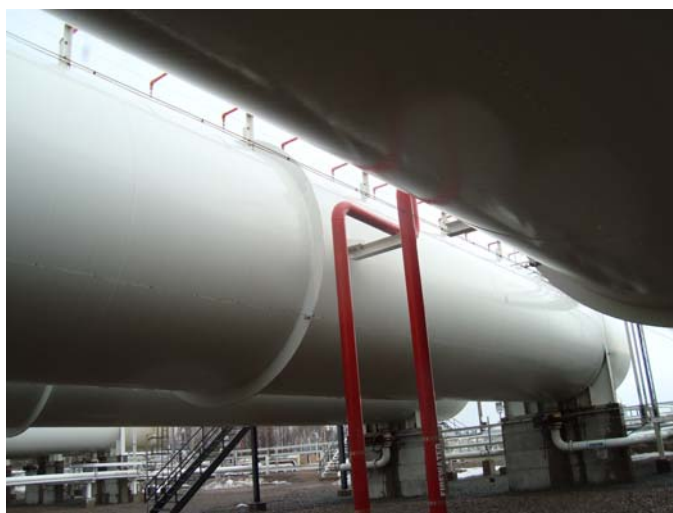
Photo 22 – West side shell of vessel, in good condition, photo taken facing South

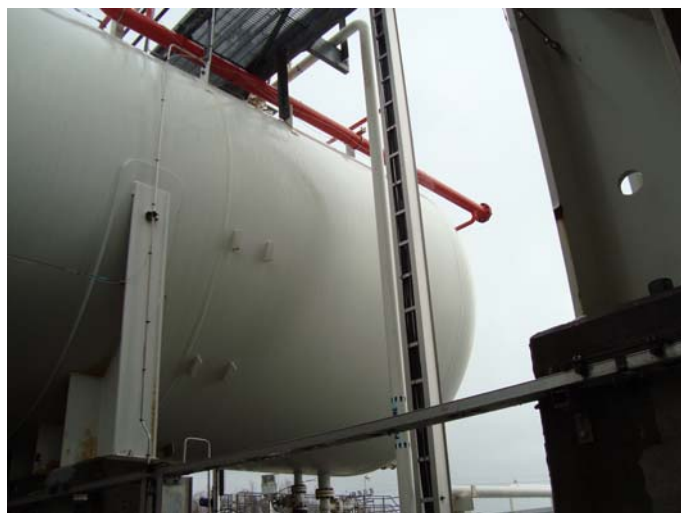
Photo 23 – West side shell of vessel, in good condition, photo taken facing South

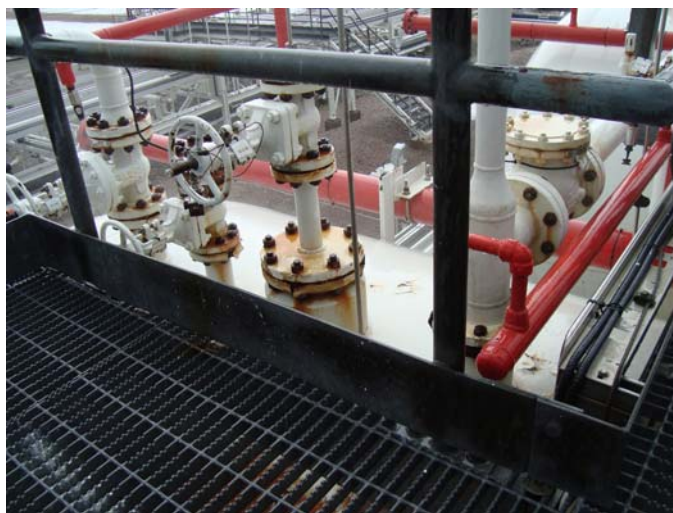
Photo 24 – Nozzles N3A, N4A, N8 & N1 showing coating breakdown, studs and nuts CAT III

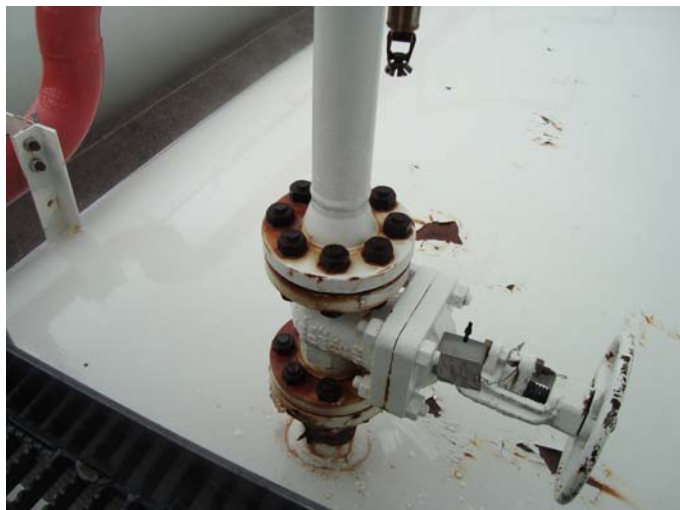
Photo 25 – Nozzle N9 showing coating breakdown, studs and nuts CAT III

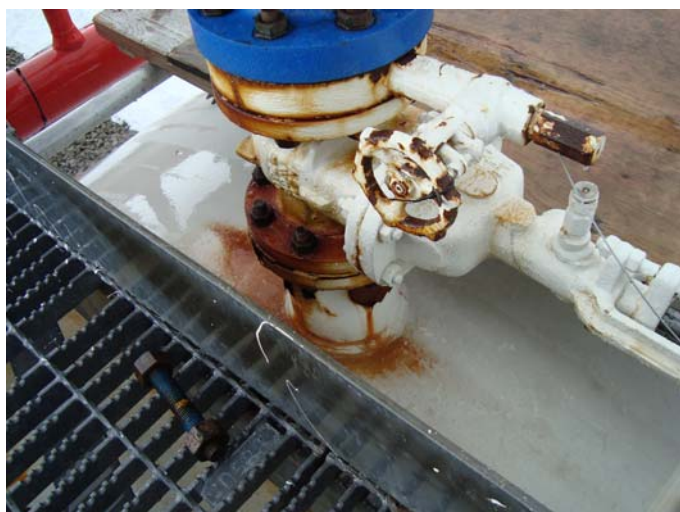
Photo 27 – Nozzle N7 with corrosion and coating breakdown

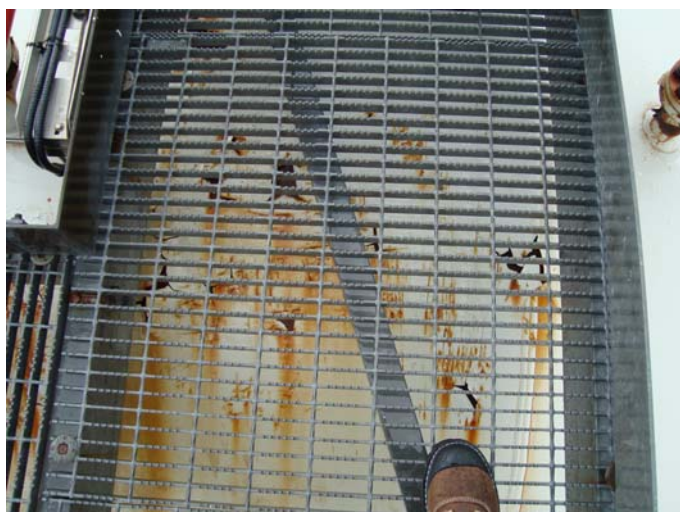
Photo 31 – Coating breakdown on top of vessel under South side walkway

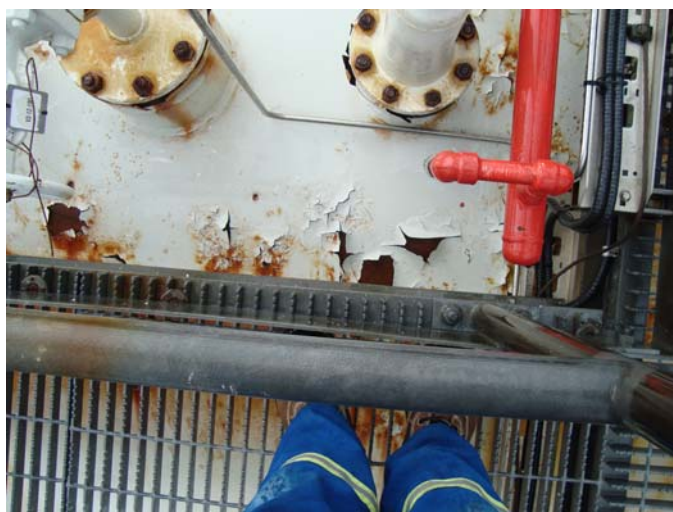
Photo 32 – Showing coating breakdown on top of South end dome next to nozzles N3A, N4A, N8 & N1

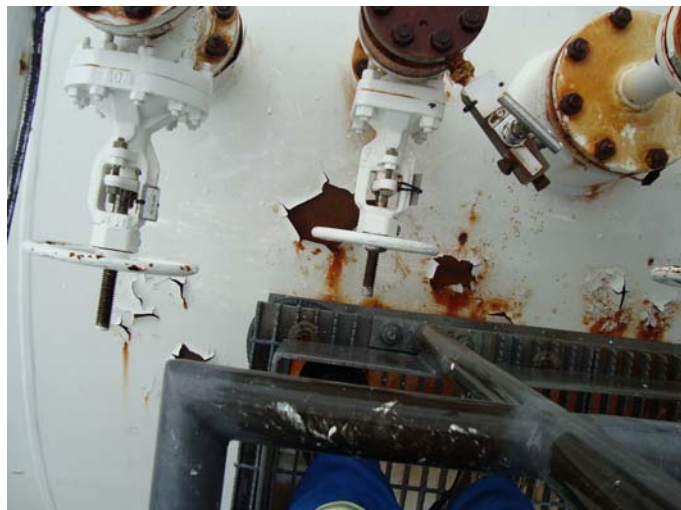
Photo 33 – Showing coating breakdown on top of South end dome next to nozzles N3A,N4A,N8 & N1

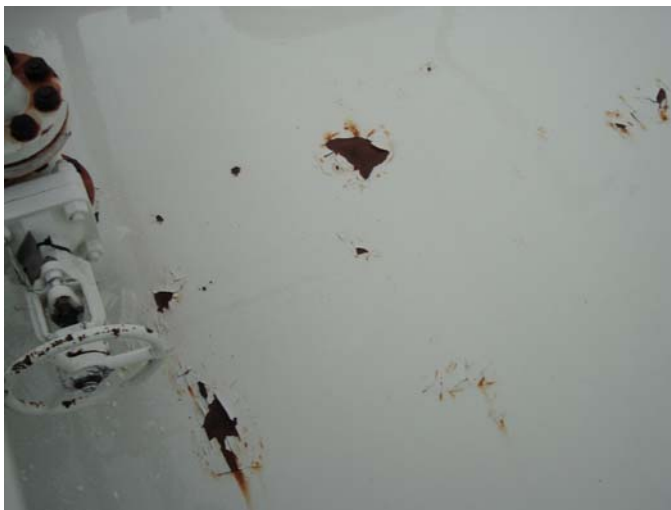
Photo 34 – Coating breakdown on top of dome North end of vessel next to nozzle N7

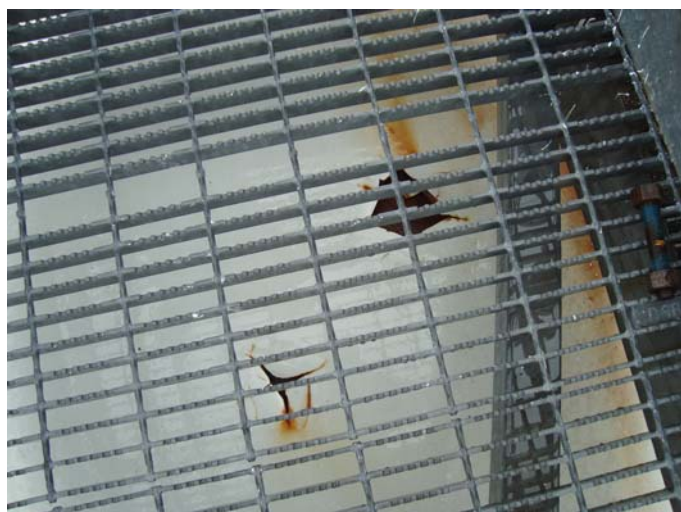
Photo 35 – Coating breakdown on top of dome North end of vessel under walkway

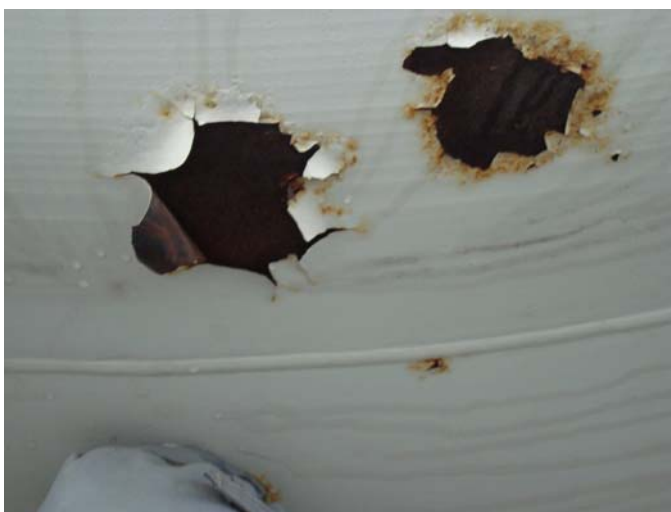
Photo 36 – Patches of coating breakdown, the largest measuring approx 160mm x 160mm under North end dome next to nozzle N10
