# INSPECTION REPORT

Pressure Vessel Survey			
<b>Location:</b>	Point Tupper	<b>EM&amp;I J Report No.:</b>	PT-D2100D-090714-JT-R0
<b>Client Name:</b>		<b>Client Ref No.:</b>	PT-11564783-002-D2100D
<b>Client Rep.:</b>		<b>Inspector Name:</b>	James Tulk
<b>WO No.:</b>		<b>Inspection Date:</b>	July 14, 2009
<b>SPO No.:</b>		<b>System:</b>	Propane
<b>Workscope No.:</b>	PT-2009-D2100D-INT-01	<b>EM&amp;I J Job No:</b>	EMJ0132.43
<b>Tag No.:</b>	D-2100D	<b>Equipment Description:</b>	Propane Storage Vessel D-2100D
<b>Date of Last Inspection:</b>	NA	<b>Previous Records Seen:</b>	NA
<b>Drawing No.:</b>	LA-B23-F-22-8052-01-Z4, 980047-4-2, 980047-2-4

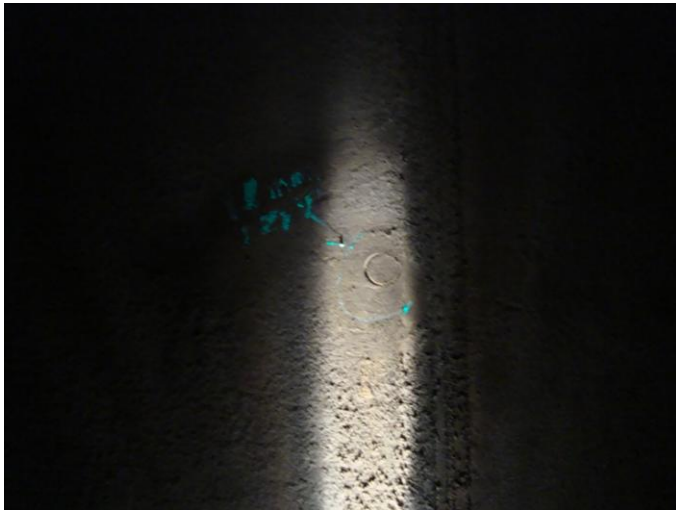
Detail of Findings
<p>Instructions: With the aid of Drawing(s), Sketch(es) and Photo(s) describe findings</p>
<p>Note 1) No signs of cracks, blisters, distortion, erosion/corrosion (other than pitting) or any forms of deterioration evident on interior shell. However, a mechanical mark having a diameter approximately 1.5" and a depth of 1.4 mm (max. depth evident) was noted adjacent to circumference weld seam 9. See photo 1 and 2. Generalized pitting found throughout shell particularly between circ seams 9 to 11. A random selection of the most pronounced pitting was measured and the maximum depth was found to be approximately 1.2 mm. Acceptable for service. See photo 3.</p> <p>Note 2) No evidence of corrosion, cracking, pitting or deterioration was found on welded joints. Acceptable for service.</p> <p>Note 3) No signs of distortion, cracks, corrosion, wall loss or any type of defect on manway, nozzels or connections was found. Acceptable for continuing service.</p> <p>Note 4) No evidence of corrosion/erosion or any mechanical damage on manway gasket and cover seals. Acceptable for service.</p> <p>Note 5) No signs of cracking, corrosion, erosion, distortion or any deterioration on screen support legs.</p> <p>Note 6) No evidence of corrosion, distortion, missing components or any deterioration on votex .</p> <p>Note: Only lower half of vessel in question could be properly inspected during time of entry. No scaffold in place to access upper half.</p>

Photo 1 – Mechanical mark adjacent to circ weld seam 9

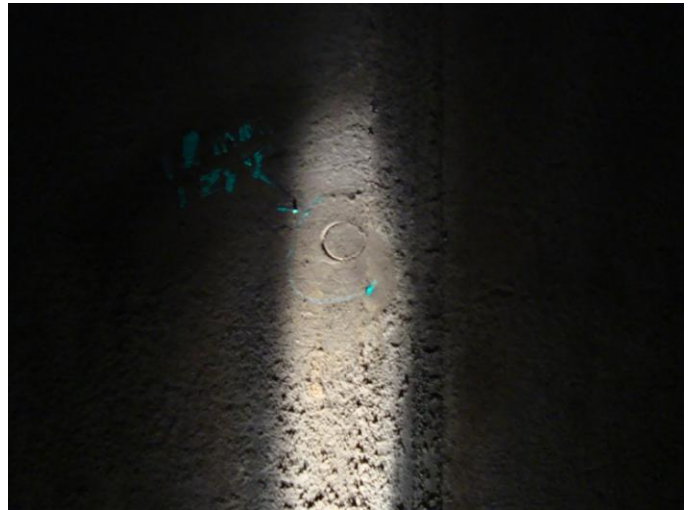
Photo 2 – Mechanical mark adjacent to circ weld seam 9

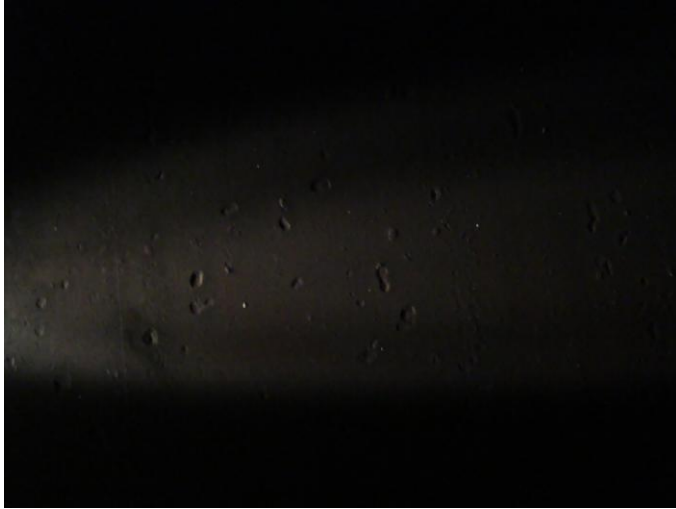
Photo 3 – Sample of pitting on shell

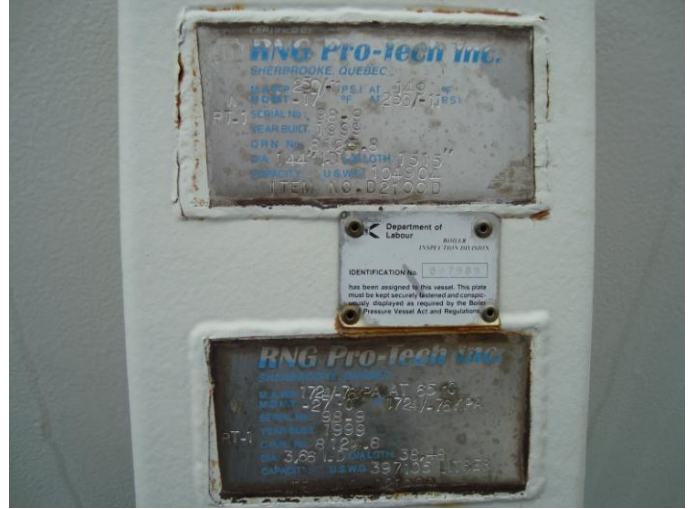
Photo 4 – ID tag

1. Check permanent identifying tags on vessel are legible and present the required information.	<input checked="" type="checkbox"/>	<input type="checkbox"/>	<input type="checkbox"/>	<input type="checkbox"/>	See Detail of Findings and photo 4

**ID Tag:**

MAWP: 210/-11 PSI @ 149°F

MDMT: -17°F @ 250/-11 PSI

Serial No: 98-9

Year Built: 1999

CRN: 8124.8

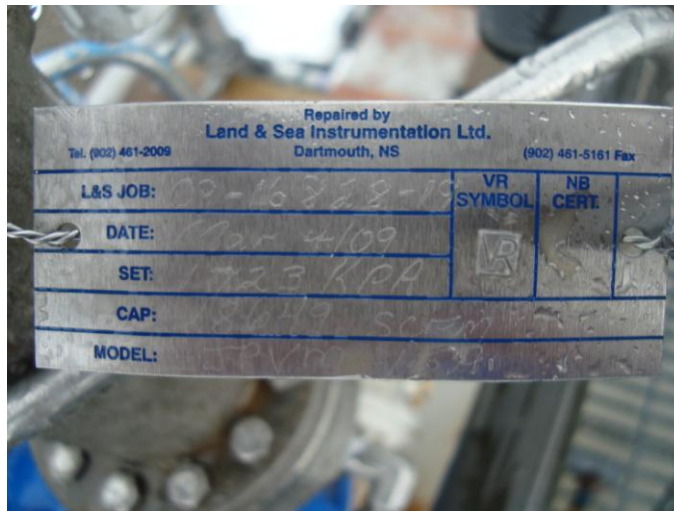
Photo 5 – PSV tag

2. If applicable, check if the PSV on the vessel is in calibration. Record tag number of PSV and calibration date.	<input checked="" type="checkbox"/>	<input type="checkbox"/>	<input type="checkbox"/>	<input type="checkbox"/>	See Detail of Findings and photo 5

**PSV Tag:**

L&S Job: 09-16828-19

Date: March 4, 2009

Set Pressure: 1723 KPA

Capacity: 18649 SCFM

Model: JPVM 15A
