INSPECTION REPORT

Pressure Vessel Survey			
Location:	Point Tupper	EM&I J Report No.:	PT-D2100E-090317-BR-R1
Client Name:		Client Ref No.:	PT-11573616-001-D2100E
Client Rep.:		Inspector Name:	Barry Ritchie
WO No.:		Inspection Date:	March 17, 2009
SPO No.:		System:	Propane
Workscope No.:	PT-2008-VESSEL-EXT-03	EM&I J Job No:	EMJ0132.33
Tag No.:	D-2100E	Equipment Description:	Propane Storage Vessel D-2100E
Date of Last Inspection:	NA	Previous Records Seen:	NA
Drawing No.:	LA-B23-F-22-8052-01-Z4, 980047-4-2, 980047-2-4, 98-CA-399735-4B-0

Ultrasonic Inspection Survey for Vessel Inspection

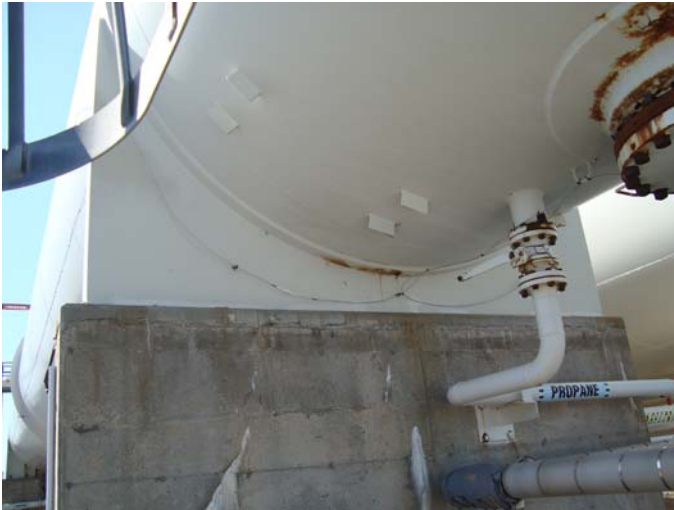
Photo 1 – North face on North vessel support coating breakdown on steel to concrete connection, also coating breakdown on weld connection to vessel

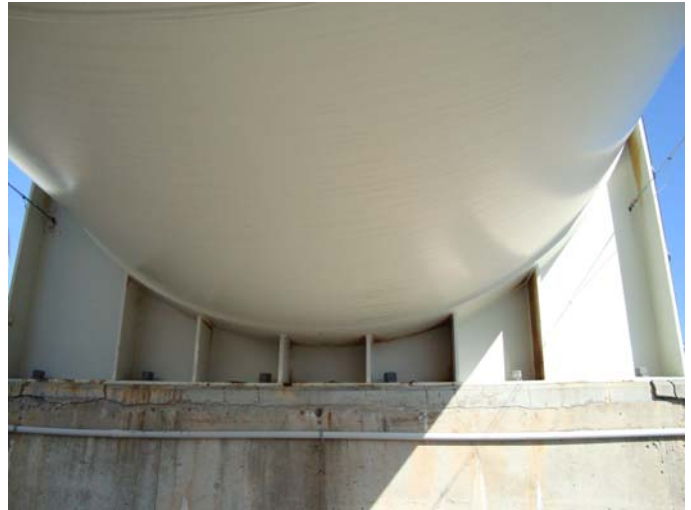
Photo 2 – South face on North vessel support coating breakdown on concrete connection, weld connections on vertical stiffeners starting to break down

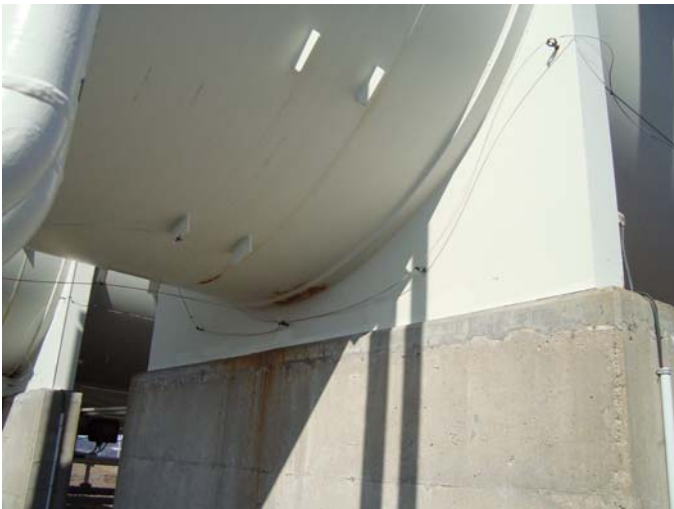
Photo 3 – South vessel support south face slight coating breakdown on cradle and vessel

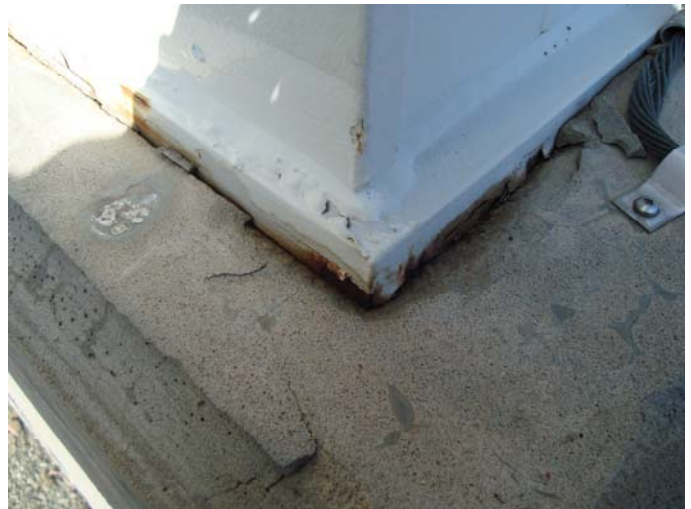
4. a) For horizontally mounted vessels, check for signs of trapped moisture, resulting in corrosion between cradle support and vessel shell.	<input type="checkbox"/>	<input checked="" type="checkbox"/>	<input type="checkbox"/>	<input type="checkbox"/>	See Photo #4

Photo 4 – South vessel support South-East corner water damage to concrete

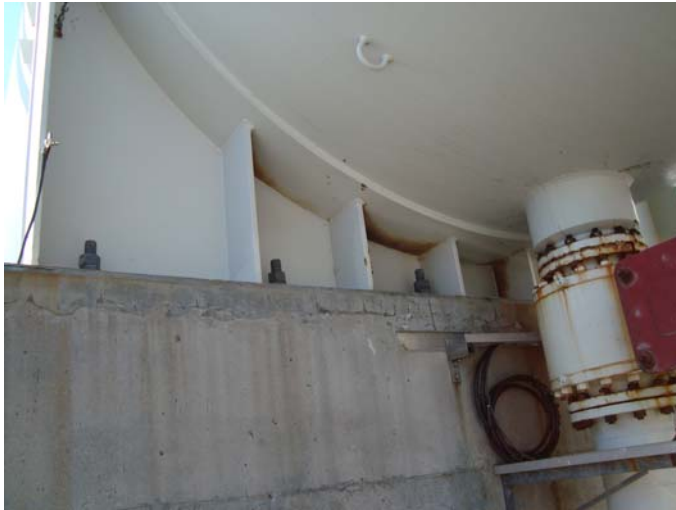
Photo 5 – North face of South vessel support slight coating breakdown on concrete connection and coating breakdown on cradle

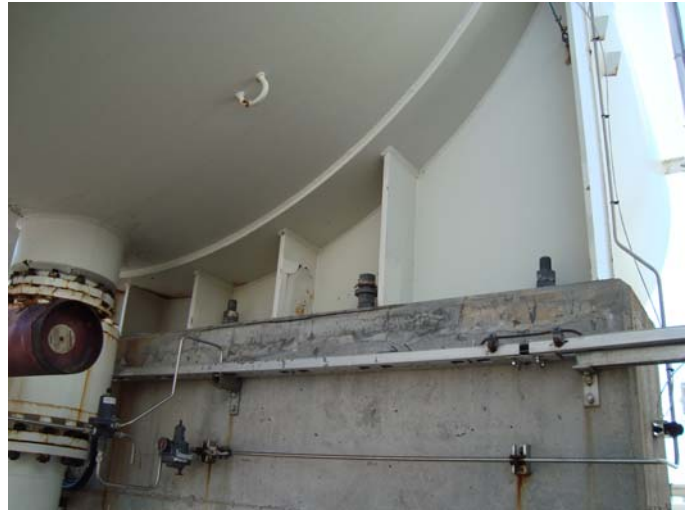
Photo 6 – North face of South vessel support, taken facing East, paint coating peeling back

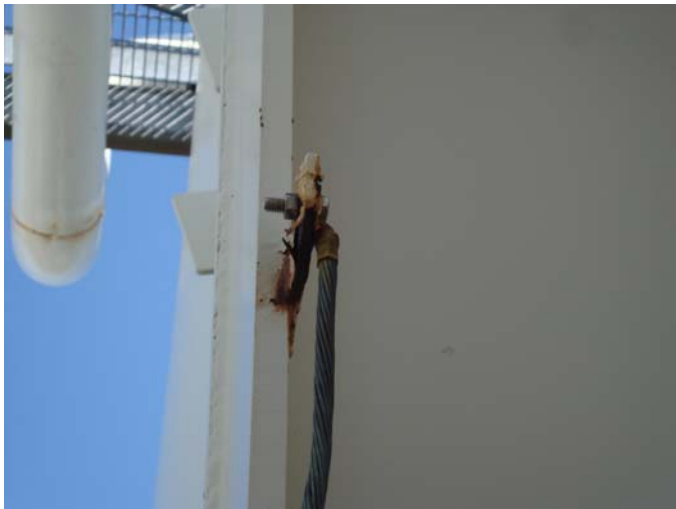
Photo 7 – Earthing strap on North vessel support

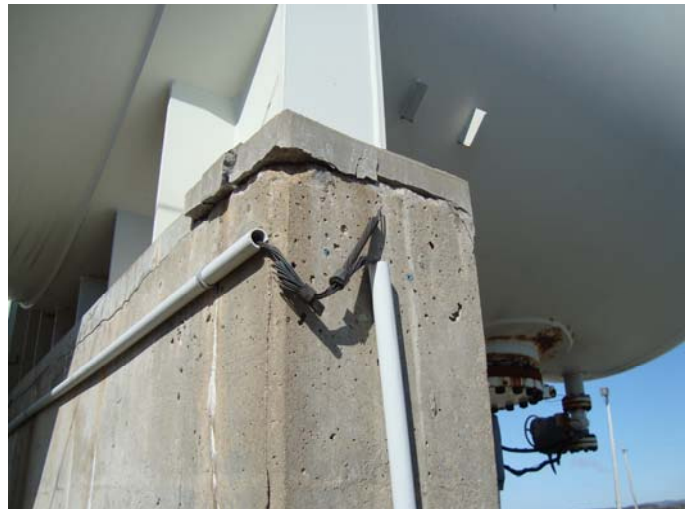
2. If applicable, check vessel supports for signs of deterioration, settlement, deflection, and/or corrosion.	<input type="checkbox"/>	<input checked="" type="checkbox"/>	<input type="checkbox"/>	<input type="checkbox"/>	Areas of concern see Photos #8, 9 & 10

Photo 8 – Earthing strap Joint on North vessel support, also showing horizontal crack in concrete support

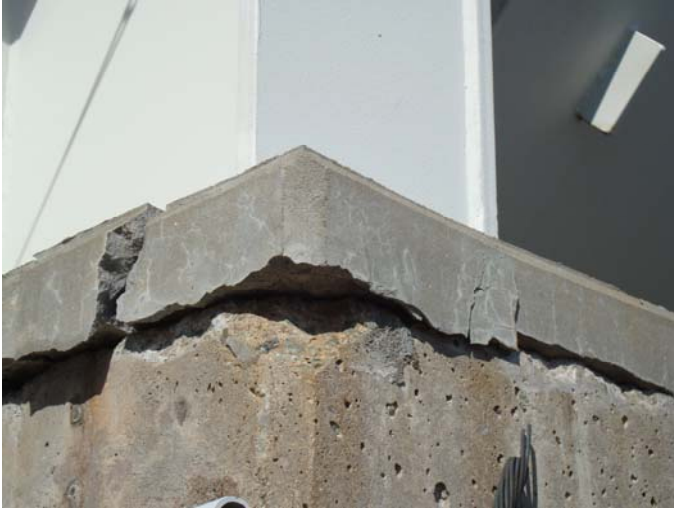
Photo 9 – Close-up of crack shown in Photo 8

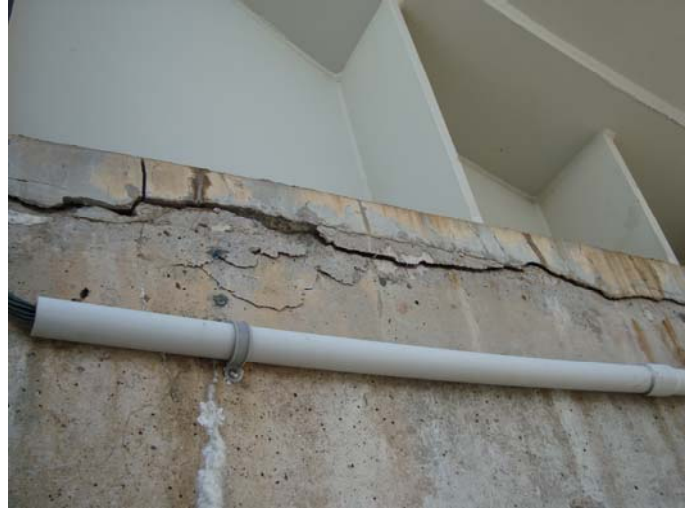
Photo 10 – Horizontal crack running along the South face of concrete block of North vessel support

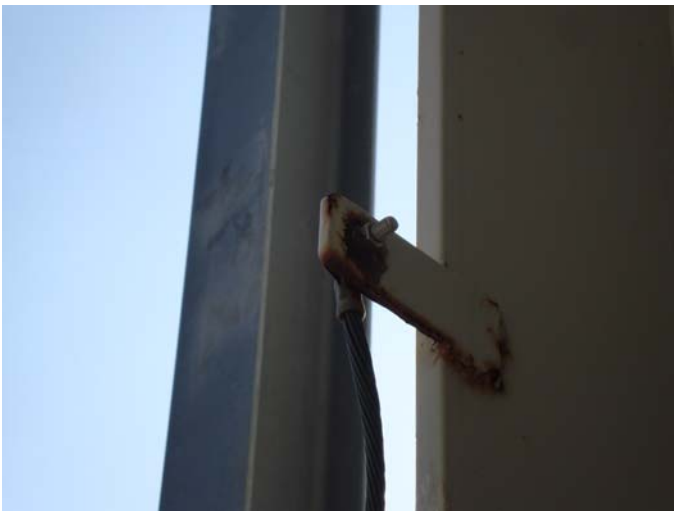
Photo 11 – Earthing strap connection on South vessel support

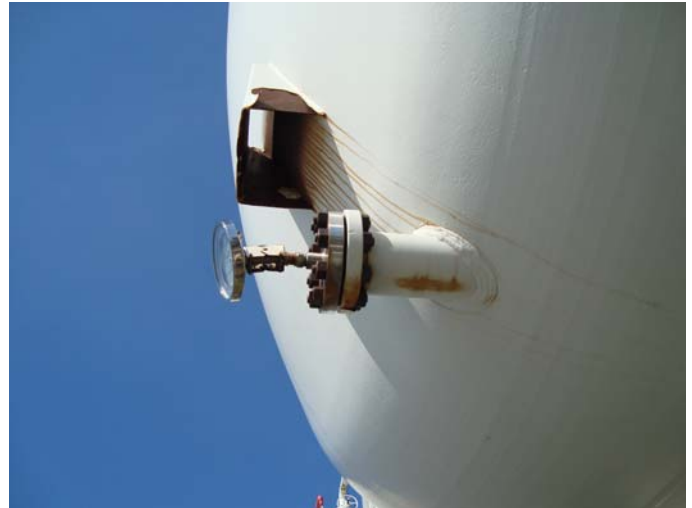
Photo 14 – General condition of nozzle N6 studs and nuts CAT III

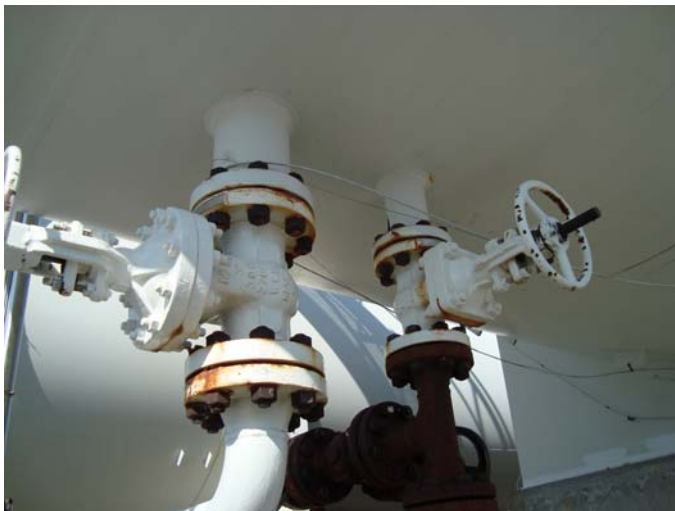
Photo 15 – Nozzles N3B & N4B in good condition, studs and nuts CAT III

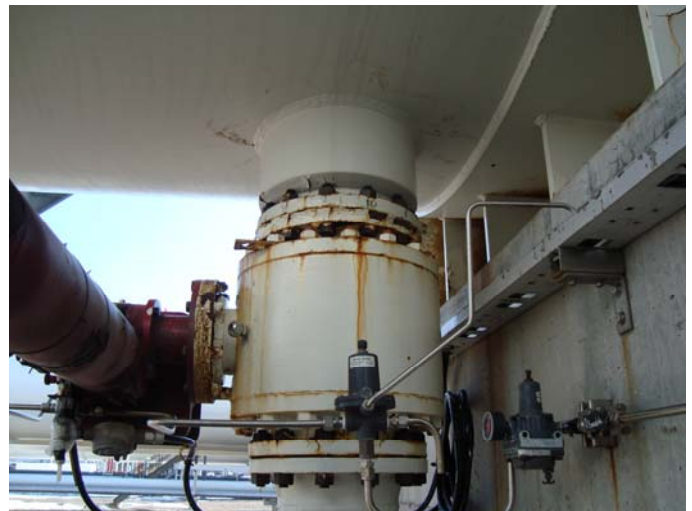
Photo 16 – Nozzle N2, slight coating coating breakdown on nozzle, studs and nuts CAT III

UT reading on Nozzle N2 exceeds 2.2mm corrosion allowance.

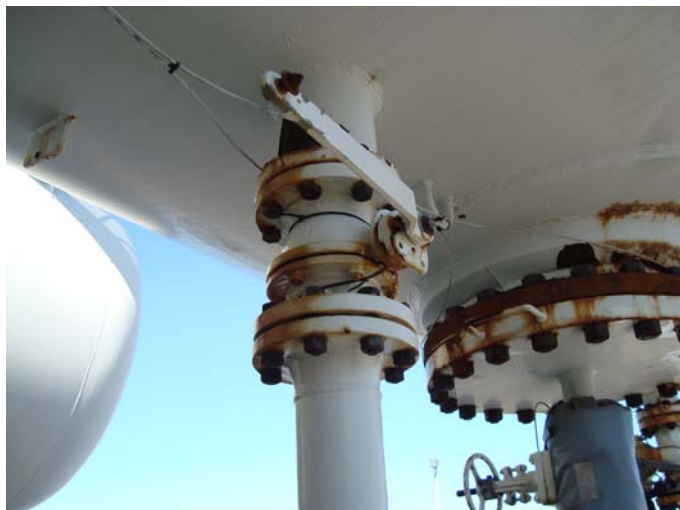
3. Inspect fittings, nozzles and other connections, including the surrounding vessel shell / head for any signs of distortion or cracks, wall loss, leakage, deterioration of coatings, etc. Specify extent and location.	<input checked="" type="checkbox"/>	<input type="checkbox"/>	<input type="checkbox"/>	<input type="checkbox"/>	Only two areas of concern on nozzles (see Photos #17 & 37)

Photo 17 – Nozzle N5, 35% of nozzle area has coating loss, studs and nuts CAT III

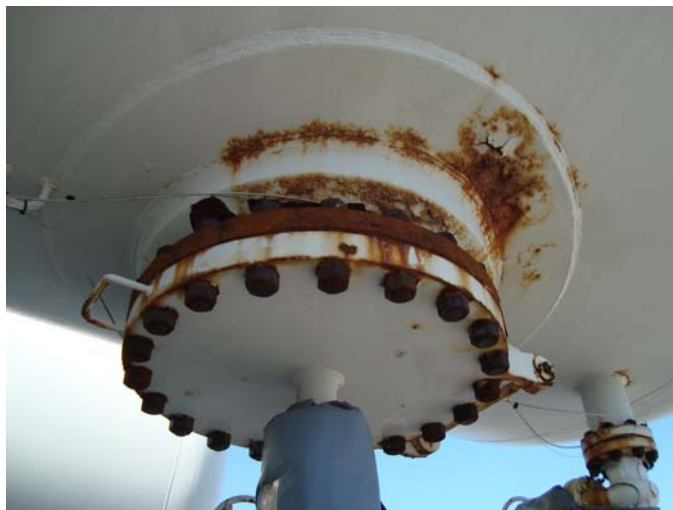
Photo 18 – General condition of manhole, coating has started to breakdown only on the East side

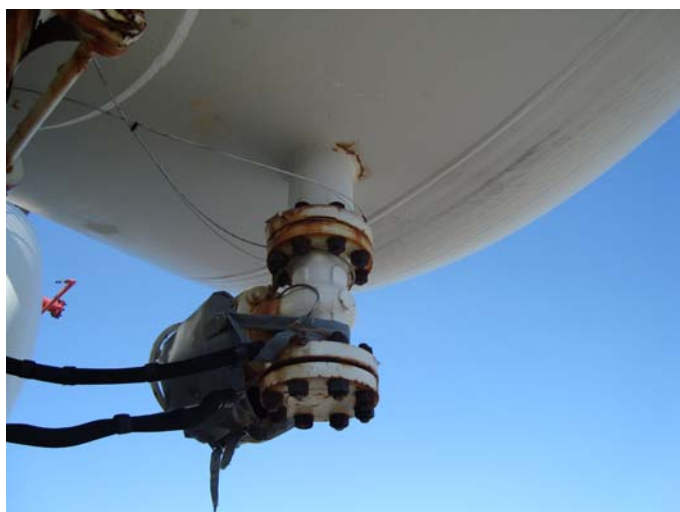
Photo 19 – Nozzle N10, slight coating breakdown on weld connection and flange no insulation bag present

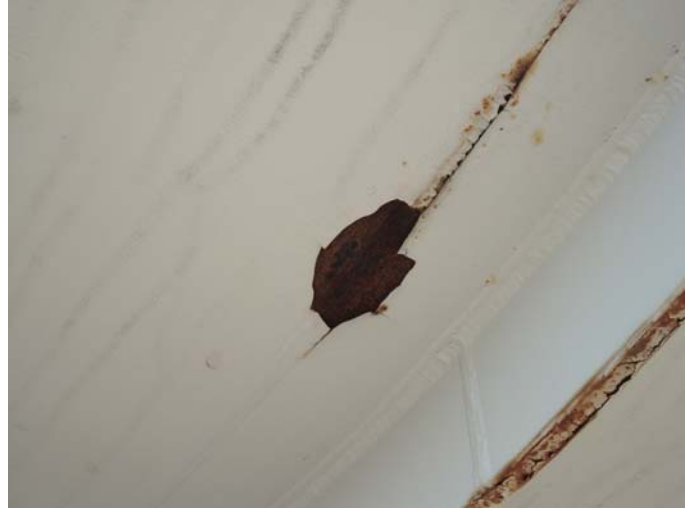
5. Check all welded seams and connections for any signs of deterioration, corrosion, cracking, pitting or other sign of failure. Specify.	<input type="checkbox"/>	<input type="checkbox"/>	<input type="checkbox"/>	<input type="checkbox"/>	Coating breakdown only (see Photo #22)

Photo 22 – Showing general condition of east side shell. Taken facing North, showing one isolated patch located in the mid bottom section on weld seam approx 100mm x 100mm

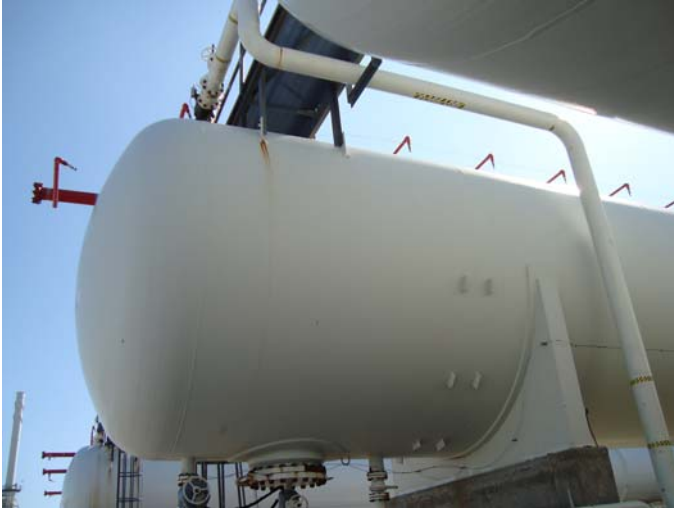
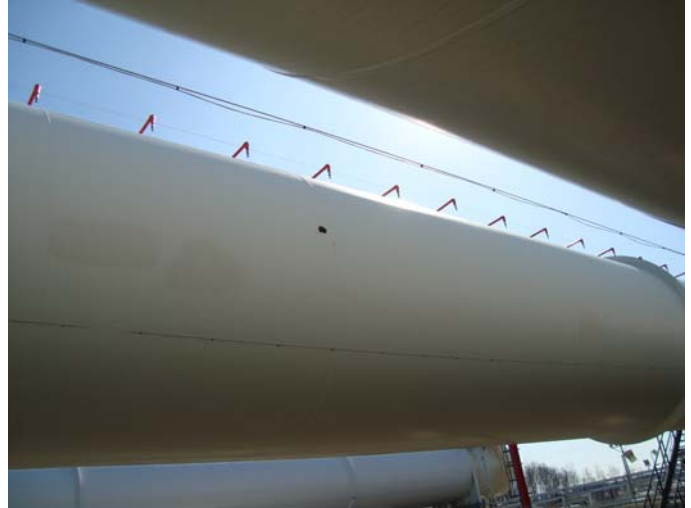
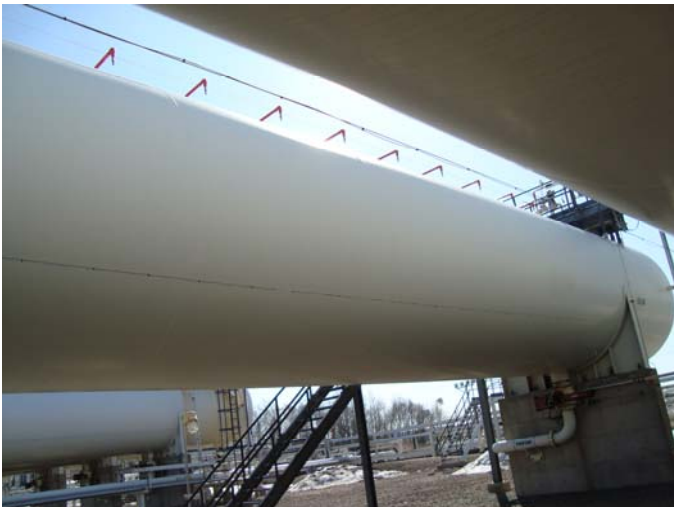
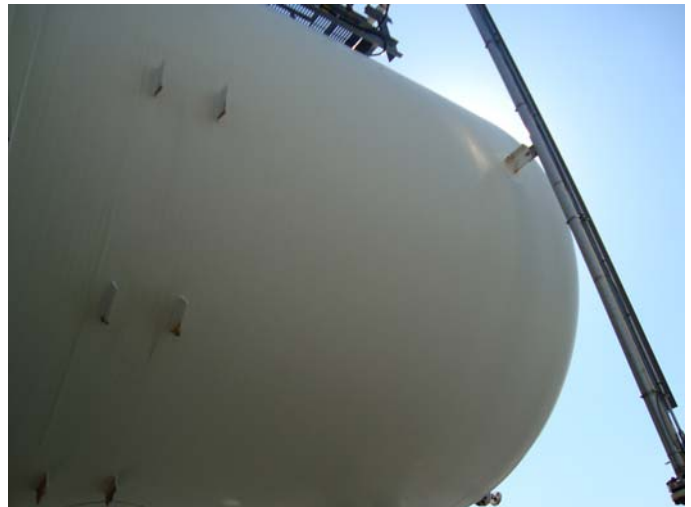
Photo 25 – General good condition of West side shell only one patch of coating breakdown shown, photo taken facing South

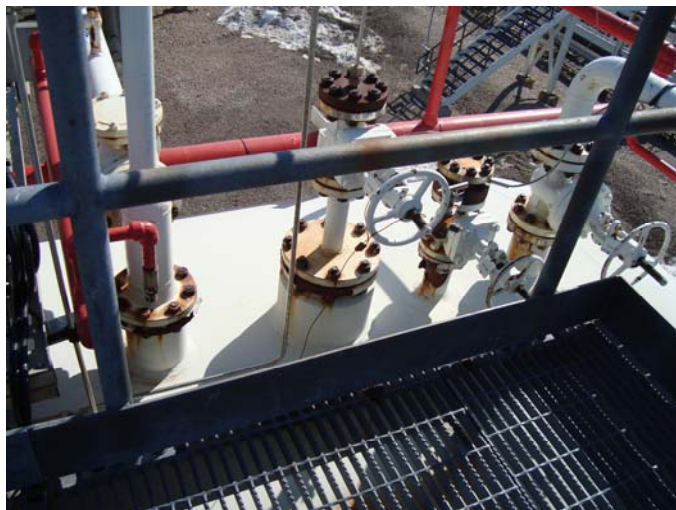
Photo 30 – Nozzels located at South end top N3A, N4A, N8 & N1, showing general condition all studs and nuts at this location are in good condition, CAT III

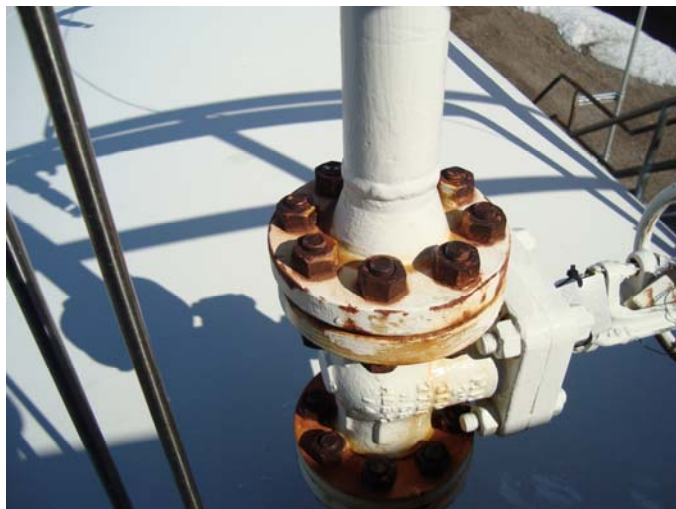
Photo 32 – General view of nozzle N9 studs and nuts CAT III

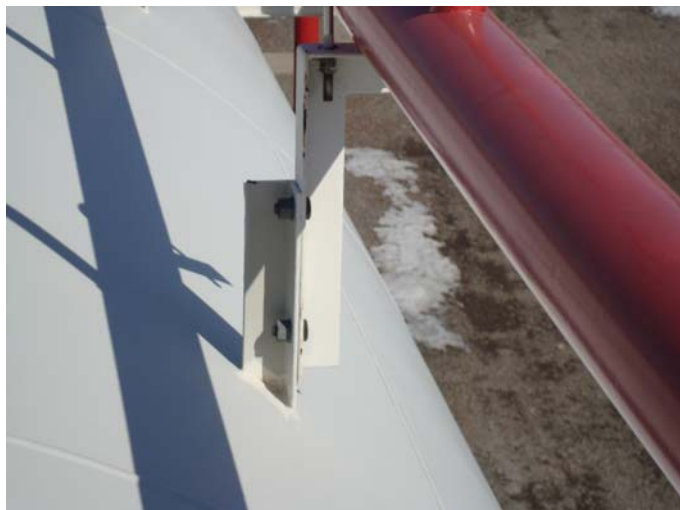
Photo 33 – Typical condition of deluge pipe supports located along vessel top

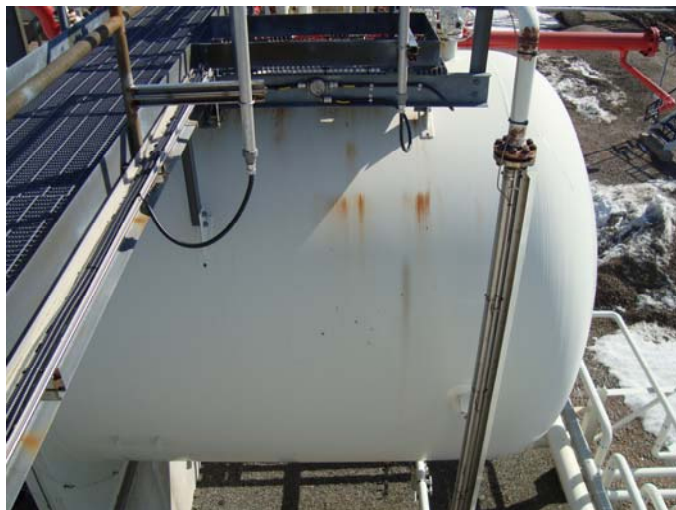
Photo 34 – Showing upper section of South-West side shell a few very small areas of coating breakdown

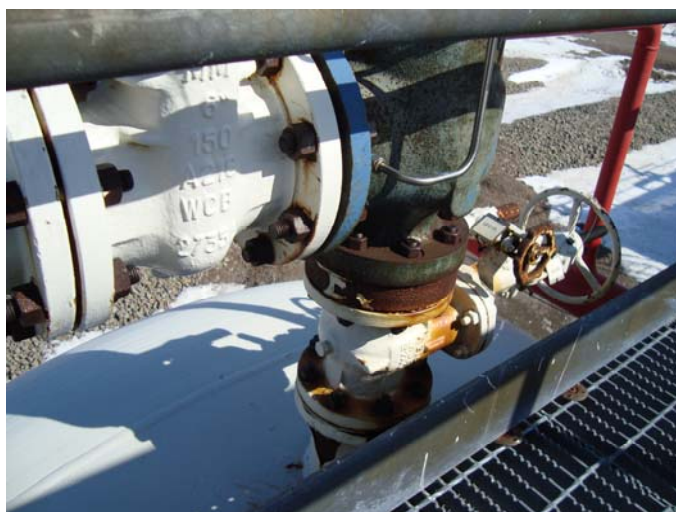
Photo 36 – Nozzle N7 PSV, coating breakdown around nozzle studs and nuts CAT III

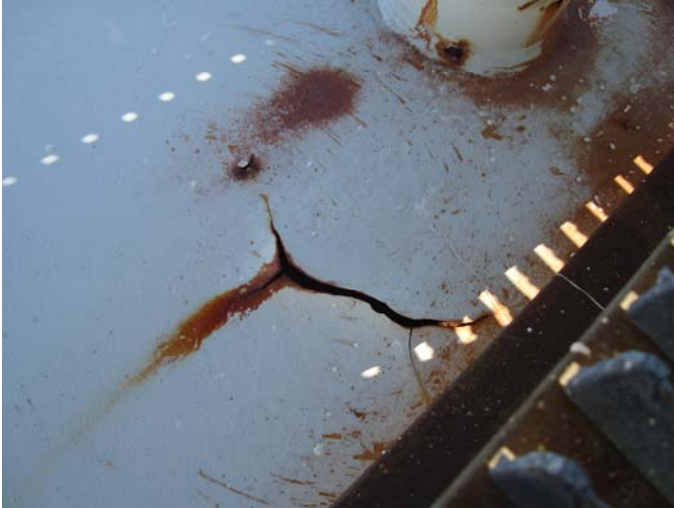
Photo 37 – N7 coating loss

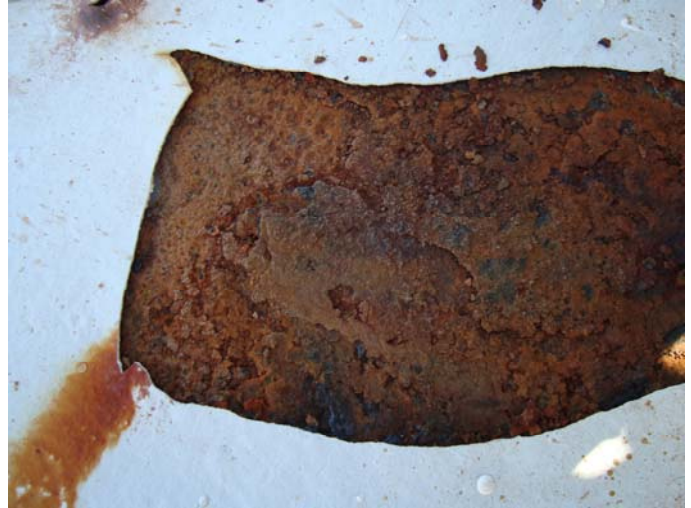
Photo 38 – Showing patch next to N7 largest area of coating breakdown found so far approx 200mm x 150mm light to moderate corrosion. The corrosion will be removed and a UT scan will be carried out and noted in the UT report
