# INSPECTION REPORT

Pressure Vessel Survey			
<b>Location:</b>	Point Tupper	<b>EM&amp;IJ Report No.:</b>	PT-D2100E-090708-CR-R0
<b>Client Name:</b>		<b>Client Ref No.:</b>	PT-11564784-001-D2100E
<b>Client Rep.:</b>		<b>Inspector Name:</b>	Colin Robinson
<b>WO No.:</b>		<b>Inspection Date:</b>	July 08, 2009
<b>SPO No.:</b>		<b>System:</b>	Propane
<b>Workscope No.:</b>	PT-2009-D2100E-INT-01	<b>EM&amp;IJ Job No:</b>	EMJ0132.43
<b>Tag No.:</b>	D2100E	<b>Equipment Description:</b>	Propane Storage Vessel D-2100E
<b>Date of Last Inspection:</b>	N/A	<b>Previous Records Seen:</b>	N/A
<b>Drawing No.:</b>	LA-B23-F-22-8052-01-Z4, 980047-2

**D-2100E, Internal**

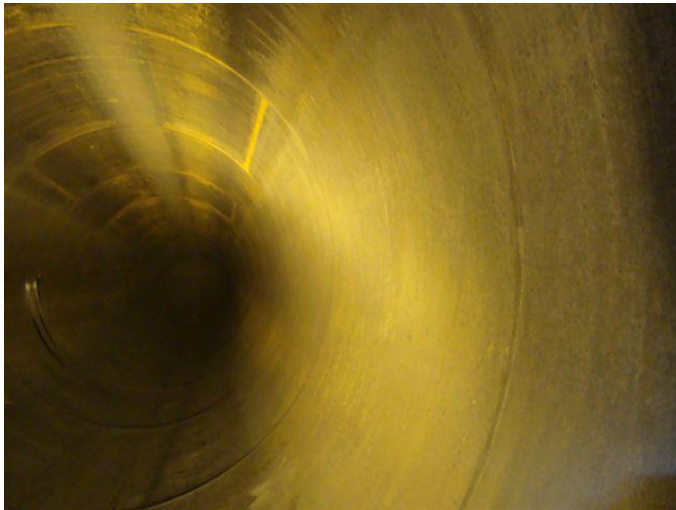
The vessel was in good condition with no evidence of any distortion or cracking on the shell, dome ends or welded seams.

Photo 1 – General view looking south

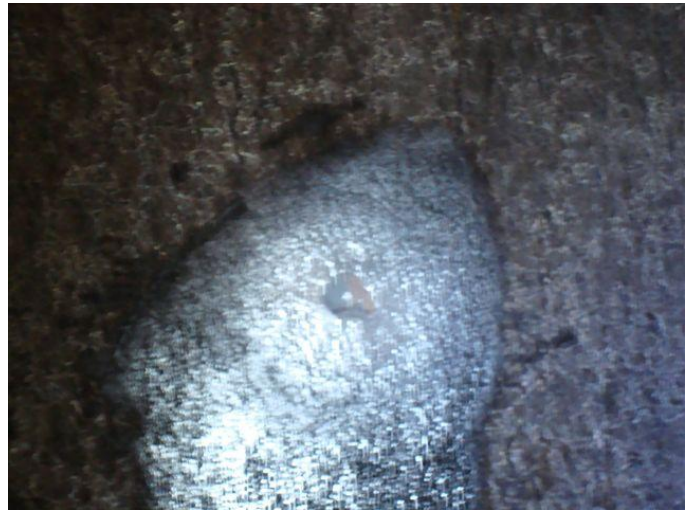
Item	Condition				Comments
Vessel Internal Surfaces	Good	Fair	Poor	NA	
1. Check for signs of corrosion, erosion, cracks, blisters, pitting, distortion, or other forms of deterioration on the internal vessel surfaces. If any, specify type, location and extent.	<input checked="" type="checkbox"/>	<input type="checkbox"/>	<input type="checkbox"/>	<input type="checkbox"/>	One isolated pit located between circ weld 9 and 10 from south end

A pit was located on the shell between the 9<sup>th</sup> and 10<sup>th</sup> circumferential weld seams from the south end of the vessel. Facing north, the pit was located at the 3 o'clock position and was approximately 10mm in diameter and 2.5mm deep.

Photo 2 – Close up of isolated pit between circ welds

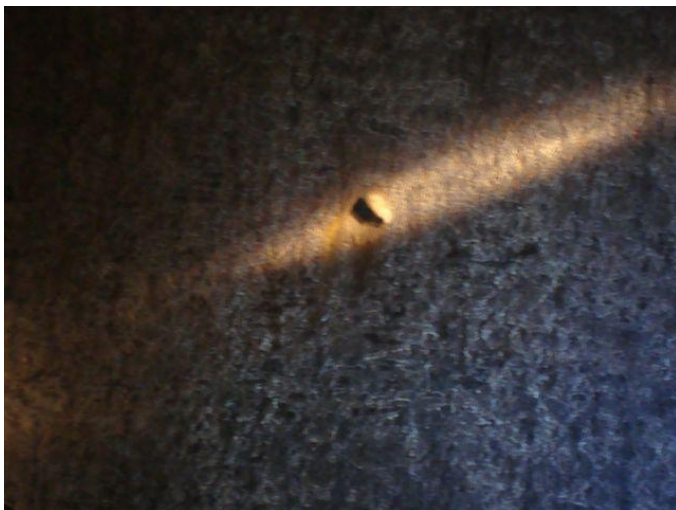
Photo 3 – View of isolated pit between circ welds

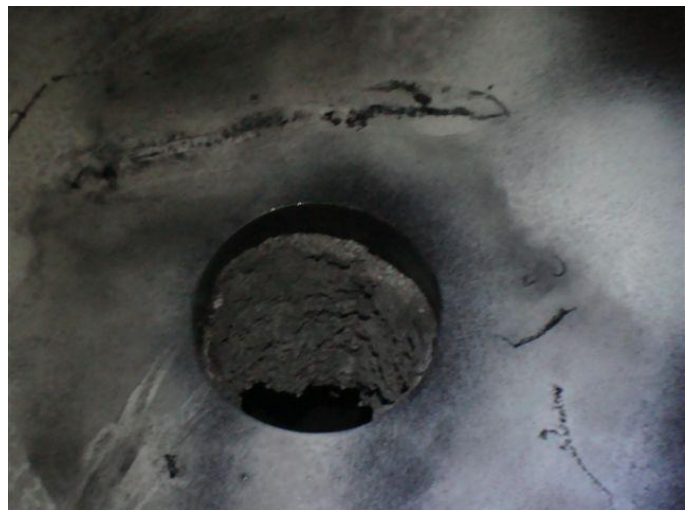
Deposits were noted adjacent to nozzles N3B and N6. It was later determined that the deposits were sealant material used to attain a good seal on the adjacent valves. These valves were subsequently removed maintenance. Excess sealant was removed prior to closure of the vessel.

Photo 4 – Nozzle N3 showing deposits

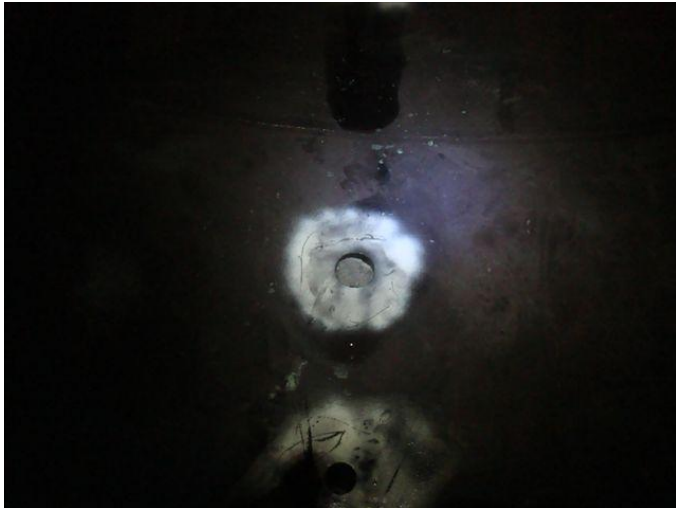
Photo 5 – Nozzle N3B and N4B

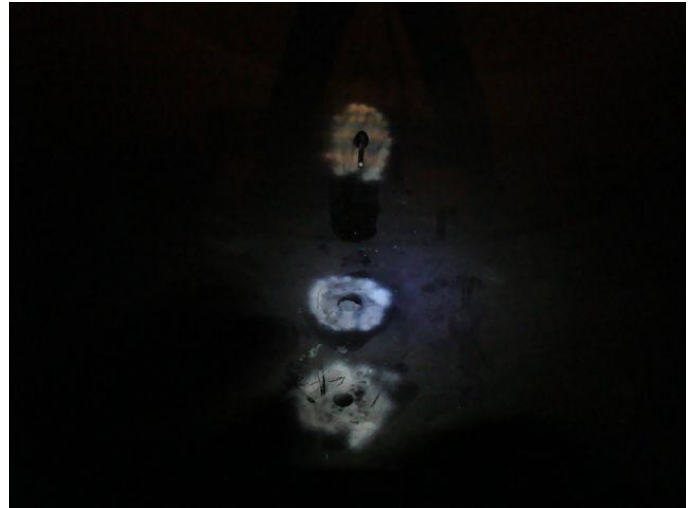
Photo 6 – Nozzle N6, N3B and N4B

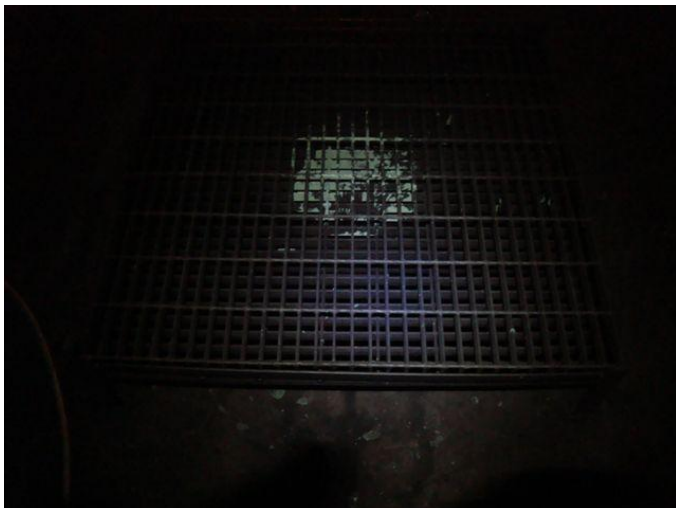
2. If applicable, check vessel's internals for signs of corrosion, distortion and deterioration, missing components etc.	<input checked="" type="checkbox"/>	<input type="checkbox"/>	<input type="checkbox"/>	<input type="checkbox"/>	Vortex breaker in good condition

Photo 7 – Vortex breaker on nozzle N2

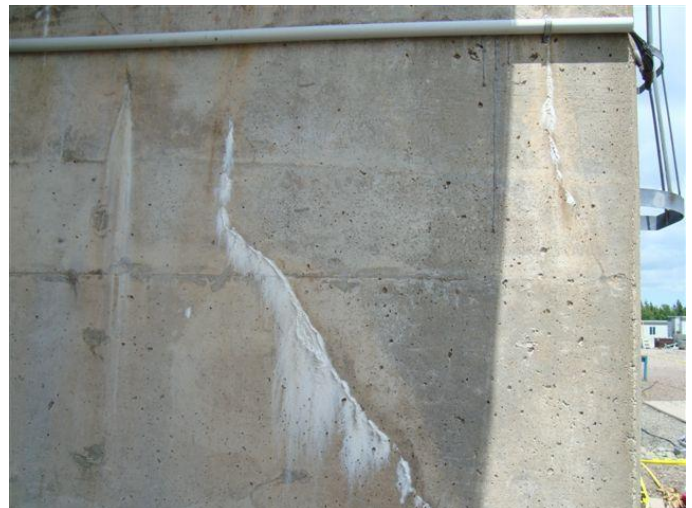
Photo 8 – North foundation support - crack in concrete

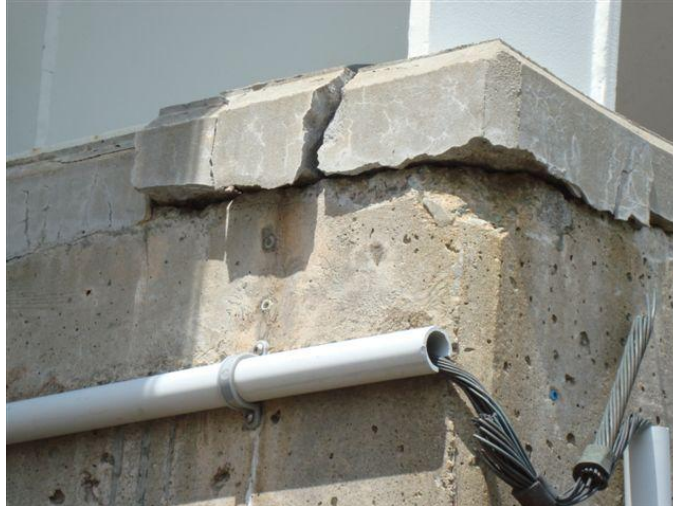
Photo 9 – North Foundation support – crack in concrete
