INSPECTION REPORT

Pressure Vessel Survey			
Location:	Point Tupper	EM&I Report No.:	PT-D2105A-090429-JW-R0
Client Name:		Client Ref No.:	PT-11564910-002-D2105A
Client Rep.:		Inspector Name:	Jeremy Wolfe
WO No.:		Inspection Date:	April 29, 2009
SPO No.:		System:	Butane
Workscope No.:	PT-2009-D-2105A-INT-01	EMI&J Job No:	EMJ0132.43
Tag No.:	D-2105A	Equipment Description:	Butane Storage Vessel D-2105A
Date of Last Inspection:	NA	Previous Records Seen:	NA
Drawing No.:	LA-B23-F-22-8060-01-Z4, 98-CA-399735-1C-5

BUTANE STORAGE VESSEL
 GENERAL ARRANGEMENT
 ITEM NO.: D2105A/B

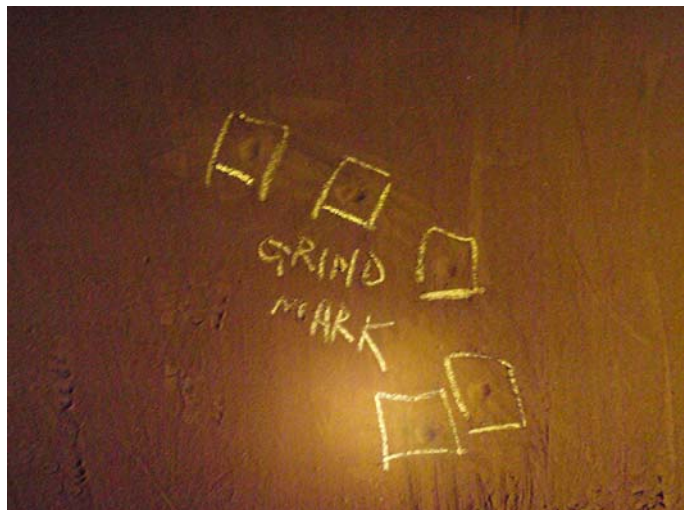
Note #2: Minor pitting noted in shell course. Pitting is situated at the centre line elevation of the shell, shallow depth and small diameter. Numerous grind marks noted throughout the shell at various locations. Generally the diameter and depth is minimal, less than 3cm and 0.5mm respectiviely.

Photo 1 – Grind marks on shell, max 0.5mm deep

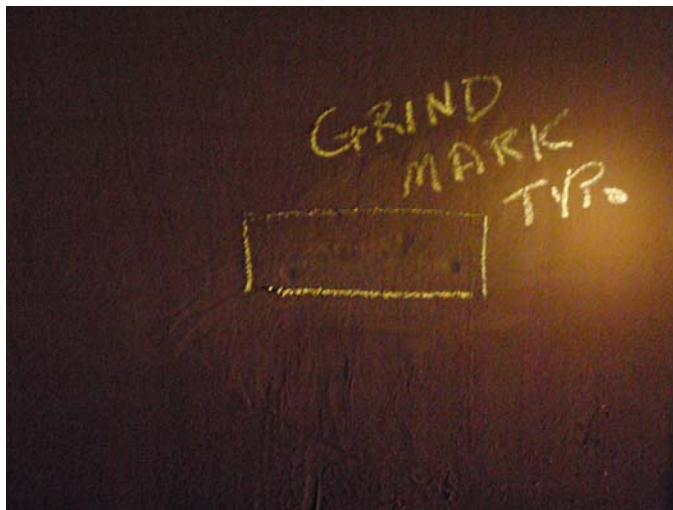
Photo 2 – Grind marks on shell, max 0.5mm deep

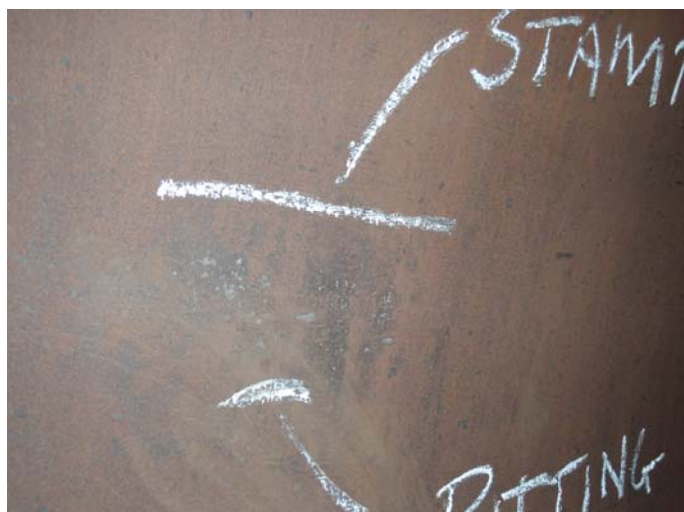
Photo 3 – Material identification stamp on shell. (Low stress dye stamped)

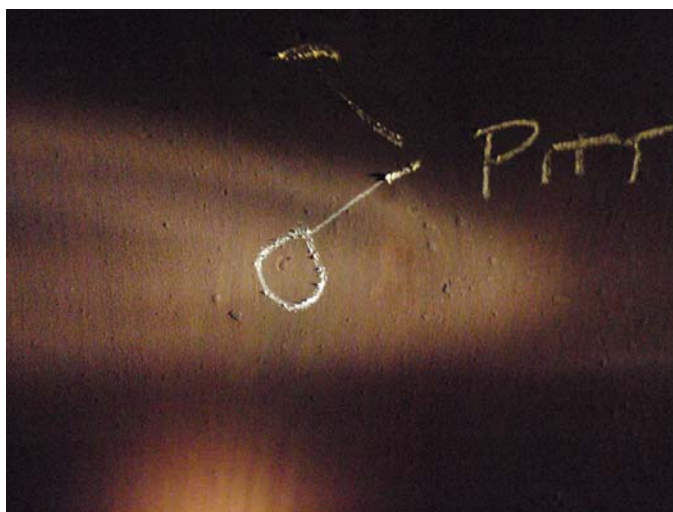
Photo 4 – Pit noted on shell at 4 O'clock position, 0.5mm deep

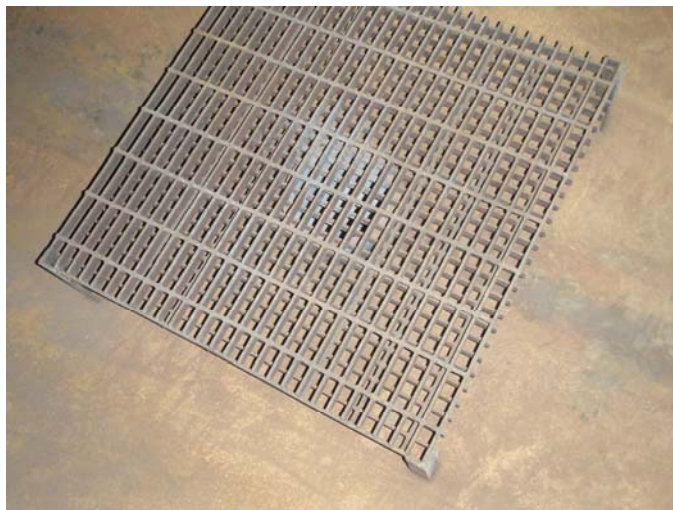
Photo 6 – Vortex breaker, good condition

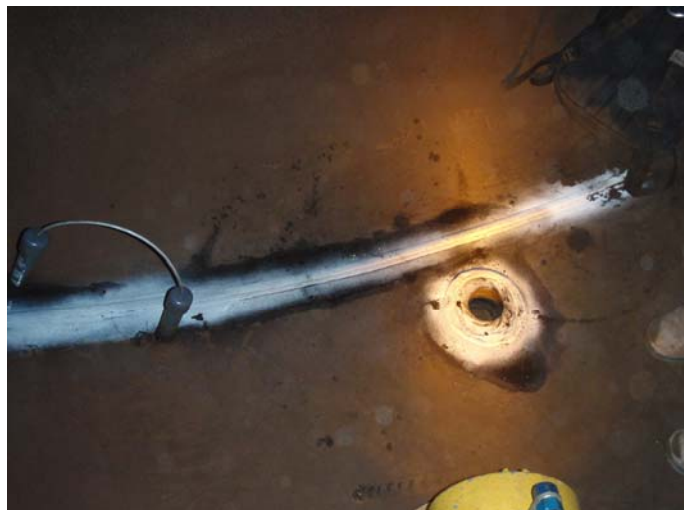
Photo 9 – Magnetic Particle Inspection of girth weld and nozzle N3B, North end

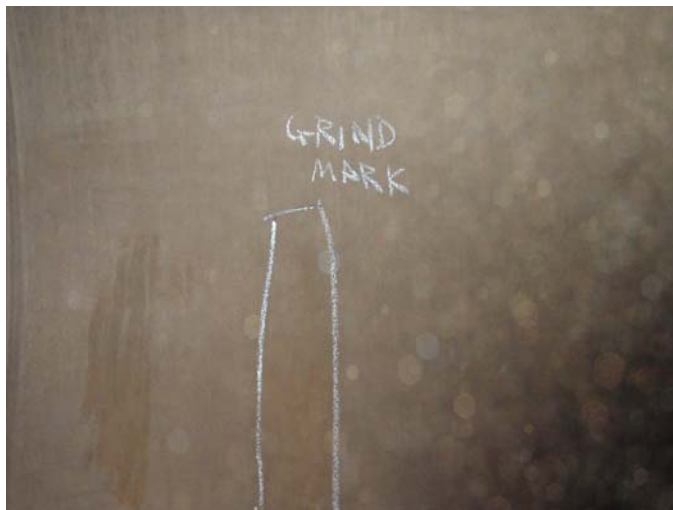
Note #4: Numerous shallow grind marks are scattered over the shell, minimal depth noted and average diameter of each individual grind mark is 25mm.

Photo 10 – Grind marks on shell

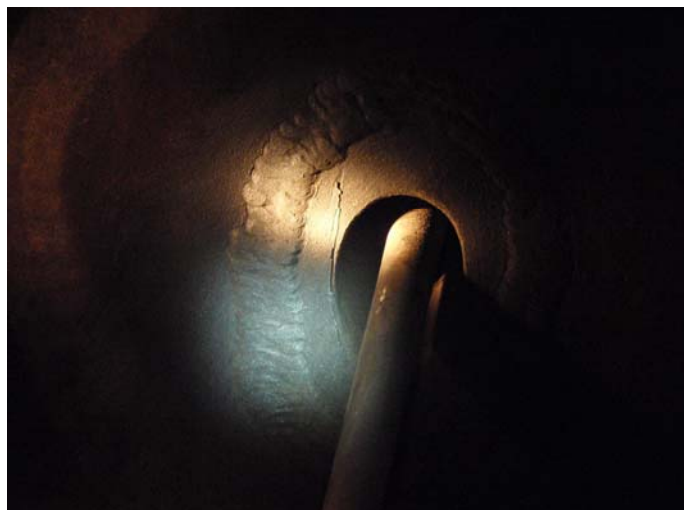
Note #3: Linear defect noted in Nozzle N6 East side of nozzle neck. Defect is approxiately 15cm long, does not appear as a service related defect, but a manufacturing defect. Nozzles N3B, N4B, N5, M and N10 were inspected by MT (DC wet colour contrasting method) and VT all found acceptable. Shell circumferential welds C2 and C6 were inspected by MT (DC wet colour contrasting method) for a length of one meter from the shell centre line down, West side of vessel - found acceptable. Shell circumferential welds C4 and C10 were inspected by MT (DC wet colour contrasting method) for a length of one meter from the shell centre line down East side of vessel - found acceptable. Shell circumferential welds C0, C8 and C12 were inspected by MT at the bottom for a length of 3 feet centered on the bottom centerline of the vessel - found acceptable. No access to the Tee shell welds or nozzles located at the 12 O'Clock position, additionally nozzle N2 was covered by the vortex breaker and not accessible for close visual inspection.

Photo 11 – Indication found in nozzle neck face (N6)

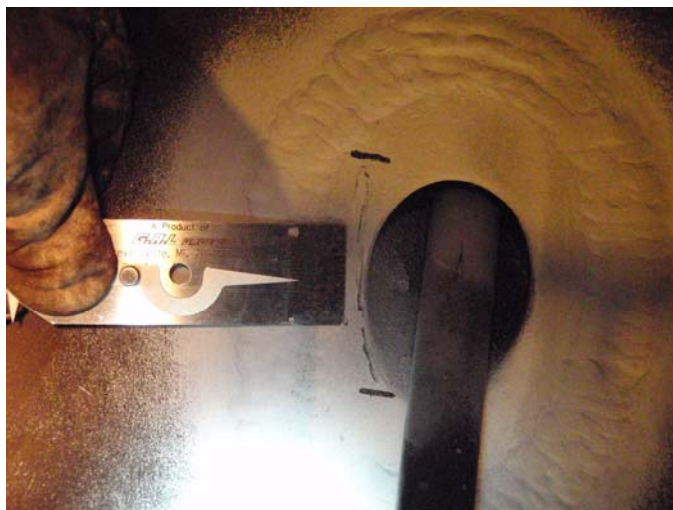
Photo 12 – Indication highlight by Magnetic Particle (MT)

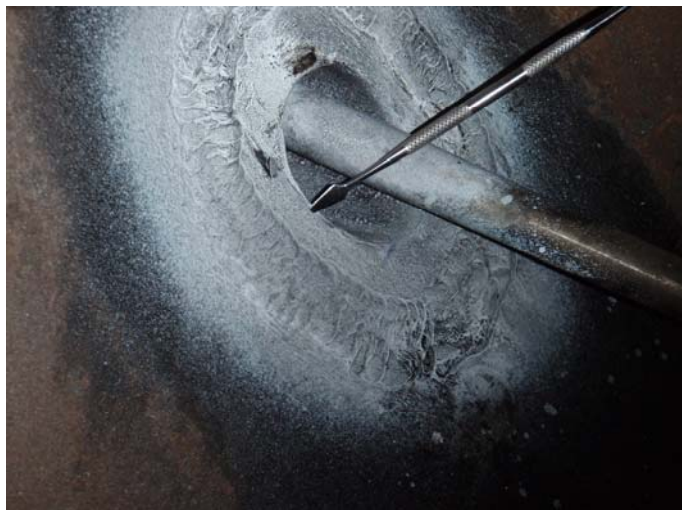
Photo 13 – Pick inserted into indication. 5/16 inches deep

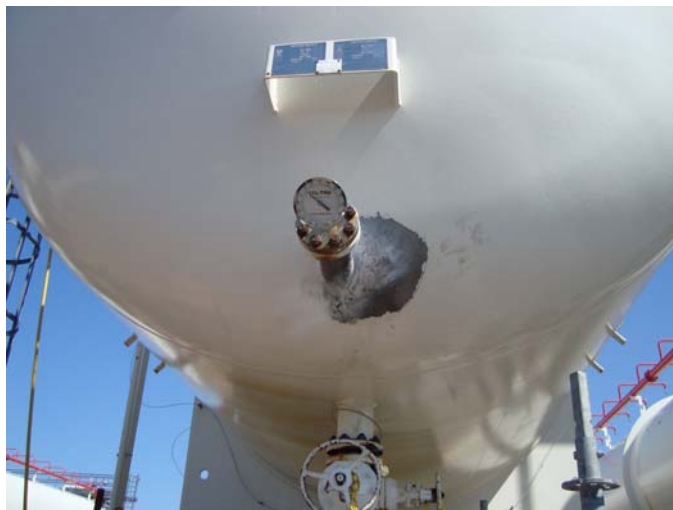
Photo 14 – External view of thermo well. Paint removed and inspected by UT and MT

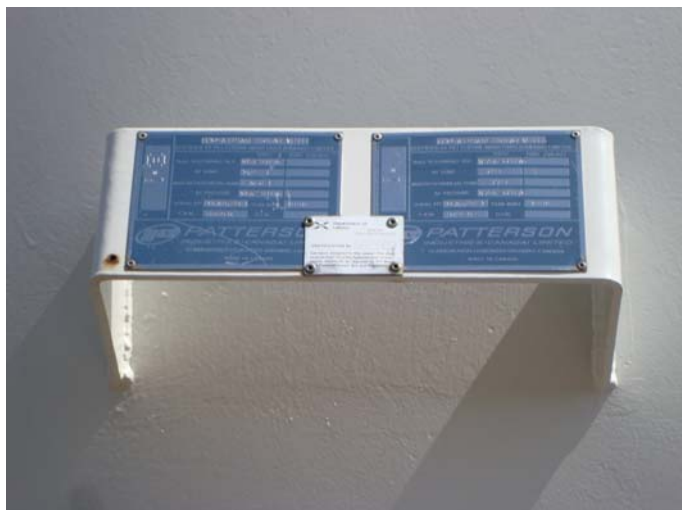
Photo 15 – Nameplate and Cal. Cert. No close visual, access platform deck 3.0m below plate.

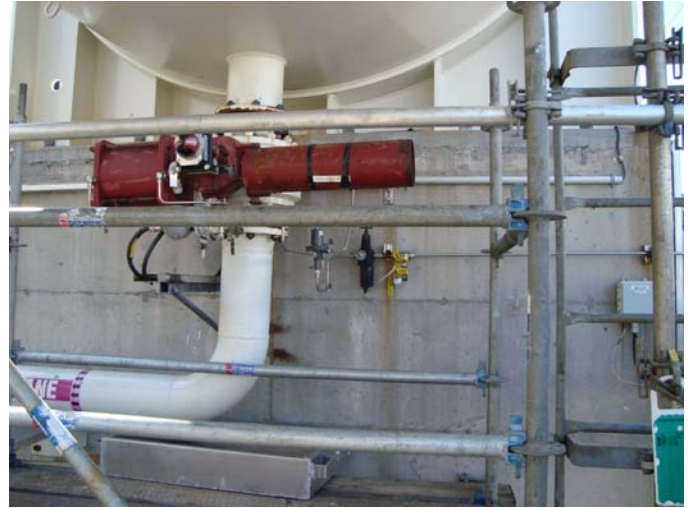
Photo 18 – N2 and Pipe work, good condition

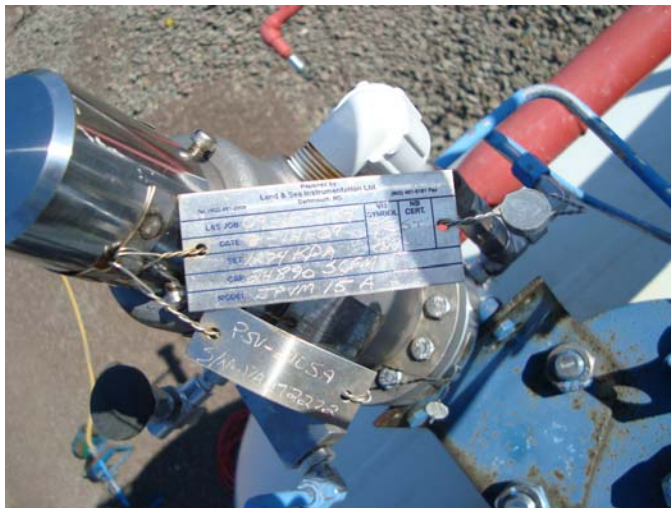
Photo 22 – PSV Tags

2. If applicable, check if the PSV on the vessel is in calibration. Record tag number of PSV and calibration date.	Good	Tags in good condition (see Photo #22)

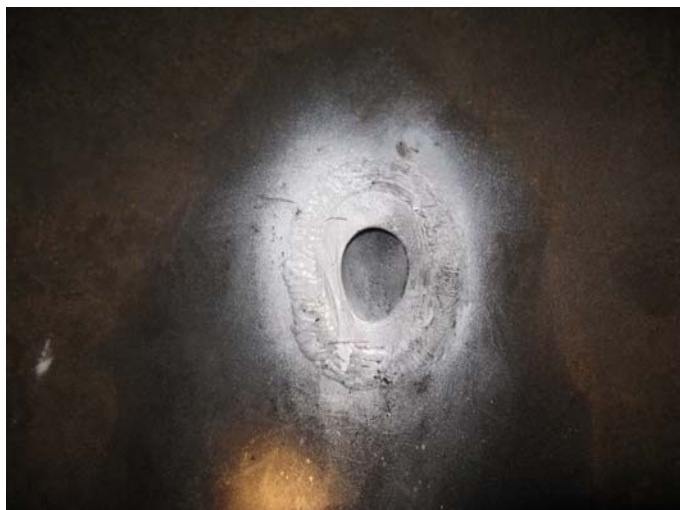
Photo 23 – Indication remove from Nozzle N6

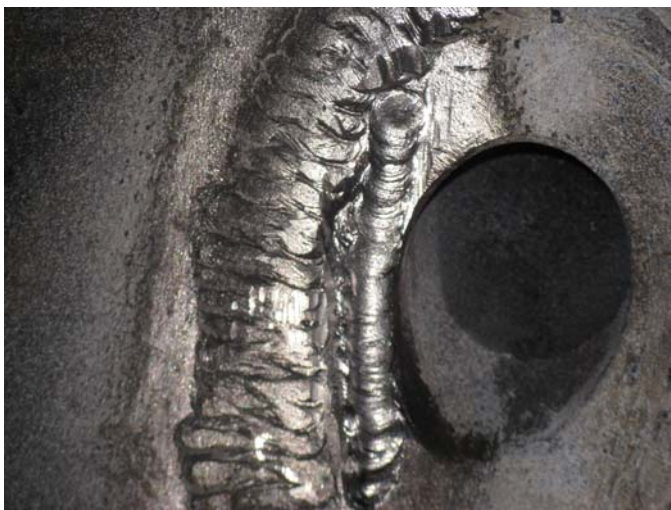
Photo 24 – Finished weld of repair completed to N6

MPI was conducted on a repair of the shell head in the vicinity of N6. It was an internal repair of the butane storage vessel D-2105A.

No abnormalities were found in area of inspection.

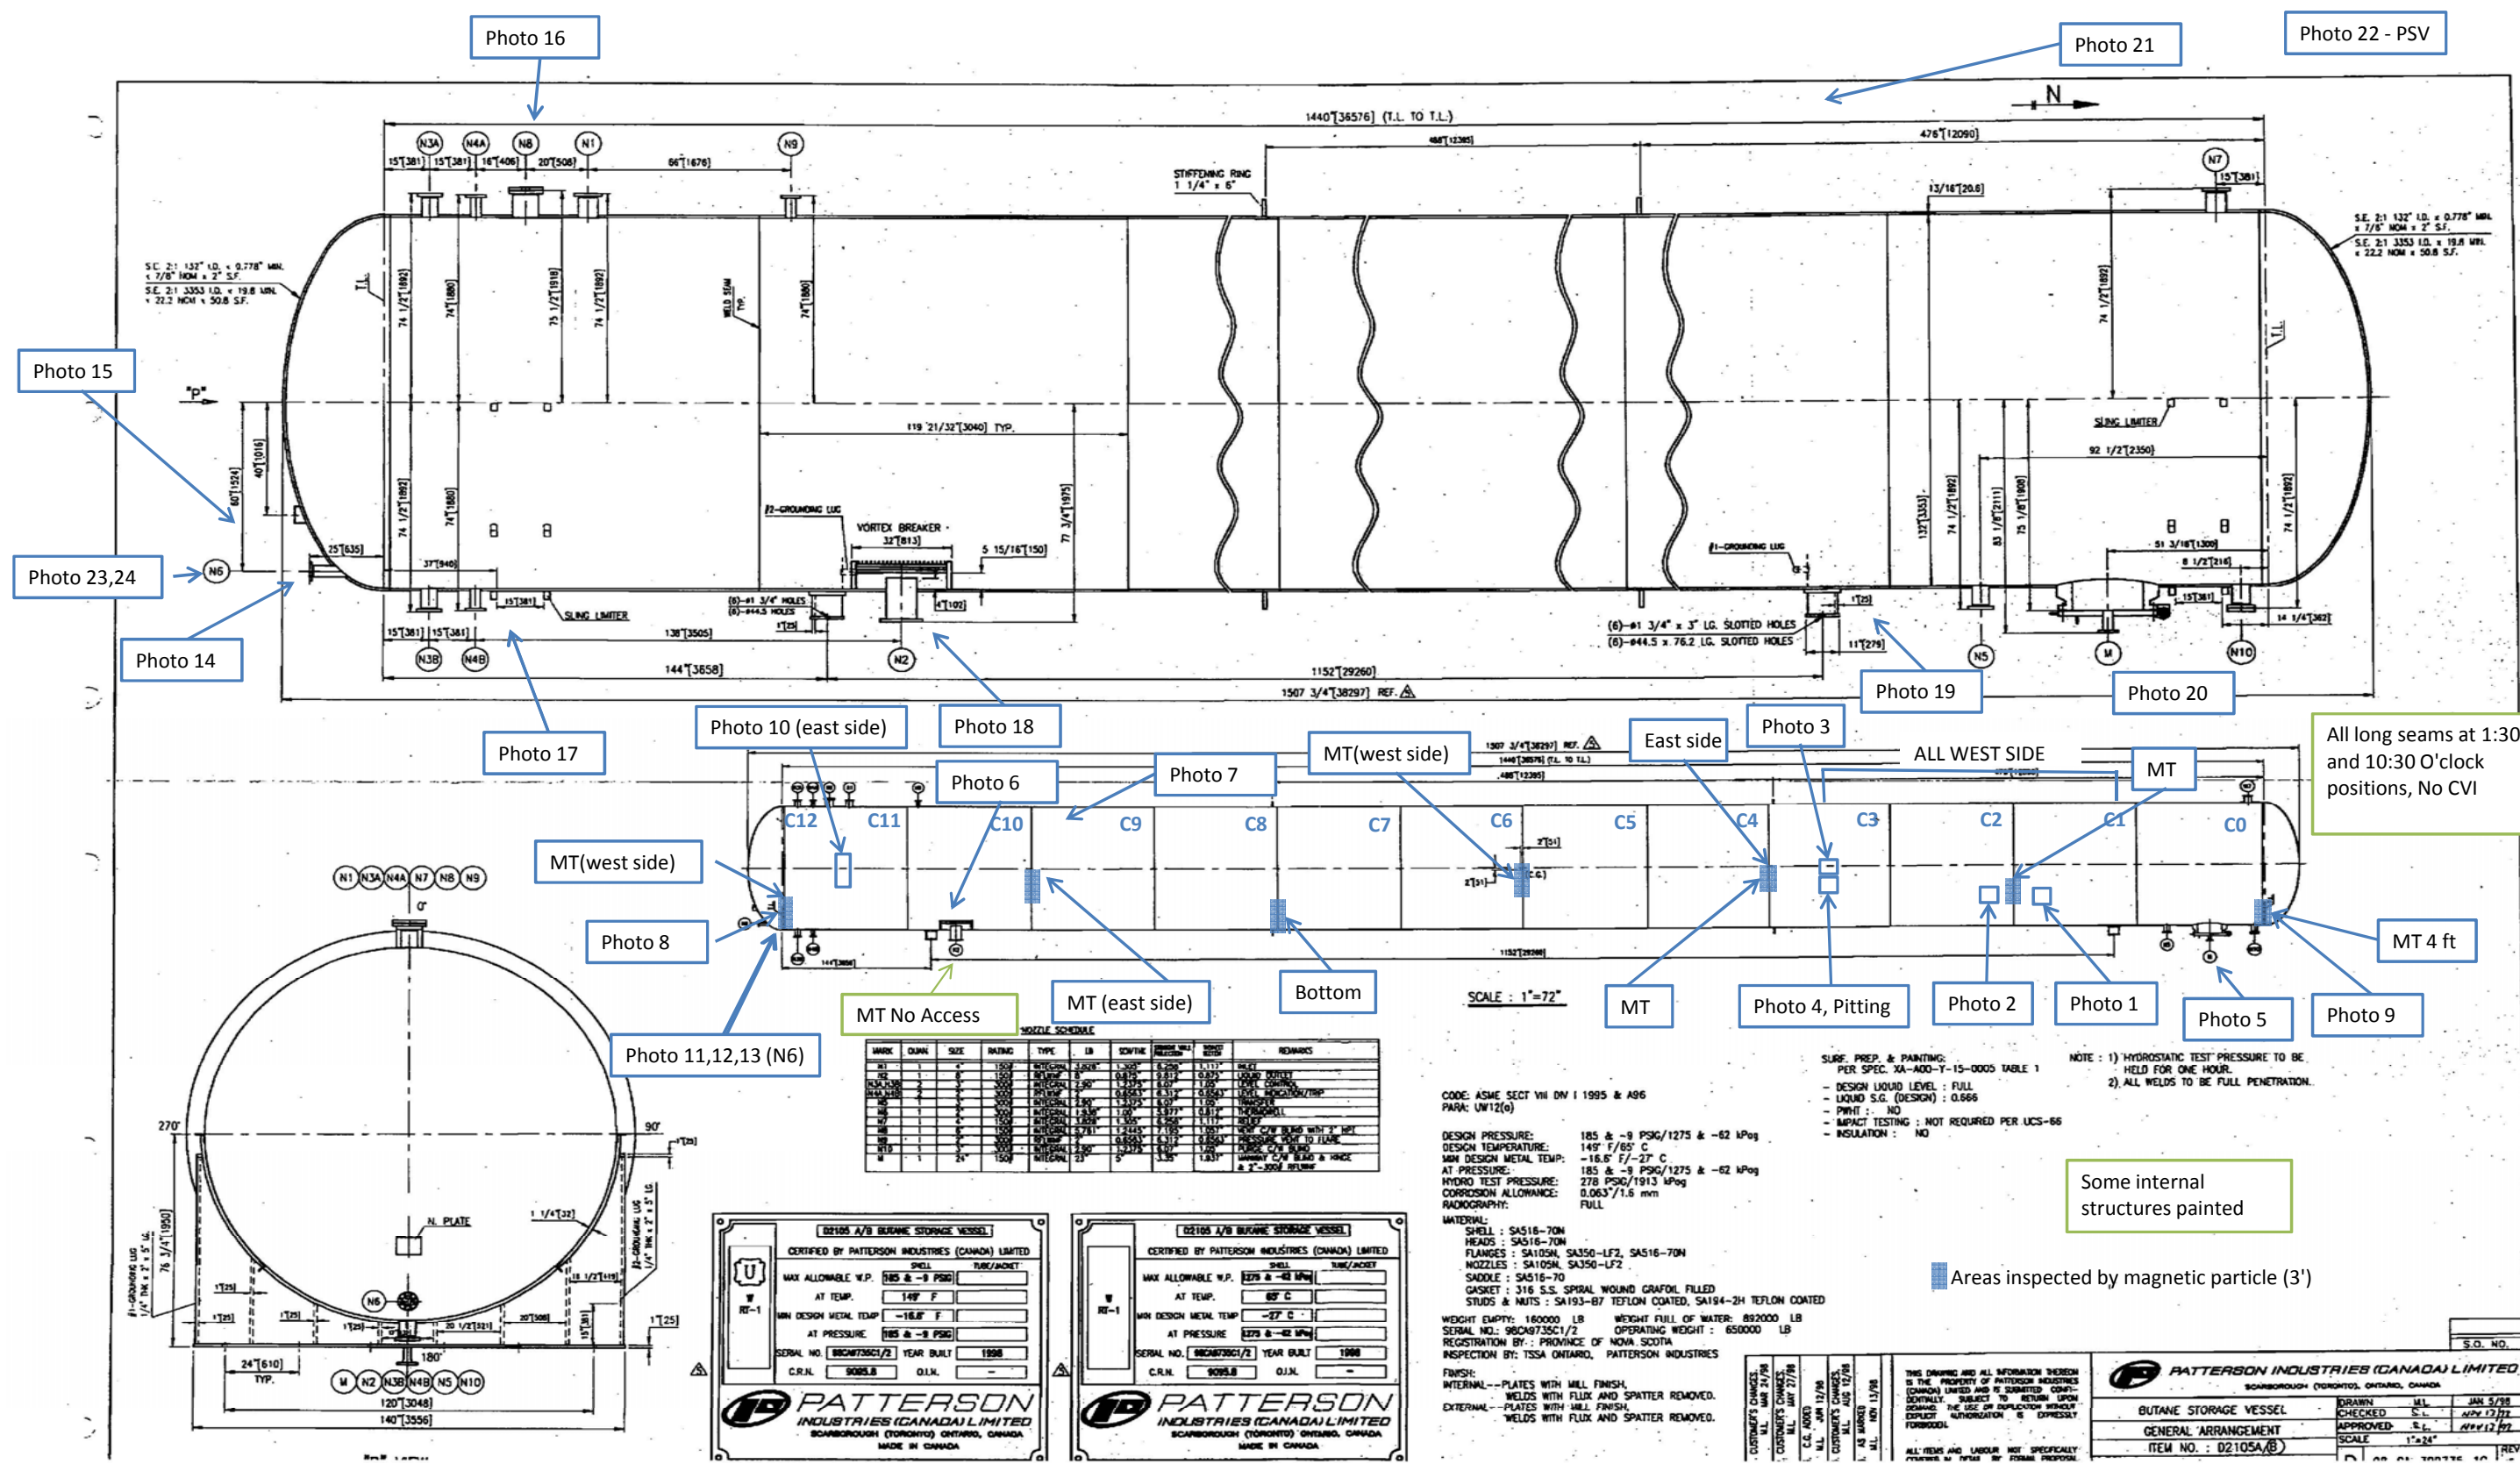
All long seams at 1:30 and 10:30 O'clock positions, No CVI

Some internal structures painted

Areas inspected by magnetic particle (3')
