INSPECTION REPORT

Pressure Vessel Survey			
Location:	Point Tupper	EM&I J Report No.:	PT-D2105B-090523-JL-R0
Client Name:		Client Ref No.:	PT-11573618-001-D2105B
Client Rep.:		Inspector Name:	John Lee
WO No.:		Inspection Date:	May 23, 2009
SPO No.:		System:	Butane
Workscope No.:	PT-2008-VESSEL-EXT-04	EM&I J Job No:	EMJ0132.33
Tag No.:	D-2105B	Equipment Description:	Butane Storage Vessel D-2105B
Date of Last Inspection:	NA	Previous Records Seen:	NA
Drawing No.:	LA-B23-F-22-8060-01-Z4, 98-CA-399735-1C-5, 98-CA-399735-4C-0

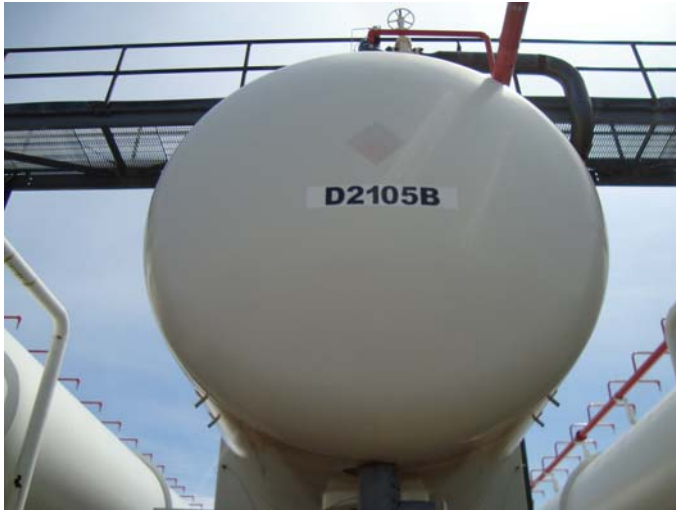
Photo 1 – Standoff view of North head

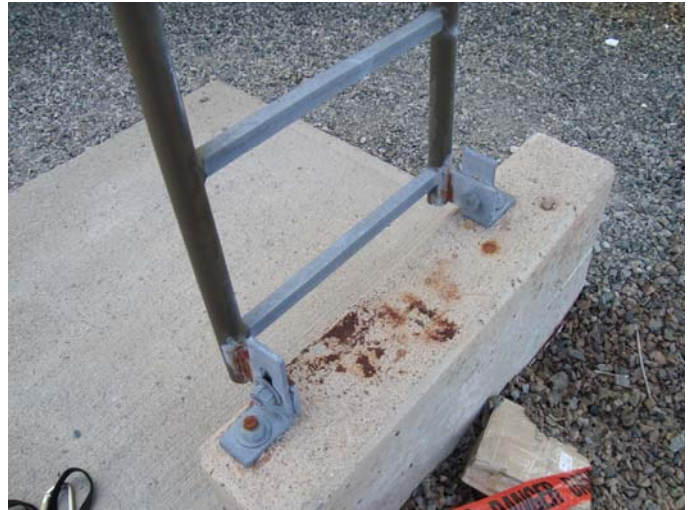
3. If applicable, check coatings for signs of deterioration, rusts spots, cracks, blistering, and/or coating disbondment.	<input checked="" type="checkbox"/>	<input type="checkbox"/>	<input type="checkbox"/>	<input type="checkbox"/>	No notable coating breakdown or deterioration (see Photos #2,3)

Photo 2 – Structure access ladder, in good condition. However, sways violently with slightest encouragement

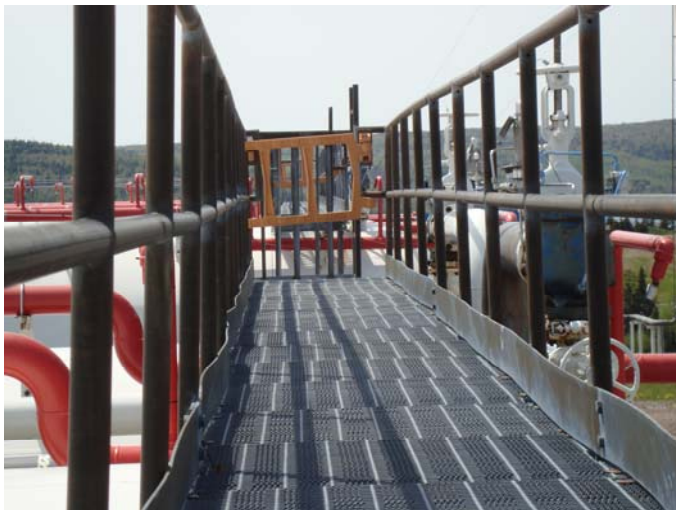
Photo 3 – Structure access ladder, in good condition. However, sways violently with slightest encouragement

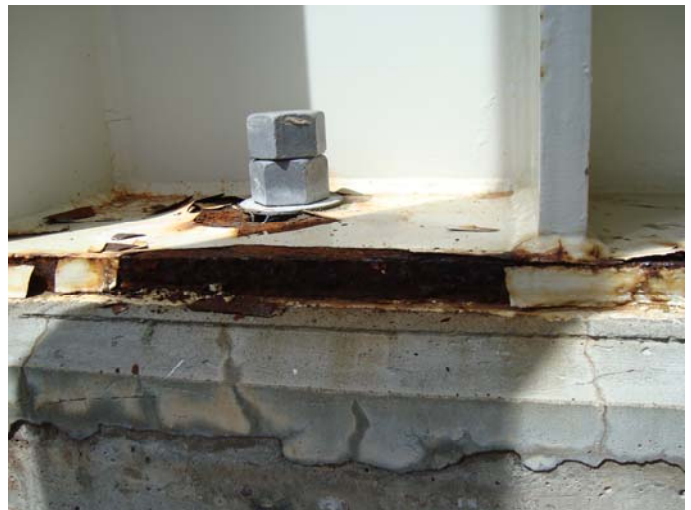
2. If applicable, check vessel supports for signs of deterioration, settlement, deflection, and/or corrosion.	<input type="checkbox"/>	<input checked="" type="checkbox"/>	<input type="checkbox"/>	<input type="checkbox"/>	100% coating breakdown with no substrate loss of vessel support base to concrete (see Photos #4,5,11)

7. If applicable, check the vessel sliding foot free to move and hold-down bolts are free.	<input type="checkbox"/>	<input type="checkbox"/>	<input checked="" type="checkbox"/>	<input type="checkbox"/>	North end structural support bolts are correctly positioned with expansion-purpose gap

Inspection Summary					
Item	Condition				Comments
					between bolt and vessel (see Photos #4,5). South end structural support bolts are lacking in thread protrusion up to 20mm (see Photos #8,9,10,12,13,14)
Vessel External Surfaces	Good	Fair	Poor	NA

North end structural support bolts are correctly positioned with expansion-purpose gap between bolt and vessel (this was confirmed with Operators and Authorities). However South end structural support bolts are lacking in thread protrusion up to 20mm and Operators and Authorities informed for further investigation by themselves.

Photo 4 –General condition of studs and nuts, good condition. North end structural support bolts are correctly positioned with expansion-purpose gap between bolt and vessel. South end structural support bolts are lacking in thread protrusion up to 20mm

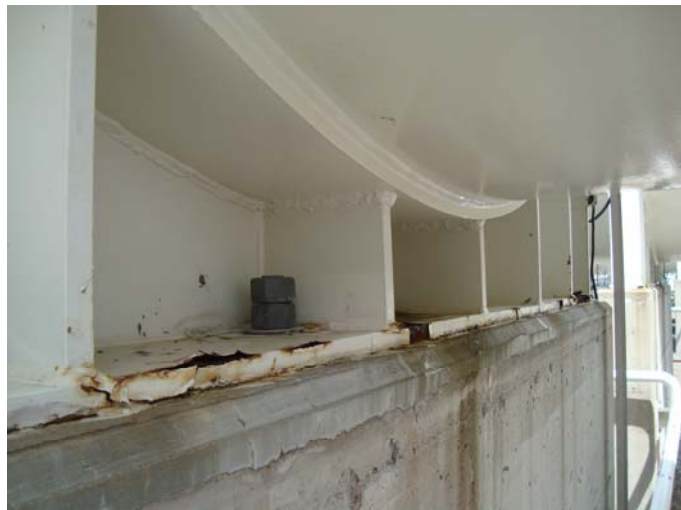
Photo 5 – General condition of studs and nuts, good condition. North end structural support bolts are correctly positioned with expansion-purpose gap between bolt and vessel. South end structural support bolts are lacking in thread protrusion up to 20mm

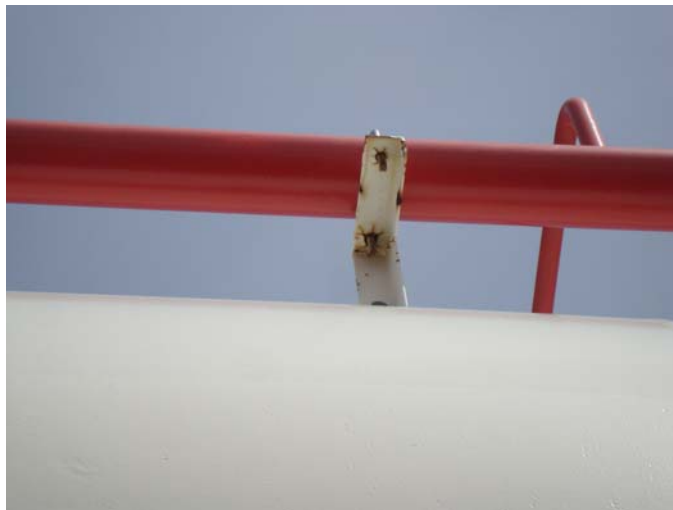
Inspection Summary					
Item	Condition				Comments
External Ladders, Access and Support Structure	Good	Fair	Poor	NA	
1. If applicable, check ladders, stairways, platforms and walkways that are connected to, or bearing on the vessel for signs of corrosion, missing components, or deterioration.	<input type="checkbox"/>	<input checked="" type="checkbox"/>	<input type="checkbox"/>	<input type="checkbox"/>	General condition of ladders, stairways, platforms and walkways in good condition. North and South ladder and walkway structure sways violently at bolted connection to vessels (see Video "North Access Structure Walkway", see Photo #2,3). Pipe supports generally in good condition, however 2 isolated cases of missing nuts on one pipe support (see Photos #6,7)

Photo 6 – Pipe support missing nuts

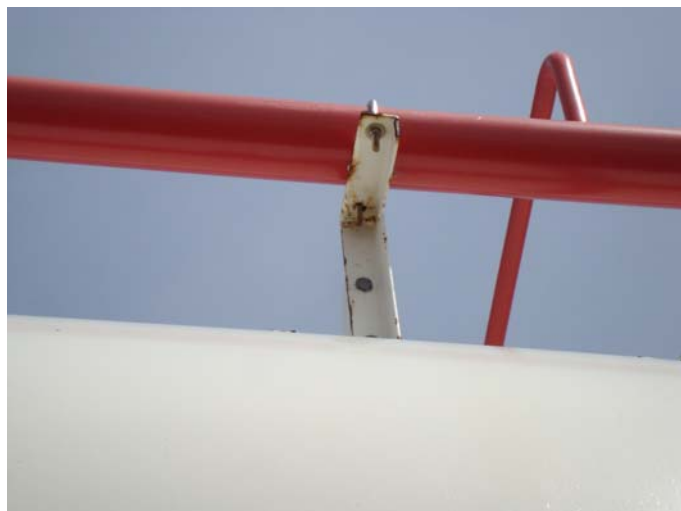
Photo 7 – Pipe support missing nuts

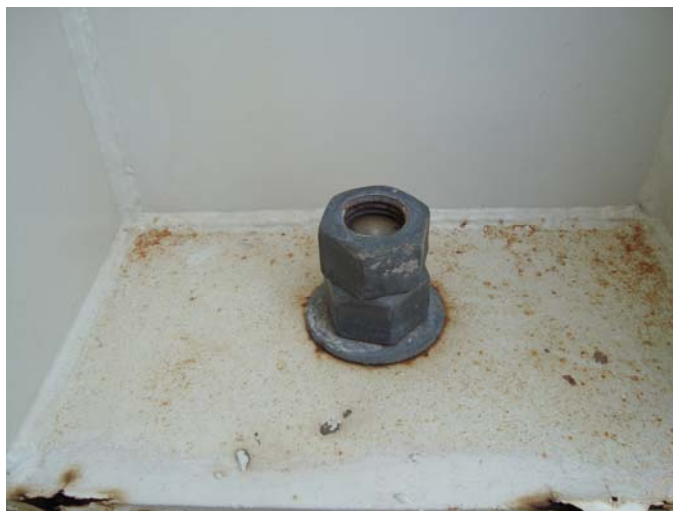
2. If applicable, check that all bolts/studs extend fully through their nuts, having a protrusion beyond the nut of not less than one thread; flange bolts have bolt heads all on the side of the joint.	<input type="checkbox"/>	<input checked="" type="checkbox"/>	<input type="checkbox"/>	<input type="checkbox"/>	General condition of studs and nuts good, however North end structural support bolts are correctly positioned with expansion-purpose gap between bolt and vessel (see Photos #4,5). South end structural support bolts are lacking in thread protrusion up to 20mm (see Photos #8,9,10,12,13,14, 17, 19-25)

Photo 8 –General condition of studs and nuts, good condition. North end structural support bolts are correctly positioned with expansion-purpose gap between bolt and vessel. South end structural support bolts are lacking in thread protrusion up to 20mm

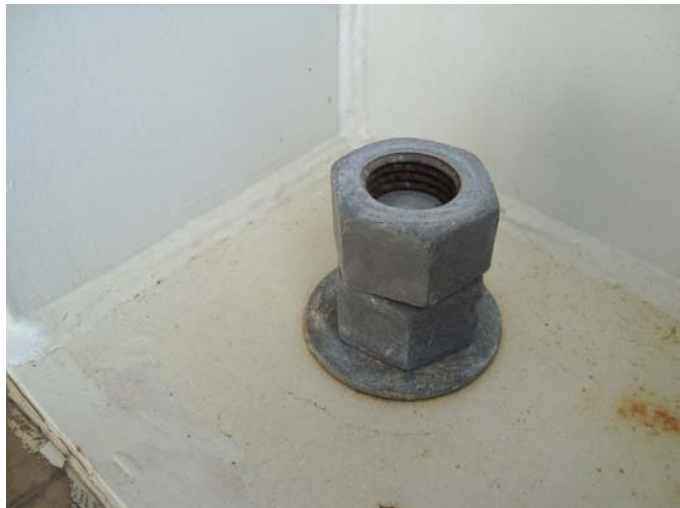
Photo 9 – General condition of studs and nuts, good condition. North end structural support bolts are correctly positioned with expansion-purpose gap between bolt and vessel. South end structural support bolts are lacking in thread protrusion up to 20mm

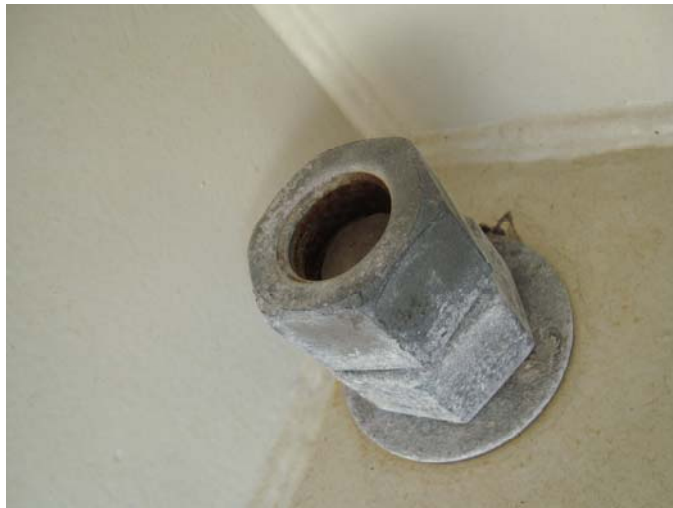
Photo 10 – General condition of studs and nuts, good condition. North end structural support bolts are correctly positioned with expansion-purpose gap between bolt and vessel. South end structural support bolts are lacking in thread protrusion up to 20mm

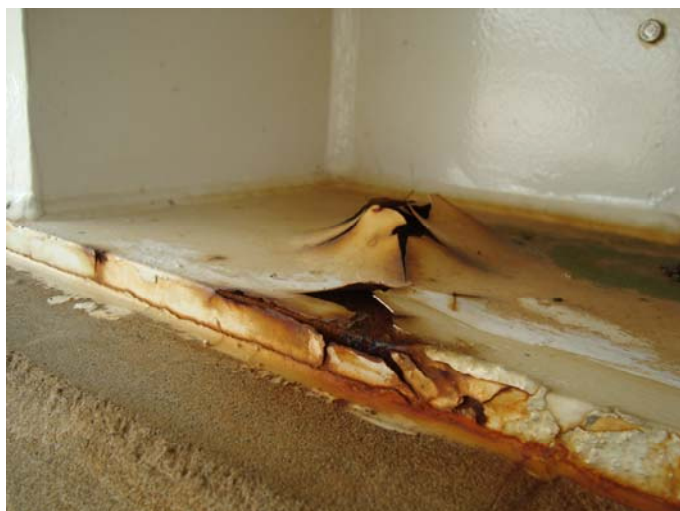
Photo 11 – Delamination/debonding of structural support flange to base

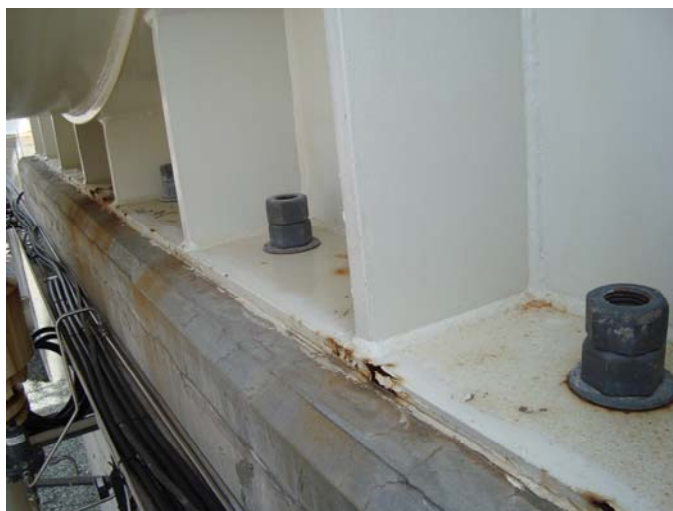
Photo 12 – General condition of studs and nuts, good condition. North end structural support bolts are correctly positioned with expansion-purpose gap between bolt and vessel. South end structural support bolts are lacking in thread protrusion up to 20mm

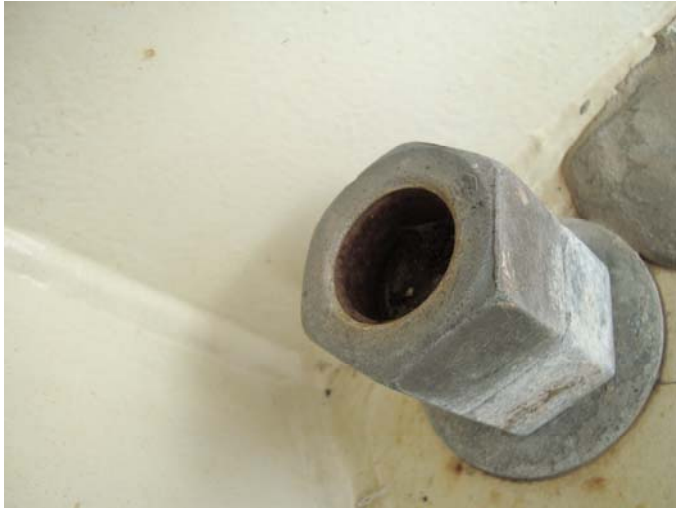
Photo 13 – General condition of studs and nuts, good condition. North end structural support bolts are correctly positioned with expansion-purpose gap between bolt and vessel. South end structural support bolts are lacking in thread protrusion up to 20mm

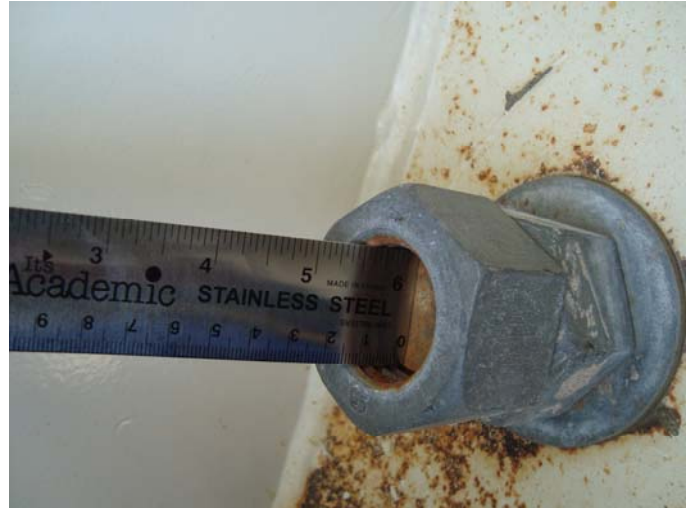
Photo 14 – General condition of studs and nuts, good condition. North end structural support bolts are correctly positioned with expansion-purpose gap between bolt and vessel. South end structural support bolts are lacking in thread protrusion up to 20mm

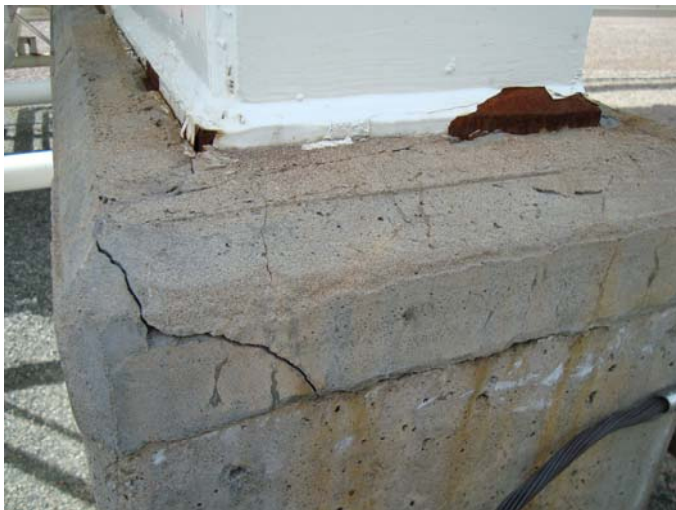
Photo 15 – Concrete support structure, signs of cracking

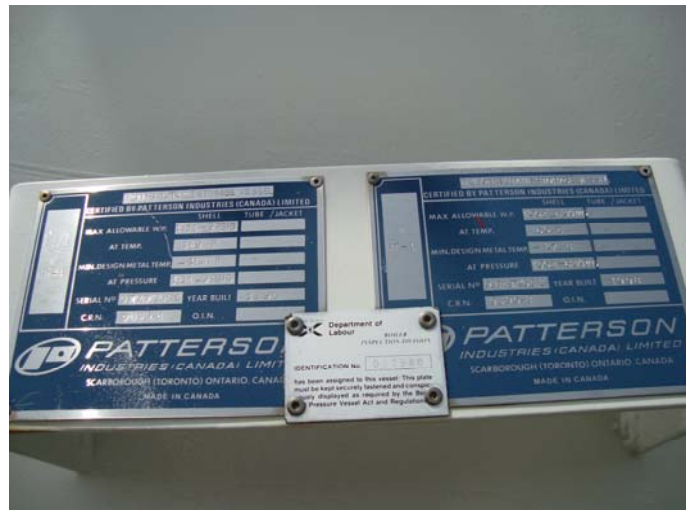
1. Check permanent identifying tags on vessel are legible and present the required information.	<input checked="" type="checkbox"/>	<input type="checkbox"/>	<input type="checkbox"/>	<input type="checkbox"/>	Tags in good condition at time of inspection (see Photo #16)

Photo 16 – ID tag in good condition

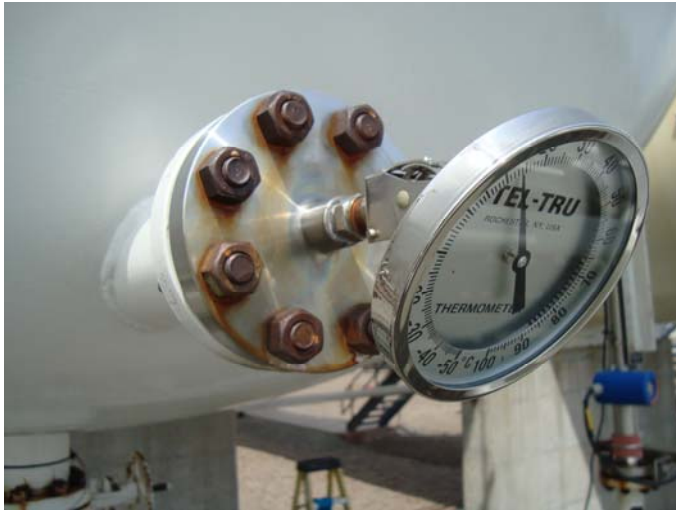
1. If applicable, check vessel trim, such as gauges, sight glasses, valves and other appurtenances, show signs of deterioration, or missing components, etc.	<input checked="" type="checkbox"/>	<input type="checkbox"/>	<input type="checkbox"/>	<input type="checkbox"/>	Thermometer in good condition - CS to SS flange to note (see Photo #17)

Photo 17 – Thermometer in good condition, CS to SS flange

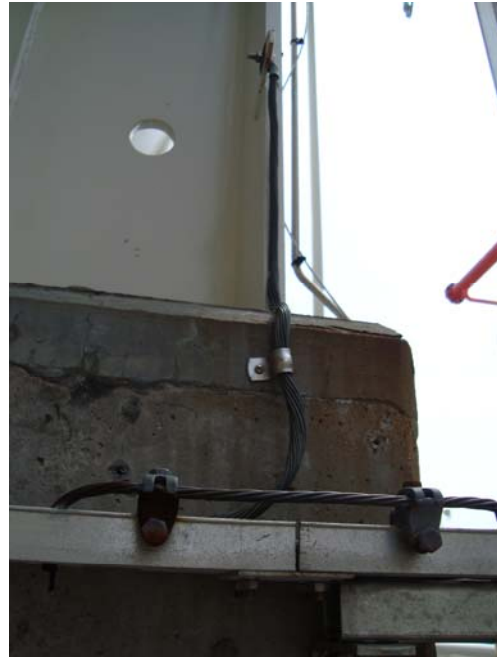
5. Check the grounding connection is correctly installed, with cable connections tight and ground wires in good condition.	<input checked="" type="checkbox"/>	<input type="checkbox"/>	<input type="checkbox"/>	<input type="checkbox"/>	Grounded connection intact and in good condition (see Photo #18)

Photo 18 – Grounding cable intact and in good condition

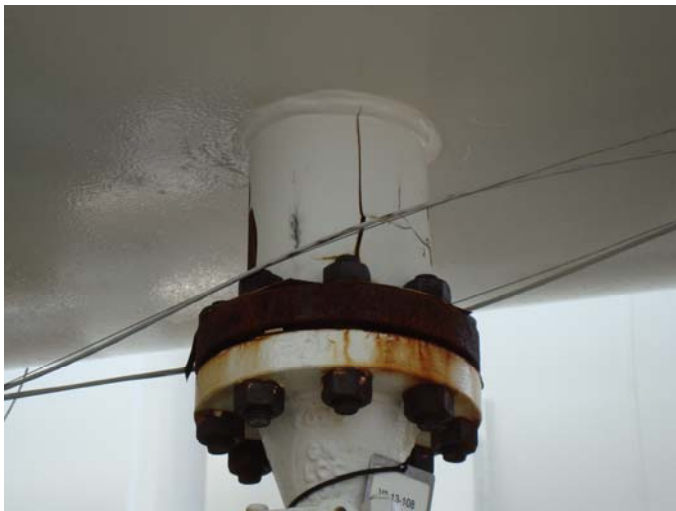
3. Inspect fittings, nozzles and other connections, including the surrounding vessel shell / head for any signs of distortion or cracks, wall loss, leakage, deterioration of coatings, etc. Specify extent and location.	<input type="checkbox"/>	<input type="checkbox"/>	<input checked="" type="checkbox"/>	<input type="checkbox"/>	All nozzles in fair condition with coating breakdown and delamination but no notable substrate loss (see Photos #19-25)

Photo 19 – Flange in fair condition with 100% coating breakdown, no notable substrate loss

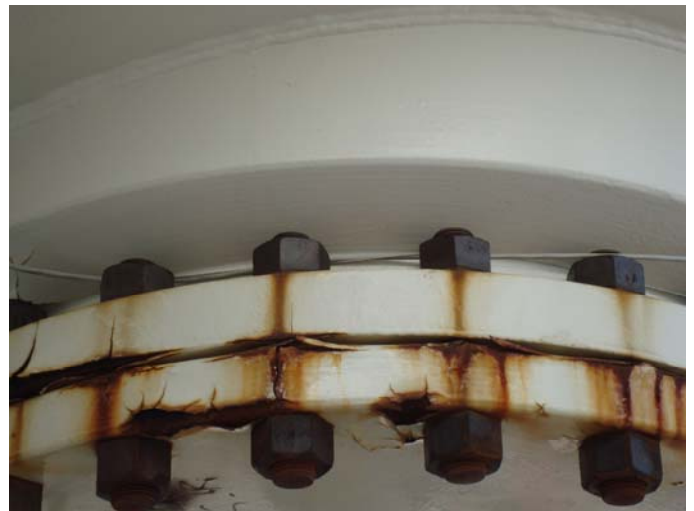
Photo 20 – Flange in fair condition with delamination of coating, no notable substrate loss

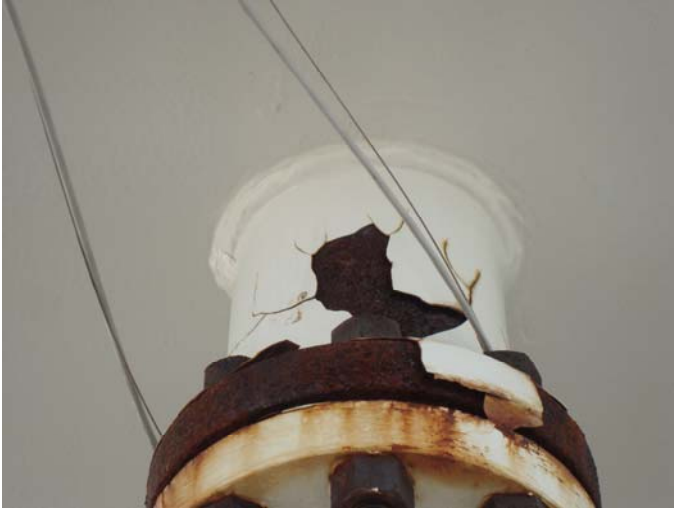
Photo 21 – Flange in fair condition with 100% coating breakdown, no notable substrate loss

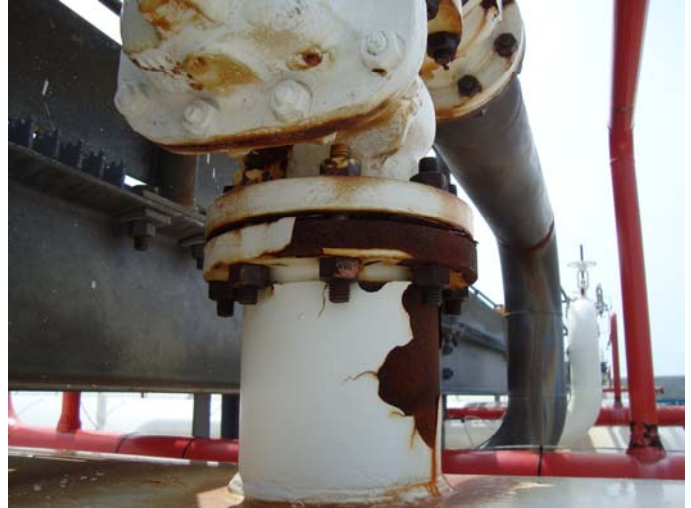
Photo 22 – Flange in fair condition with 80-90% coating breakdown, no notable substrate loss

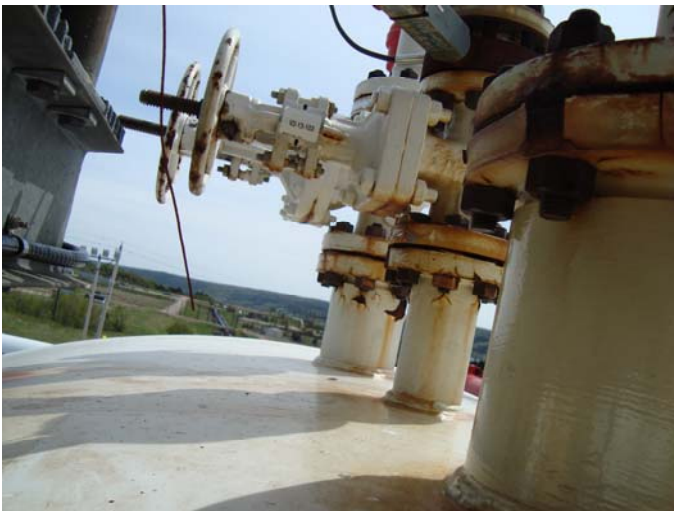
Photo 23 – Flange in fair condition with partial coating breakdown & delamination, no notable substrate loss

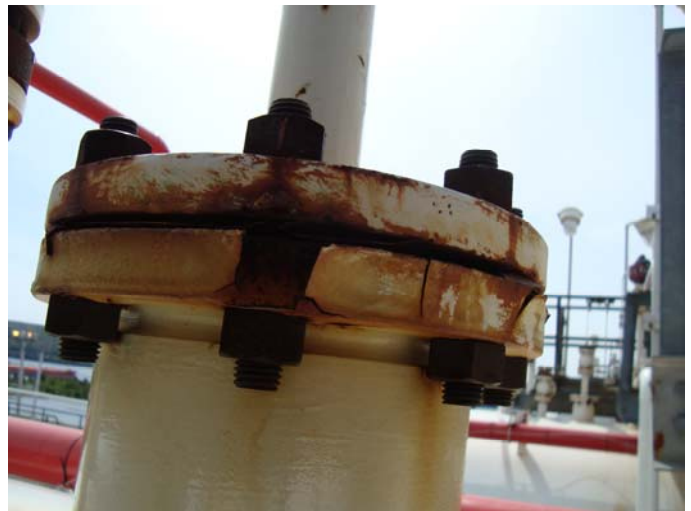
Photo 24 – Flange in fair condition with coating breakdown & delamination, no notable substrate loss

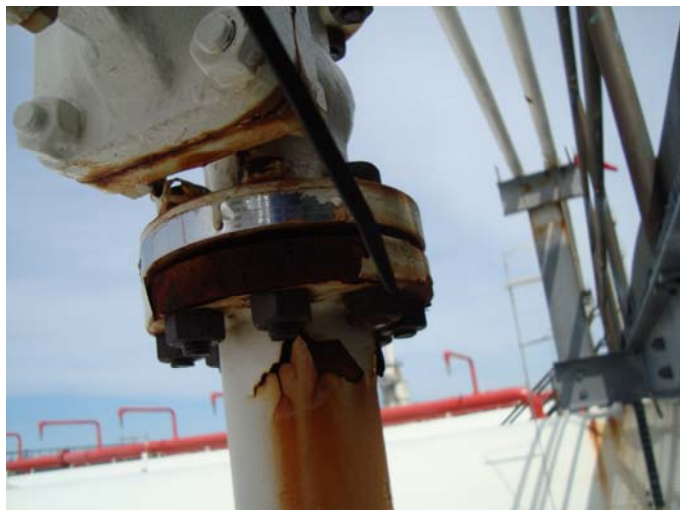
Photo 25 – Flange in fair condition with 100% coating breakdown, no notable substrate loss

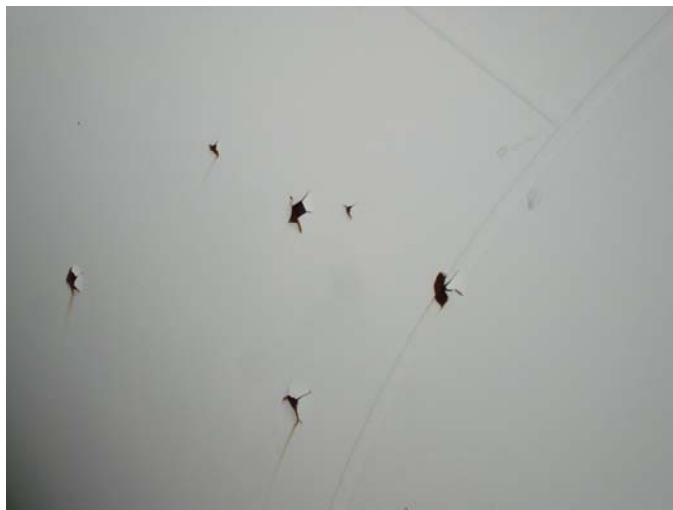
7. Carry out visual inspection of the exterior surface of the vessel, including coatings for any signs of leaks, cracks, deformation, distortion, pitting, corrosion or other forms of deterioration. If so, specify type, location and extent.	<input checked="" type="checkbox"/>	<input type="checkbox"/>	<input type="checkbox"/>	<input type="checkbox"/>	Vessel surface in generally good condition with minor coating breakdown and no notable substrate loss (see Photos #26,27,28, 29)

Photo 26 – Isolated areas of coating breakdown on shell, no notable substrate loss, ASTM grade 5-S

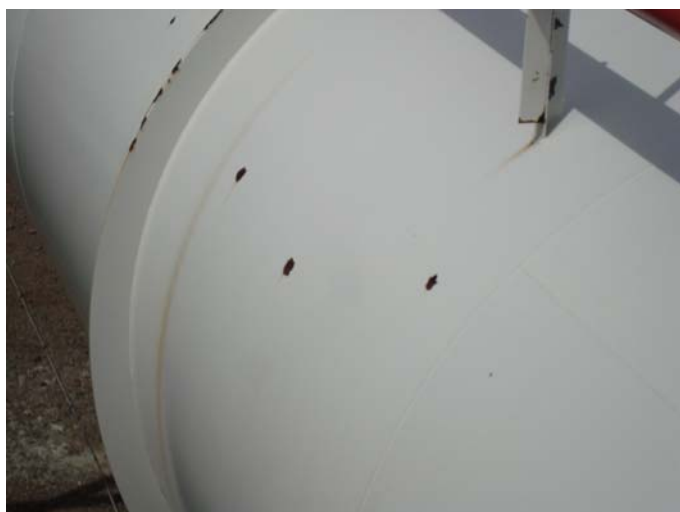
Photo 27 – Isolated areas of coating breakdown on shell, no notable substrate loss, grade 6S-7S

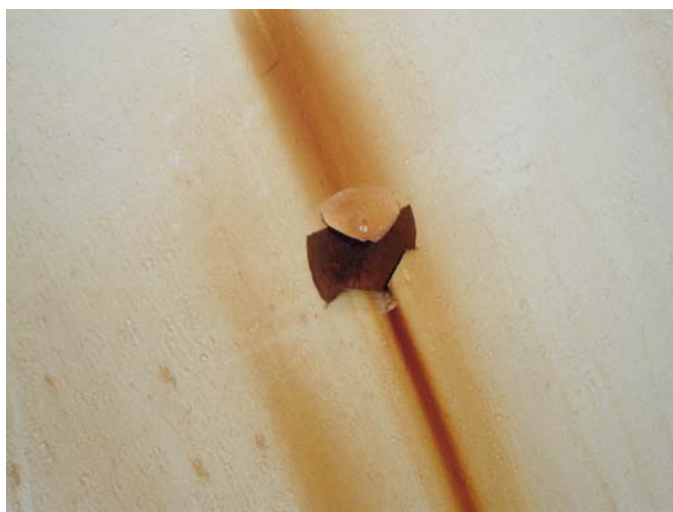
Photo 28 – Isolated areas of coating breakdown on shell, no notable substrate loss, grade 6S-7S

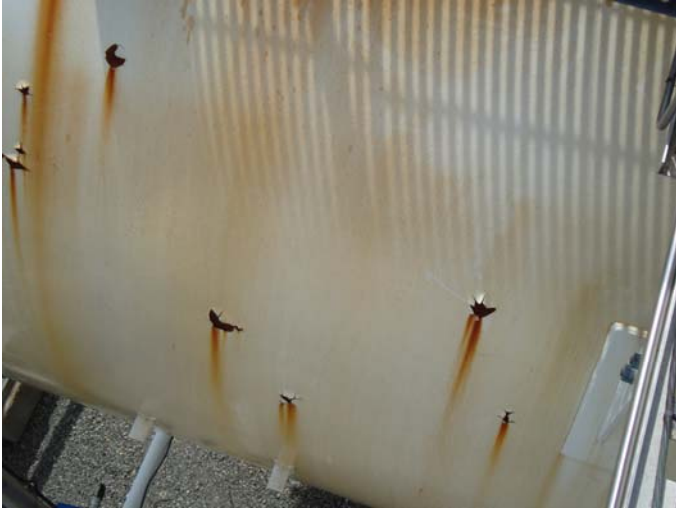
Photo 29 – Isolated areas of coating breakdown on shell, no notable substrate loss, grade 6-S

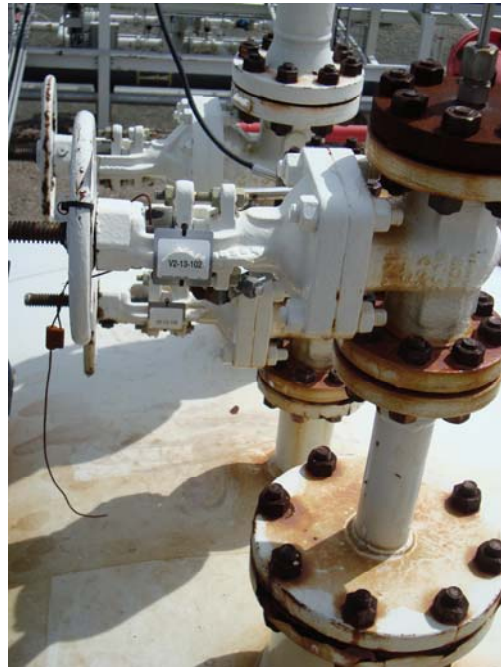
Photo 30 – Flange in fair condition with 100% coating breakdown, no notable substrate loss
