INSPECTION REPORT

Pressure Vessel Survey			
Location:	Point Tupper	EM&I J Report No.:	PT-D2105B-090729-JT-R0
Client Name:		Client Ref No.:	PT-11564911-001-D2105B
Client Rep.:		Inspector Name:	James Tulk
WO No.:		Inspection Date:	July 29, 2009
SPO No.:		System:	Butane
Workscope No.:	PT-2009-D2105B-INT-01	EM&I J Job No.:	EMJ0132.43
Tag No.:	D-2105B	Equipment Description:	Butane Storage Vessel D-2105B
Date of Last Inspection:	NA	Previous Records Seen:	NA
Drawing No.:	98-CA-399735C

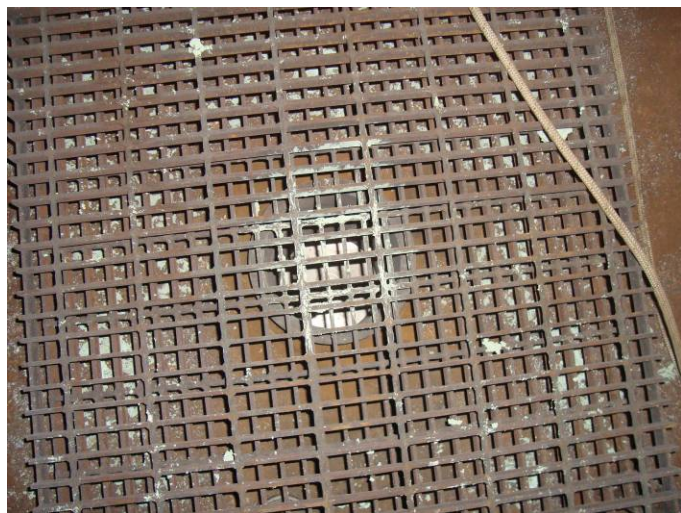
Note 6) No evidence of corrosion, distortion, missing components, or any deterioration on vortex breaker for nozzle N2 outlet

Photo 5 – Looking down at nozzle N2-8” outlet and vortex breaker

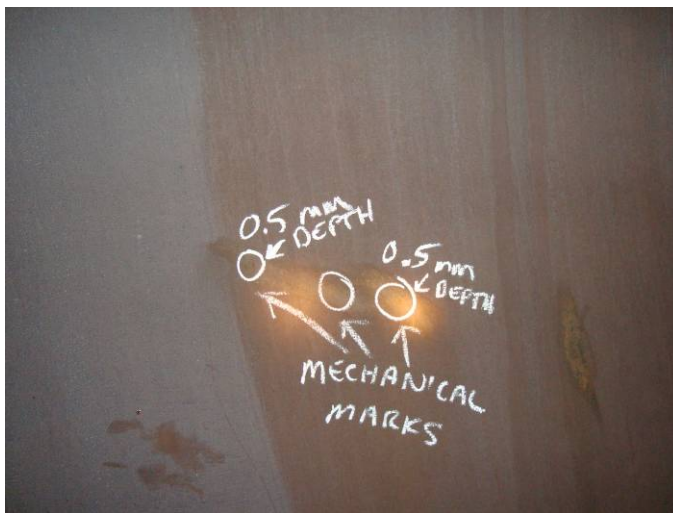
Photo 6 - Mechanical marks created by excessive grinding upon removal of possible defects during fabrication, located between circ welds #8 and #9 having a depth of approximately 0.5mm and less. Acceptable for service.

Photo 6 – Mechanical marks on shell looking West inside vessel between #8 and #9 circ welds

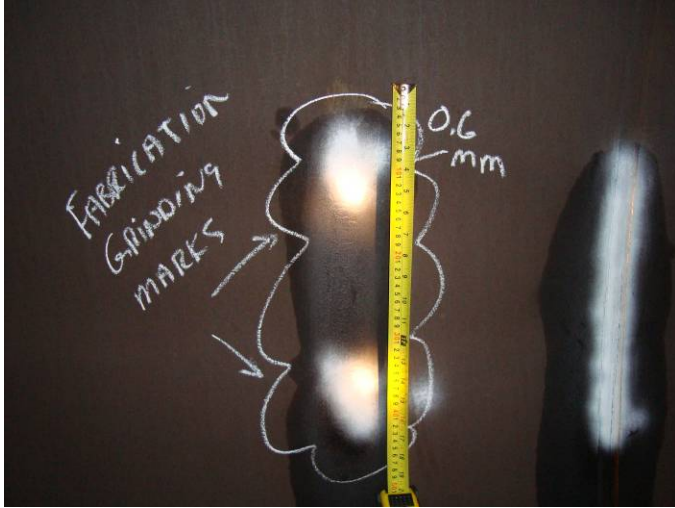
Photo 7 - Mechanical marks created by excessive grinding upon removal of possible defects during fabrication. These two marks are located between circ welds #7 and #8 having a depth of approximately 0.6mm and less. Acceptable for service.

Photo 7 – Mechanical marks on interior shell looking West between #7 and #8 circ welds

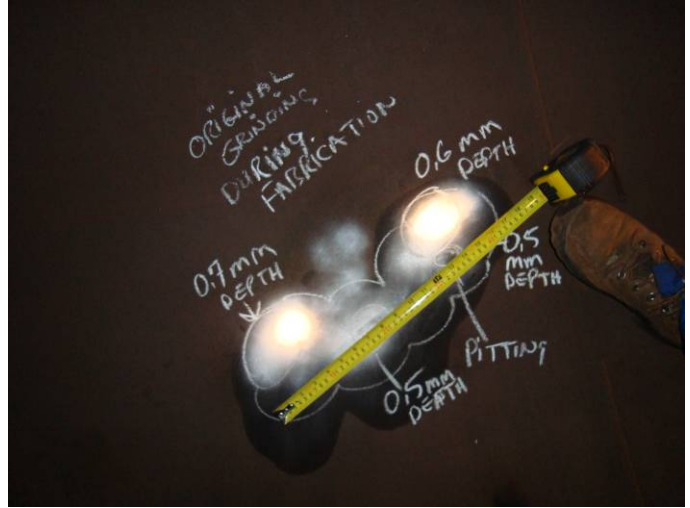
Photo 8 - Mechanical marks created by excessive grinding upon removal of possible defects during fabrication. These three marks are located between circ welds #5 and #6 having a depth of 0.5mm, 0.6mm, and approximately 0.7mm. As well, one localized corrosion pit was also evident in the immediate area having a depth of 0.5mm. Acceptable for service.

Photo 8 – Mechanical marks on localized corrosion pit looking West between #6 and #7 circ welds

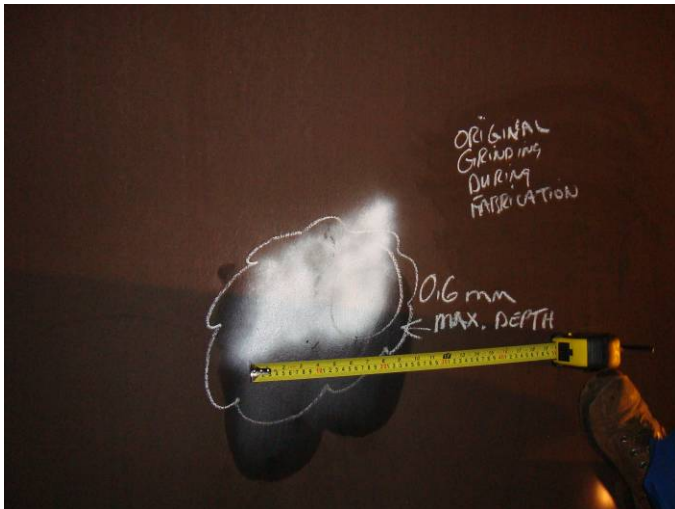
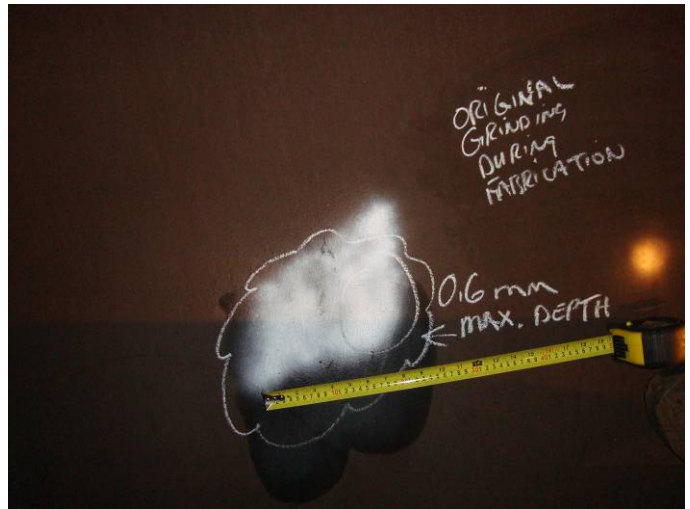
Photos 9 and 10 - Mechanical marks created by excessive grinding upon removal of possible defects during fabrication. These marks are located between circ welds #3 and #4 having a depth of approximately 0.6mm and less. Acceptable for service.

Photo 9 – Mechanical marks on interior shell between circ welds #3 and #4

Photo 10 – Mechanical marks on interior shell between circ welds #3 and #4

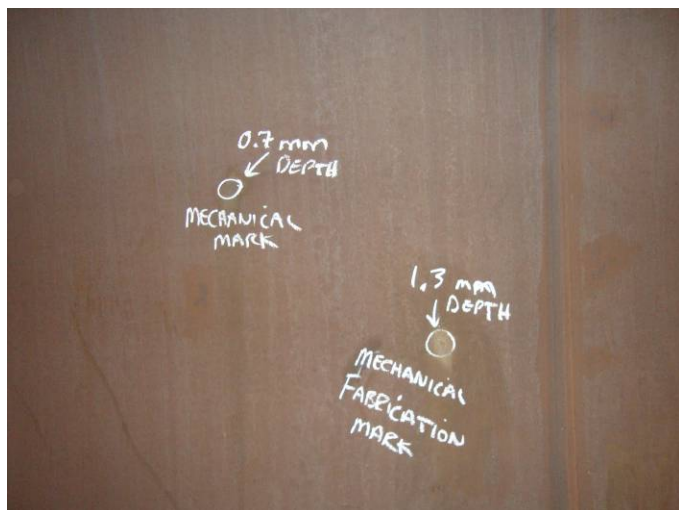
Photo 11 = Two mechanical marks created during fabrication of vessel. These two marks are located just south of circ weld #3. The upper mark on the photo has a depth of 0.7mm but the lower mark has a depth of 1.3mm and it appears to have been created during the removal of a welded dog leg. Upon doing so, a portion of the original wall plate interior surface went with it.

Photo 11 – Mechanical marks on interior shell just south of circ weld #3, looking West

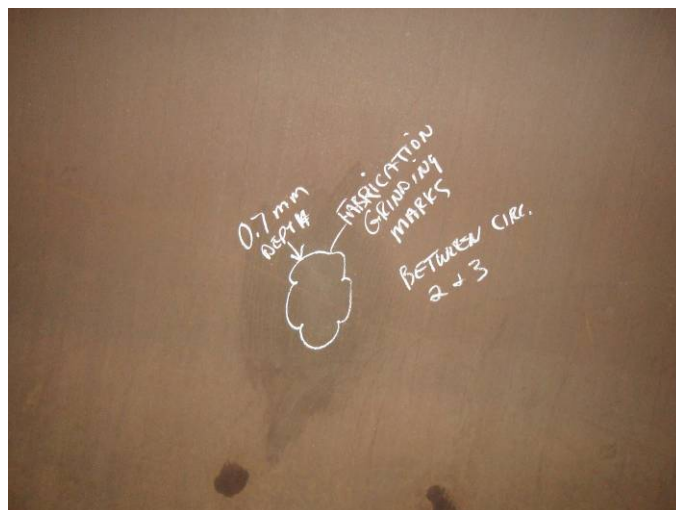
Photo 12 = Mechanical marks created by excessive grinding upon removal of possible defects during fabrication. This area of marks were found to have a maximum depth of 0.7mm and are located between circ welds #2 and #3 looking East

Photo 12 – Mechanical marks on interior shell surface between circ welds #2 and #3, looking East

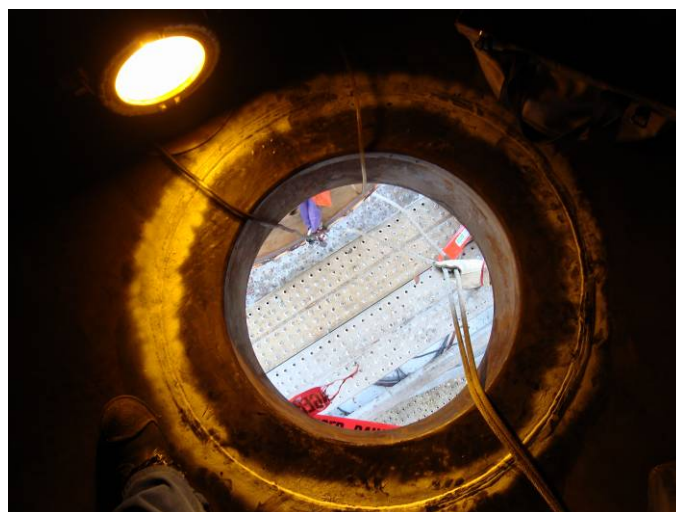
Note 4) No evidence of corrosion/erosion or any mechanical damage on man-way gasket and cover seals. Acceptable for service.

Photo 14 – Looking down at manway M-24" from interior of vessel at North end
