INSPECTION REPORT

Pressure Vessel Survey			
Location:	Point Tupper	EM&I J Report No.:	PT-D2105C-090503-DL-R0
Client Name:		Client Ref No.:	PT-11573619-001-D2105C
Client Rep.:		Inspector Name:	Daniel Lewis
WO No.:		Inspection Date:	May 03, 2009
SPO No.:		System:	Butane
Workscope No.:	PT-2008-VESSEL-EXT-04	EM&I J Job No:	EMJ0132.33
Tag No.:	D-2105C	Equipment Description:	Butane Storage Vessel D-2105C
Date of Last Inspection:	NA	Previous Records Seen:	NA
Drawing No.:	LA-B23-F-22-8062-01-Z4, 98-CA-399735-E, 98-CA-399735-4C

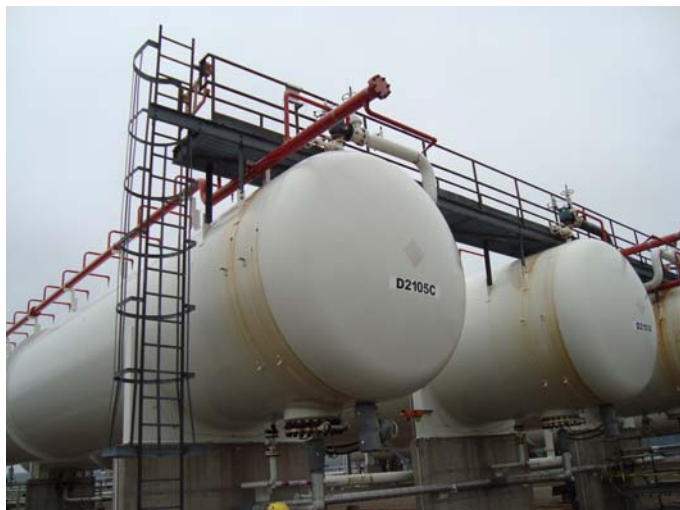
Inspection Summary					
Item	Condition				Comments
External Ladders, Access and Support Structure	Good	Fair	Poor	NA	
1. If applicable, check ladders, stairways, platforms and walkways that are connected to, or bearing on the vessel for signs of corrosion, missing components, or deterioration.	<input type="checkbox"/>	<input checked="" type="checkbox"/>	<input type="checkbox"/>	<input type="checkbox"/>	Supports for access way allow a lot of movement. This could possibly be placing stress on the re-enforcement plates

Photo 1 – North dome end of vessel and vessel access structure. Rust staining is propagating from the reinforcement plates of the supports of the access way

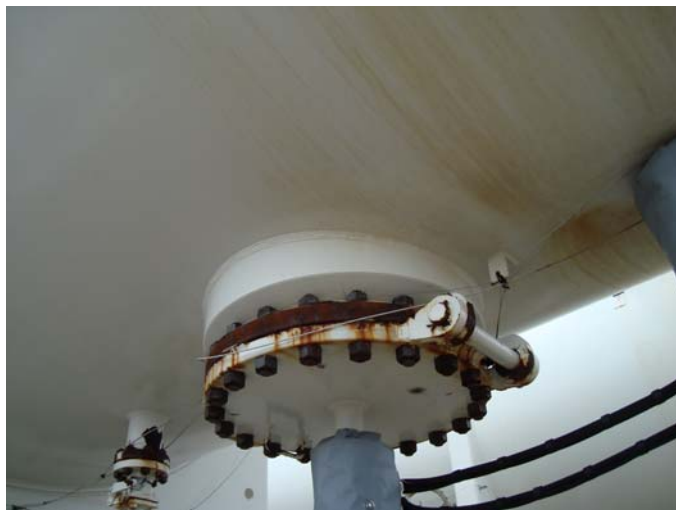
Photo 2 – (M1) 100% coating breakdown with surface corrosion of flange and CAT II studs and nuts

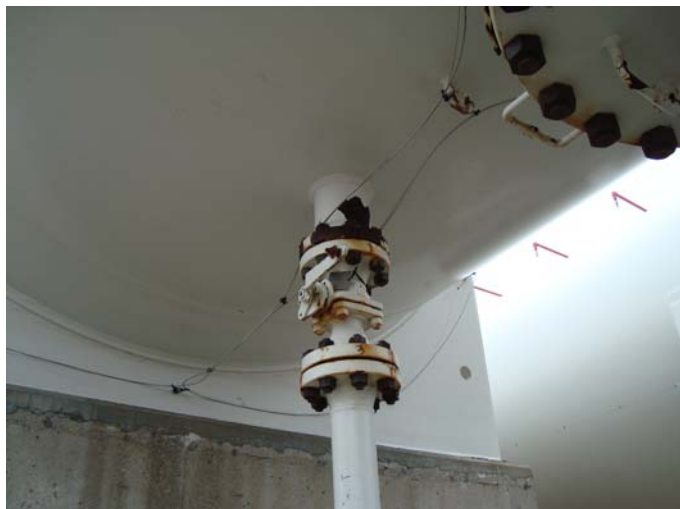
Photo 3 – (N5) 100% coating breakdown with surface corrosion of flange and CAT II studs and nuts. 20% coating breakdown with surface corrosion occurring on nozzle

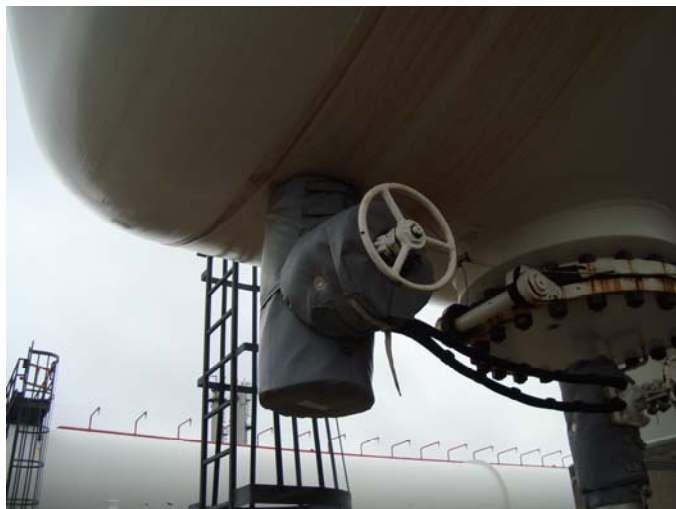
Photo 4 – (N10) Covered by insulation jacket. Heat trace in place, insulation jacket not removed due to proximity of linear heat trace. No CUI appears to be occurring at nozzle. Studs and nuts CAT II

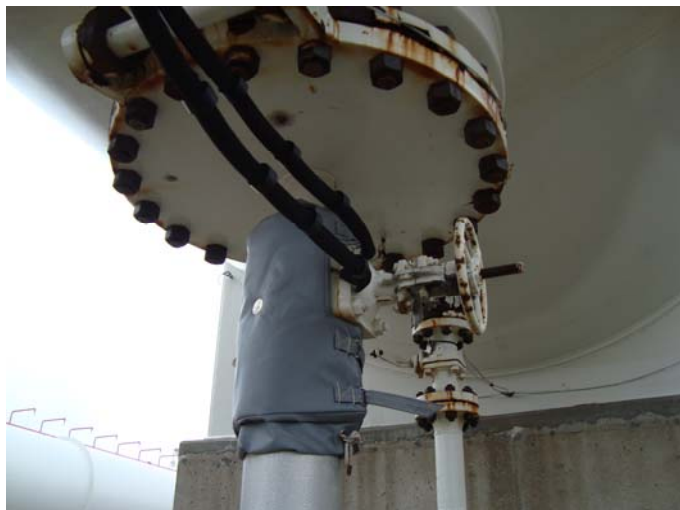
2. If applicable, check that all bolts/studs extend fully through their nuts, having a protrusion beyond the nut of not less than one thread; flange bolts have bolt heads all on the side of the joint.	<input type="checkbox"/>	<input checked="" type="checkbox"/>	<input type="checkbox"/>	<input type="checkbox"/>	The nozzle attached to the man-way has CAT I studs and nuts

Photo 5 – Nozzle attached to M1, studs and nuts CAT I

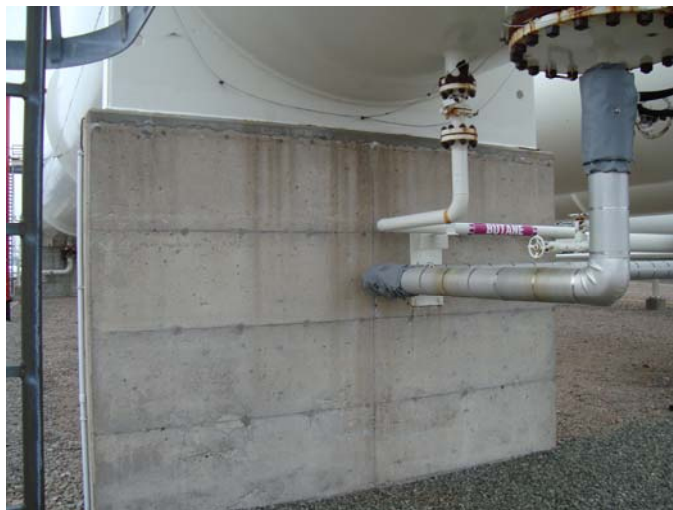
2. If applicable, check vessel supports for signs of deterioration, settlement, deflection, and/or corrosion.	<input checked="" type="checkbox"/>	<input type="checkbox"/>	<input type="checkbox"/>	<input type="checkbox"/>	Vessel supports are in good condition. Small cracks at the top of the concrete legs

Photo 6 – Concrete support leg in good condition

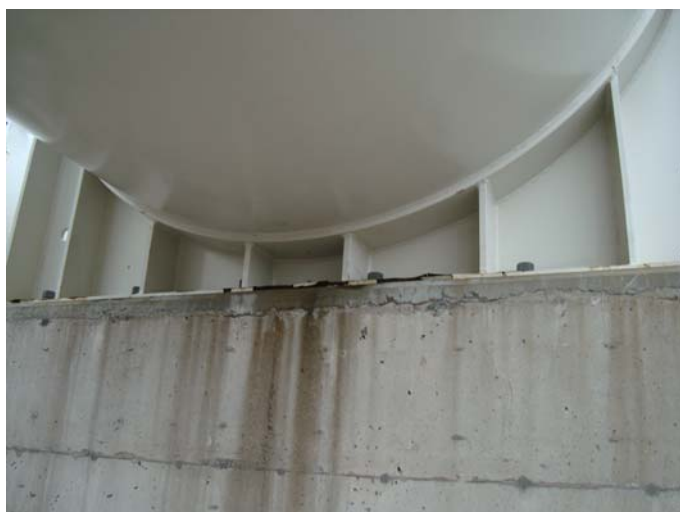
Photo 7 – Coating breakdown with surface corrosion occurring at foot of saddle support. This is a general occurrence of all the propane storage vessels

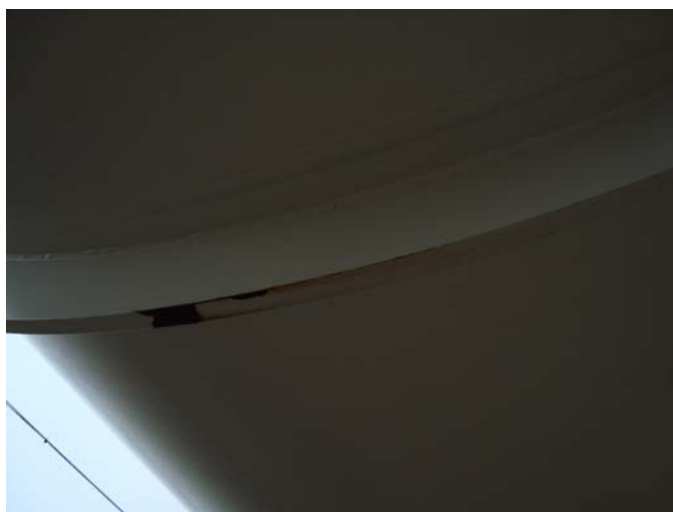
Photo 8 –Area of coating breakdown with surface corrosion on support ring at bottom of vessel

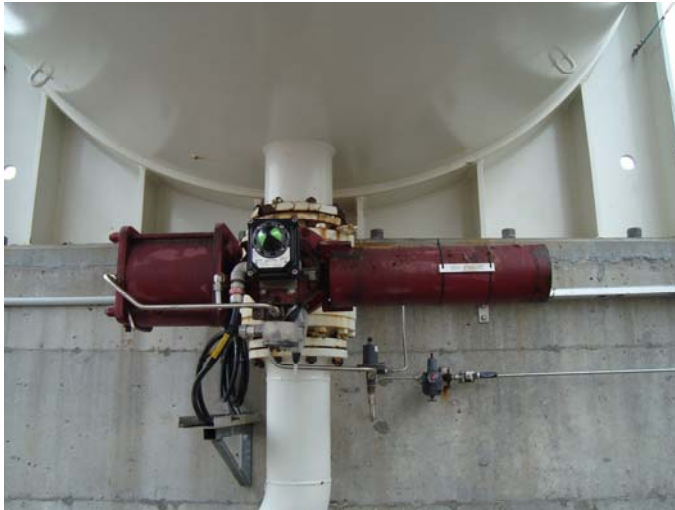
Photo 9 – Condition of SDV2105, 5% coating breakdown with surface corrosion on valve. 10% coating breakdown with surface corrosion occurring on flange of N2

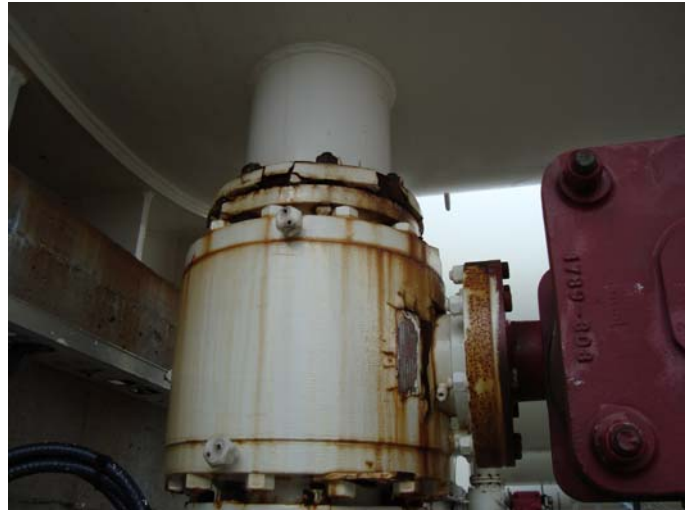
Photo 10 – (N2) 20% coating breakdown with surface corrosion occurring on flange. Studs and nuts CAT II

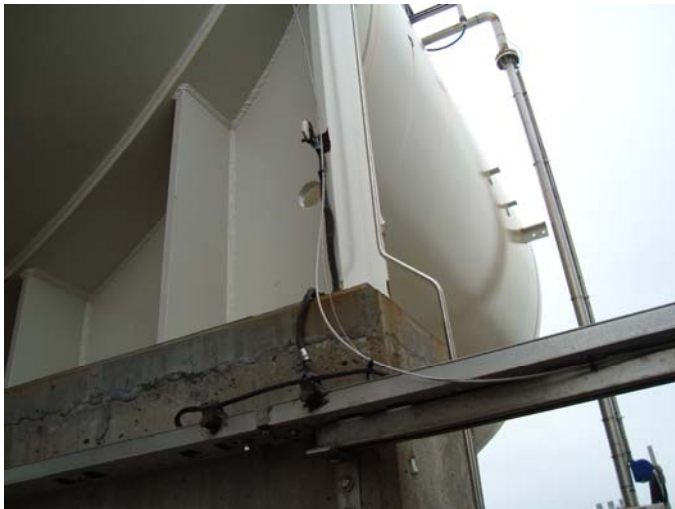
Photo 11 – Grounding cable connected and in good condition

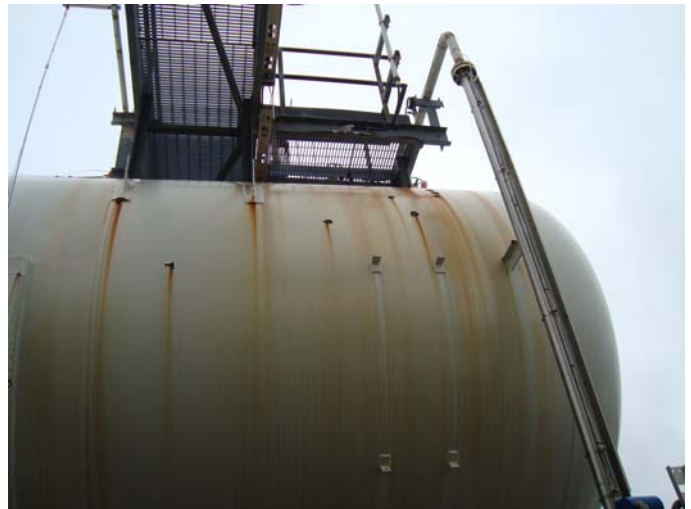
Photo 12 – Areas of coating breakdown with surface corrosion on South-West end of vessel. Corrosion appears to be light

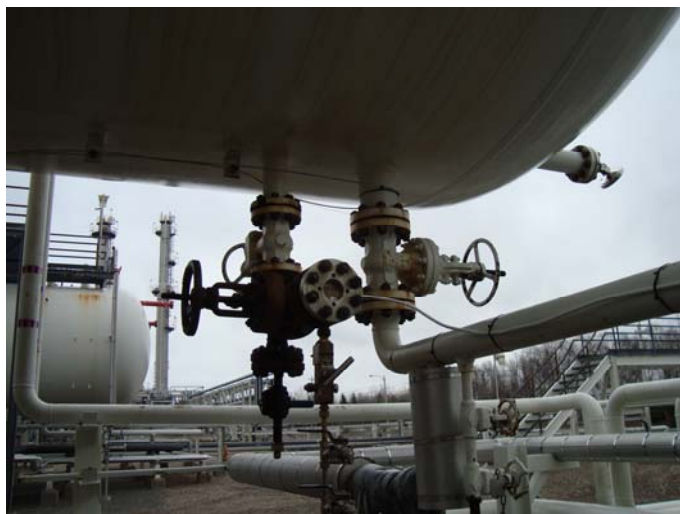
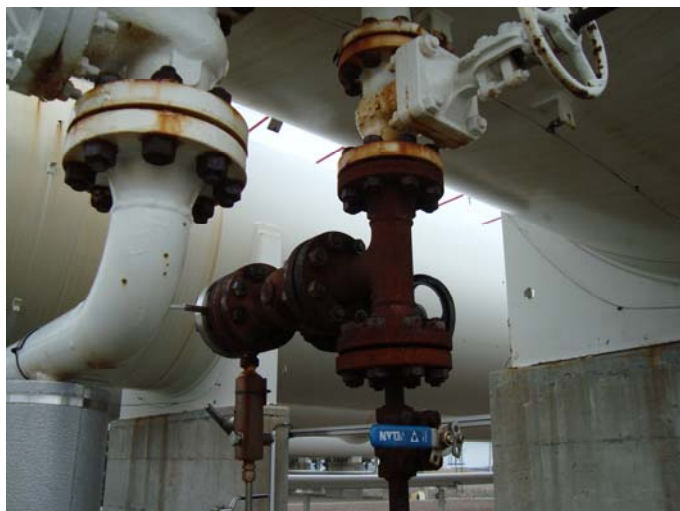
1. If applicable, check vessel trim, such as gauges, sight glasses, valves and other appurtenances, show signs of deterioration, or missing components, etc.	<input checked="" type="checkbox"/>	<input type="checkbox"/>	<input type="checkbox"/>	<input type="checkbox"/>	The vessel level gauge is Stainless Steel. This is connected to a Carbon Steel flange. The gauges on this vessel are in good condition. There is 5% coating breakdown with surface corrosion occurring on the SDV of this vessel. The trim attached to N4B has 100% coating breakdown and light surface corrosion

Photo 13 – (N4B) 40% coating breakdown with surface corrosion occurring on flange. Studs and nuts CAT II, 100% coating breakdown with surface corrosion of vessel trim attached

Photo 15 – (N4B) 40% coating breakdown with surface corrosion occurring on flange. Studs and nuts CAT II, 100% coating breakdown with surface corrosion of vessel trim attached

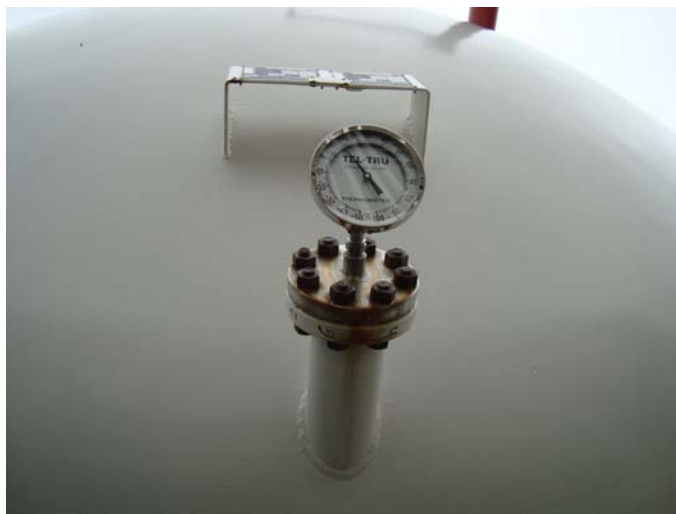
Photo 14 – Thermometer attached to N6. Note: Use of dissimilar metals. Studs and nuts CAT II

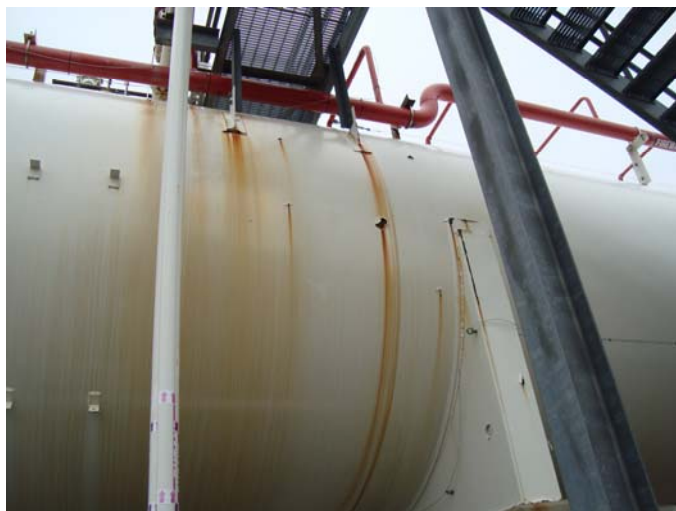
Photo 16 – Areas of coating breakdown with surface corrosion on South-East end of vessel. Corrosion appears to be light. Coating breakdown and rust staining propagating from re-enforcement plates of access way supports

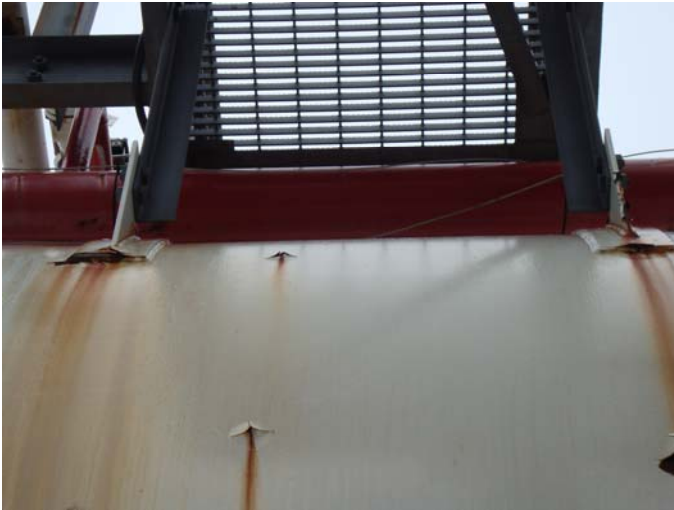
3. If applicable, check coatings for signs of deterioration, rusts spots, cracks, blistering, and/or coating disbondment.	<input type="checkbox"/>	<input checked="" type="checkbox"/>	<input type="checkbox"/>	<input type="checkbox"/>	Small areas of coating breakdown. The access way appears to be the source of some of the rust staining on the vessel ends

Photo 17 – Coating breakdown and rust staining propagating from re-enforcement plates of access way supports

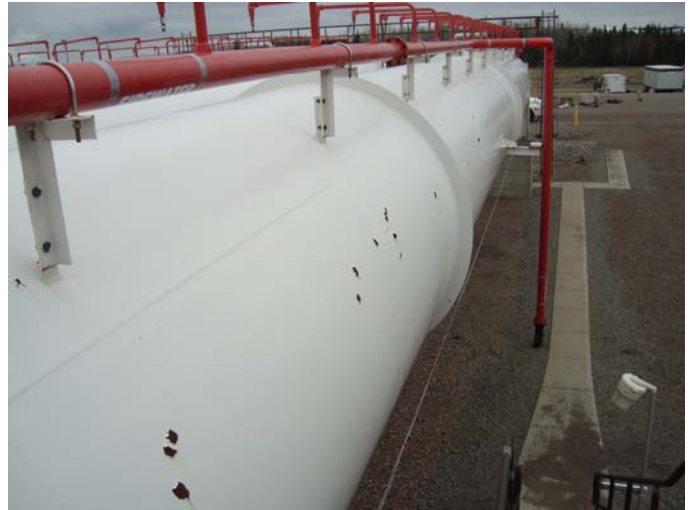
Photo 18 – Areas of coating breakdown with surface corrosion occurring on East side of vessel

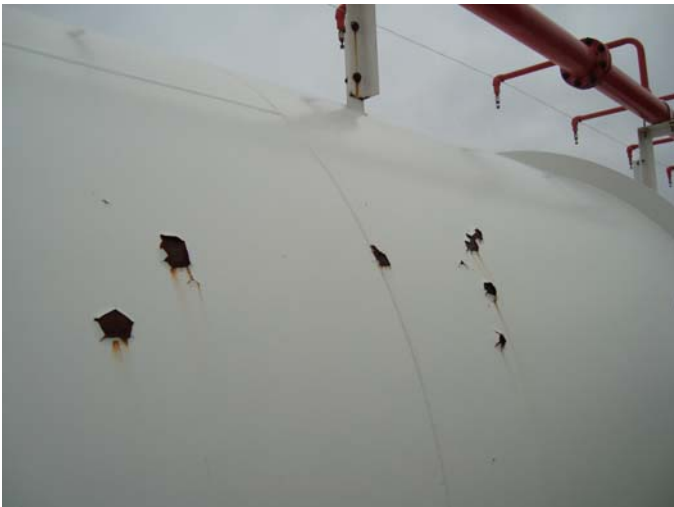
Photo 19 – Areas of coating breakdown with surface corrosion occurring on East side of vessel

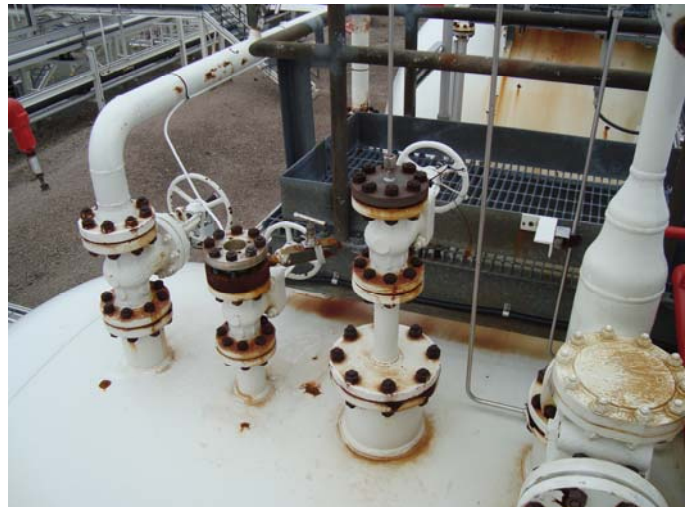
Photo 20 – (N3A, N4A, N8) Studs and nuts CAT II, coating breakdown with surface corrosion occurring on trim

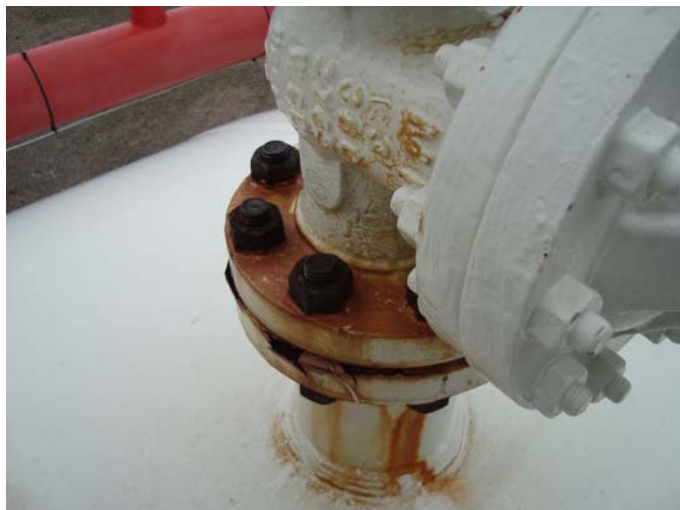
Photo 21 – (N3A) Studs and nuts CAT II, 20% coating breakdown with surface corrosion on flange

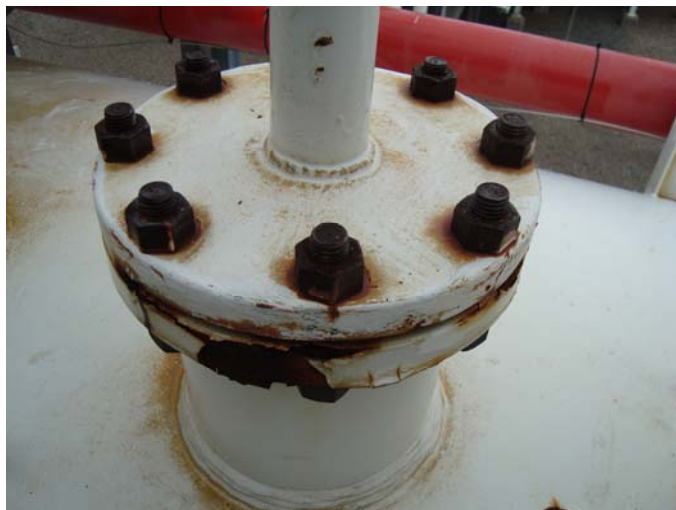
Photo 22 – (N8) Studs and nuts CAT II, 30% coating breakdown with surface corrosion on flange

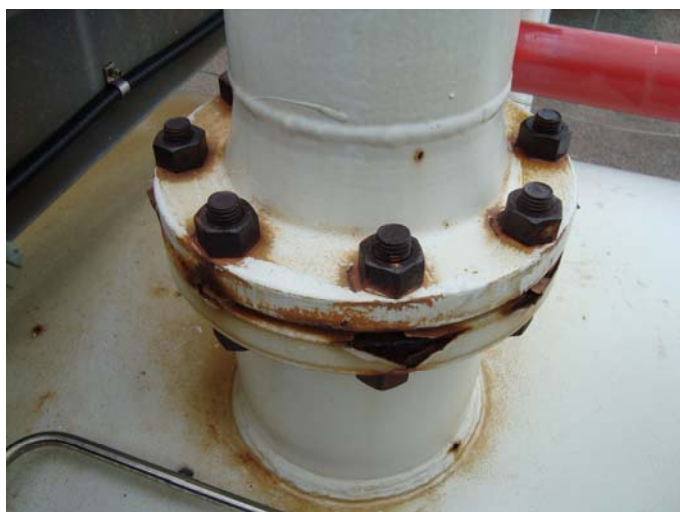
Photo 23 – (N1) Studs and nuts CAT II, 30% coating breakdown with surface corrosion on flange

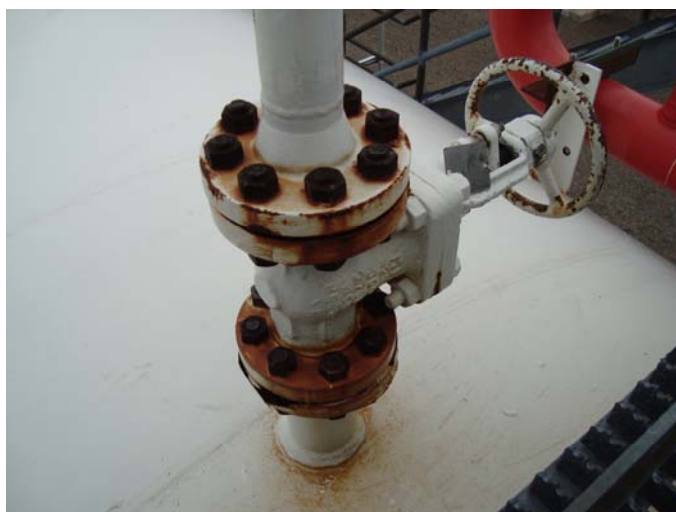
Photo 24 – (N9) Studs and nuts CAT II, 60% coating breakdown with surface corrosion on flange

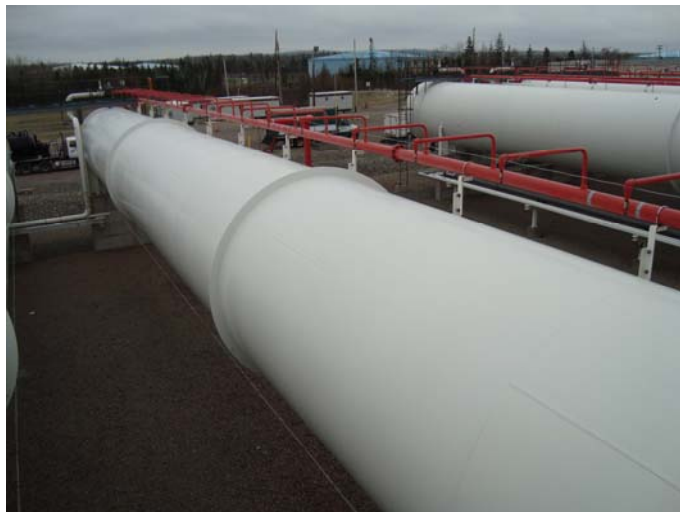
Photo 25 – General view of West side of vessel. Not lack of coating breakdown as opposed to opposite side

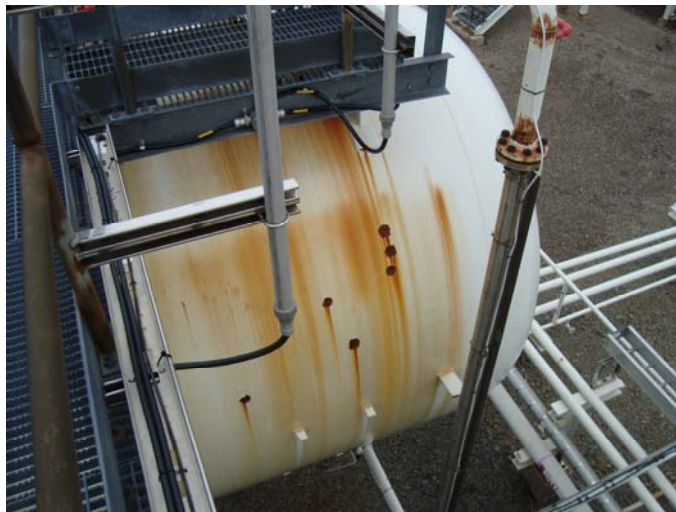
Photo 26 – Coating breakdown with surface corrosion occurring on South-West end of vessel. Rust staining also appears to be stemming from light coating breakdown with surface corrosion on access way

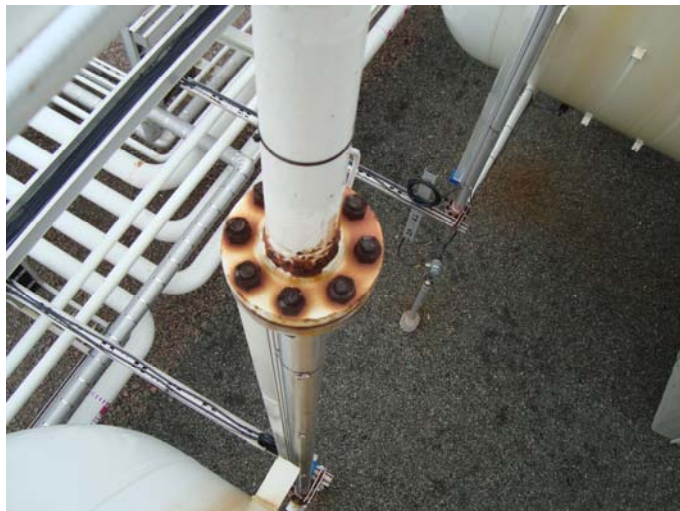
Photo 27 – Condition of vessel level gauge as viewed from above. Studs and nuts CAT II. Note: The use of similar metals

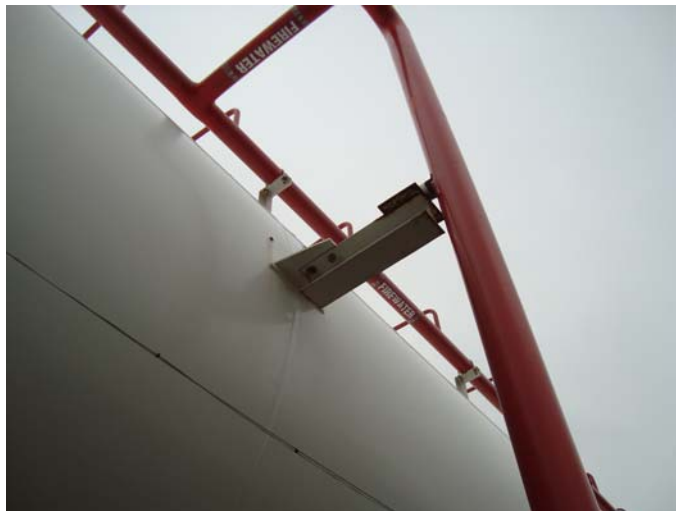
Photo 28 – Condition of pipe support for fire water line. This support is in good condition

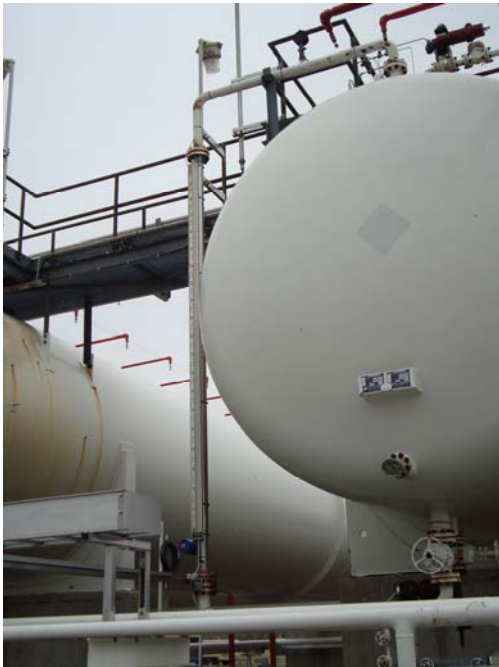
Photo 29 – View of vessel level gauge, in good condition.
Note: The use of dissimilar metals

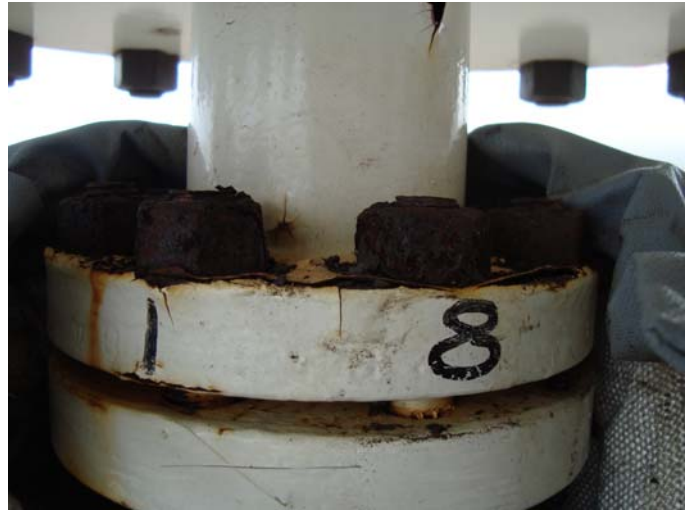
Photo 30 – Man-way nozzle with CAT I studs and nuts

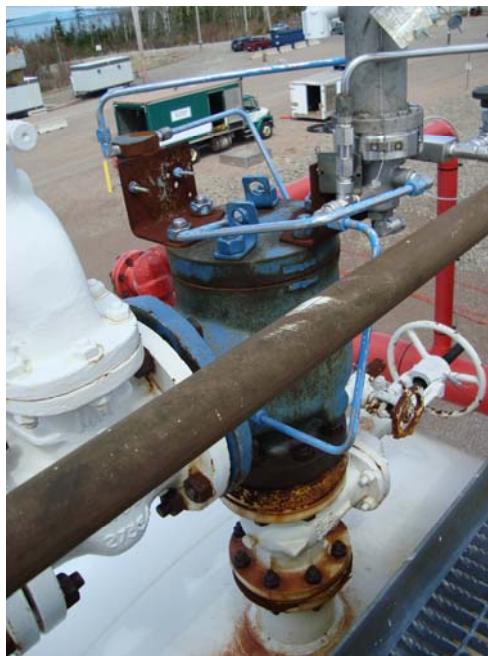
Photo 31 – PSV2105A

Condition: CAT 2 studs and nuts and 15% coating breakdown with surface corrosion
