B W	anal Occurren					
Location		essel Survey	e4 NI ~		D7 -	20405	C 000707 CD D0
Location: Client Name:	Point Tupper	EM&IJ Repor					C-090707-CR-R0
		Client Ref No			_		912-002-D2105C
Client Rep.:		Inspector Na			_	n Robi	
WO No.:		Inspection D	ate:			07, 20	JU9
SPO No.:	DT 0000 D04050 INT 04	System:	la.		Buta		40
Workscope No.:	PT-2009-D2105C-INT-01	EM&IJ Job N		.4!		0132.	
Tag No.:	D2105C	Equipment D				ine Sto	orage Vessel D-2105C
Date of Last Inspection:		Previous Rec	coras	Seen:	N/A

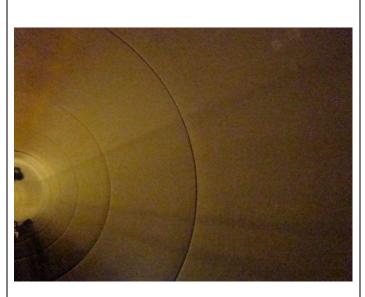
Photo 1 – View looking south on side shell 3 o'clock

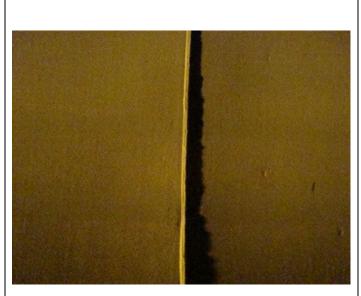
Photo 2 – View looking at south dome to shell weld

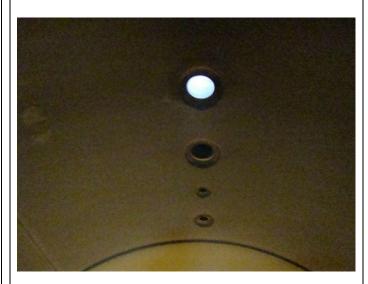
Photo 5 – View looking at top nozzles, south end

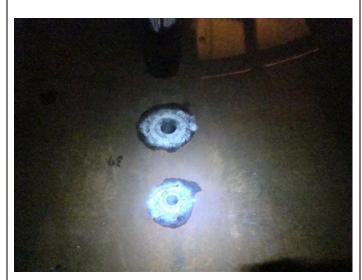
Photo 6 - View of south bottom nozzle N6

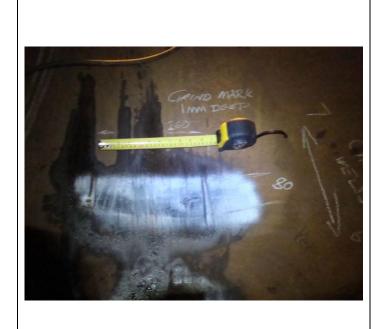
Inspection Summary					
Item		Conc	lition		Comments
Vessel Internal Surfaces	Good	Fair	Poor	NA	
1. Check for signs of corrosion, erosion, cracks, blisters, pitting, distortion, or other forms of deterioration on the internal vessel surfaces. If any, specify type, location and extent.	\boxtimes				2 areas of grinding marks were located between circ weld 6 and 7 from south end

Photo 9 - Grind marks between 6 and 7 circ welds
