GENERAL INFORMATION		
SUBMITTED DATE	08/13/2021	
ORDER #		
PUMPER/GAUGER		
LATITUDE	48.344503	
LONGITUDE	-103.040979	
CUSTOMER REPRESENTATIVE	MARLON HARRY	
UNIT DESIGNATION	1100-500-306	
API NUMBER		
UNIT SERIAL NUMBER	03209-320-0870	
GEAR REDUCER SERIAL NUMBER	9-729	
UNIT NOT IN OPERATION	NO	
UNIT NOT IN OPERATION DESCRIPTION		
UNIT NOT INSPECTED	NO	
UNIT NOT INSPECTED DESCRIPTION		
PRIMARY JOB TASK / PURPOSE FOR BEING ON-SITE	INSPECTION	
MANUFACTURE DATE		
CURRENT INSPECTION DATE	8/13/2021 8:56:08 AM	
THIS IS A UNIT TRANSFER	NO	
NEXT INSPECTION ON		
BARCODE / ASSET NUMBER		
CUSTOMER SPECIFIC INFORMATION		
UNIT SHUT DOWN UPON ARRIVAL	NO	
UNIT SHUT DOWN FOR INSPECTION	NO	
THIS IS A NEW UNIT INSTALLATION	NO

# Weatherford® Pumping Unit Inspection #E234943-20210813085608 CUSTOMER SERVICE LOCATION LEASE WELL NUMBER

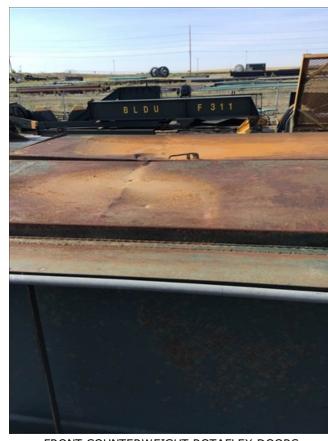
GENERAL INFORMATION		
INSTALLATION DATE		
WEATHERFORD INSPECTOR	BROOKS, BRANDON	
I HAVE REVIEWED THE ENERGY ISOLATION AND PREVENTATIVE MAINTENANCE TWIS AS APPLICABLE	YES	
No	DTES	
LIST ALL DETAILS OF THE INSPECTION, MAINTENANCE PROCEDURES OF NOTE	UNIT LAYING OVER IN ND YARD. DAMAGE TO FRONT COUNTERWEIGHT DOORS UPPERS AND LOWERS. SPEED SENTRY MISSING. GEARBOX HUB MISSING. BELT GUARD AND LADDER CAGE HARDWARE MISSING. HOLE IN FRONT OF TOWER. LOAD BELT HAS FRAYED EDGE ON LEFT SIDE. CROWN HOOD LATCH DAMAGED AND NEED REPLACED. MISSING POWER BAND FOR MOTOR. COULDN'T OPEN DOORS DUE TO THE DAMAGE TO CHECK GUIDE WHEELS. WIND GUARD HARDWARE MISSING. UNIT IS LAID OVER COULD NOT DO A FULL INSPECTION.	
FACILI	TY SIGNS	
FACILITY SIGNS MISSING	REGULATED CONFINED SPACE	
SEALS AN	D BEARINGS	
RIGHT TOP DRUM BEARING	GOOD CONDITION	
RIGHT TOP DRUM SEAL	REPAIR/REPLACE	
LEFT TOP DRUM BEARING	GOOD CONDITION	
LEFT TOP DRUM SEAL	GOOD CONDITION

PRIME MOVER			
GEAR REDUCER SHEAVE DIAMETER (INCHES)	20		
GAS ENGINE OIL USED (GALLONS)			
GAS ENGINE OIL REQUIRED FILTERING			
OIL SAMPLE TAKEN			
INSIDE (FRONT) COUNTERWEIGHT DOORS			
FRONT COUNTERWEIGHT ROTAFLEX DOORS CONDITION	REPAIR REQUIRED		
FRONT UPPER COUNTERWEIGHT ROTAFLEX DOORS CONDITION	REPAIR REQUIRED		
REMOVED SHIPPING BLOCKS BETWEEN TOWER BEAM AND COUNTERWEIGHT BOX DURING INSTALLATION	YES		
OIL SUMP RESERVOIR	CLEANING AND NEW OIL REQUIRED		
PROPER OIL LEVEL OF SUMP	ADDITIONAL OIL REQUIRED		
SUMP OILING SYSTEM FREE OF OBSTRUCTIONS AND PROPERLY OILING	REPAIR REQUIRED		
INTERNAL LOAD BELT CONDITION AND CONNECTION TO WEIGHT BOX, LOAD BELT PINS	GOOD CONDITION		
BELT AND METAL SHAVINGS PRESENT INSIDE OF TOWER	NO
