**Weatherford®****Pumping Unit Inspection #E234943-20210813162323**

| CUSTOMER | SERVICE LOCATION | LEASE | WELL NUMBER |
|---|---|---|---|
| ND Corporation | Ray, ND | ND | Yard |

| UNIT DESIGNATION | 1100-500-306 |

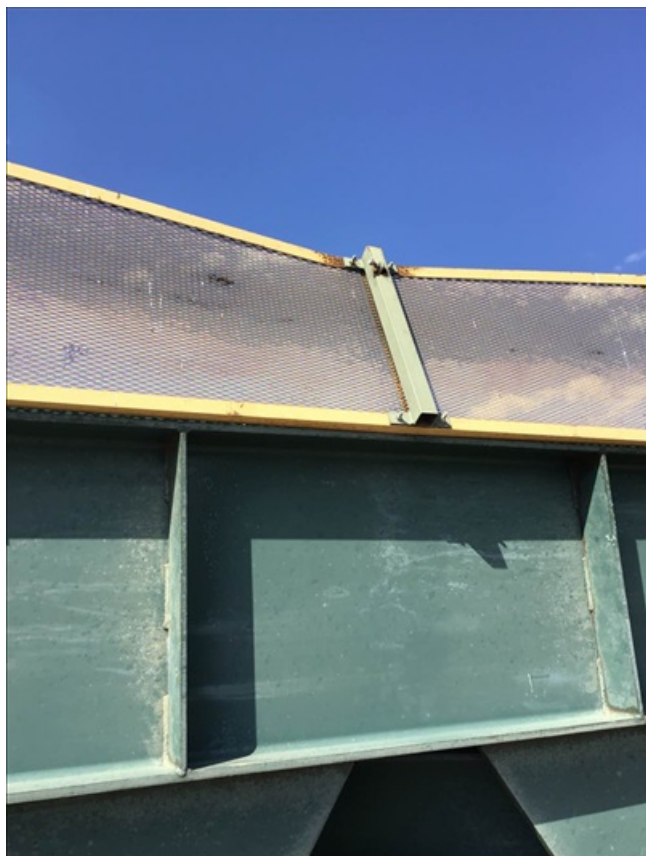
| LIST ALL DETAILS OF THE INSPECTION, MAINTENANCE PROCEDURES OF NOTE | MISSING BELT GUARD HARDWARE. DAMAGED WIND GUARD. TOP DRUM SEALS LEAKING |

DAMAGED WIND GUARD
