BORESCOPE INSPECTION REPORT

GAS TURBINE ENGINE
SATURN
HOT END DRIVE

Engine Serial Number
211263

Inspection Date
Saturday, May 27, 2017

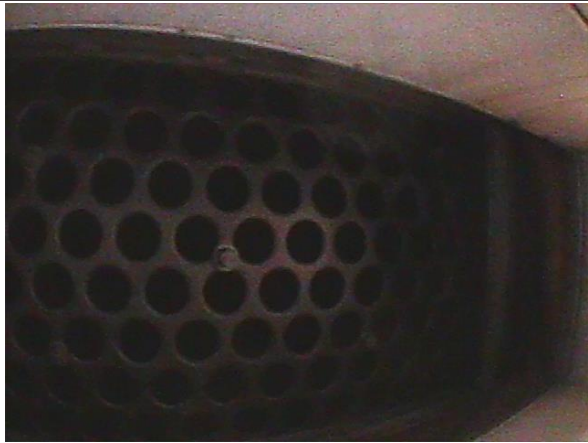
<p>a)Potential FOD b)Corrosive Pitting c)Cracks d)Excessive fouling</p>	<p>Normal Condition</p>
<p>A</p> <p>Air Inlet Screen</p>

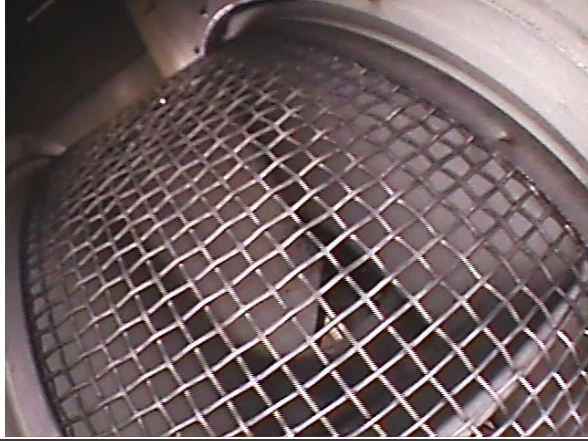
<p>a)Potential FOD b)Cracks, damaged mesh</p>	<p>Normal Condition</p>
<p>A</p> <p>1st Stg Guide Vanes</p>

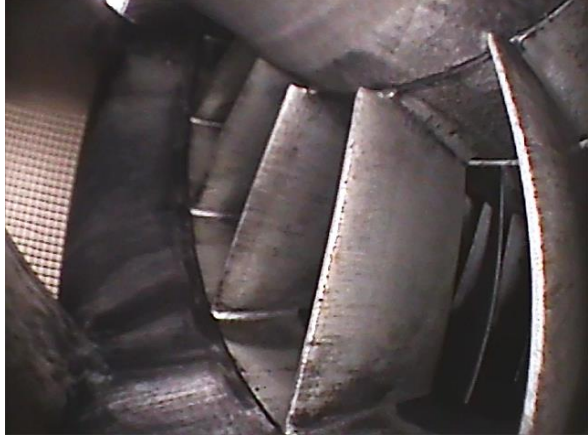
<p>a)Nicks, dents, Qty and size b)Excess fouling c)Corrosive pitting. Affected Area</p>	<p>Normal Condition Contamination, minor</p>

Continue to follow Solar's recommended maintenance practices; detergent wash regularly

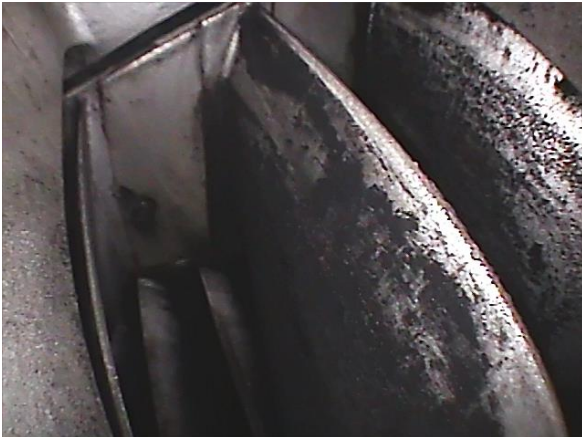
<p>a)Nicks and dents. Qty & size</p> <p>b)Excess fouling</p> <p>c)Corrosive pitting, Area</p> <p>d)Tip rub, Gap & curling</p>	<p>Normal Condition</p> <p>Contamination, minor</p>
<p>B</p> <p>Compressor Exit Guide Vanes</p>

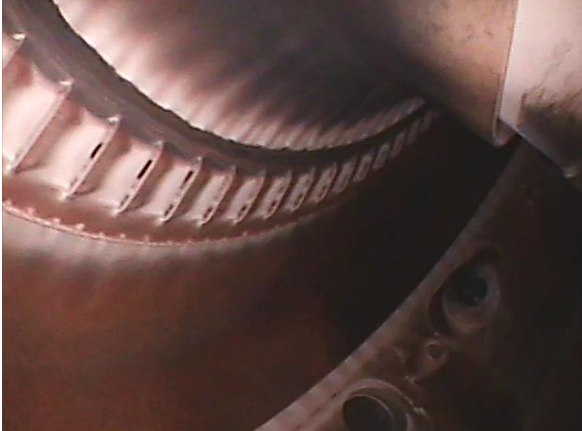
<p>a)Nicks and dents. Quantity and size</p> <p>b)Excess of fouling</p> <p>c)Corrosive pitting. Affected area</p>	<p>Normal Condition</p>
<p>B</p> <p>Injectors</p>

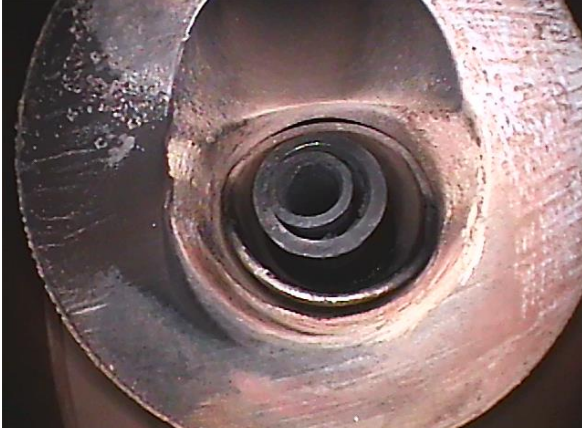
<p>a)Pilot center erosion</p> <p>b)Fuel hole contaminated, blocked</p> <p>c)Cracks</p> <p>d)Liquid: broken fuel spoke</p>	<p>Normal Condition</p> <p>Carbon build up</p>

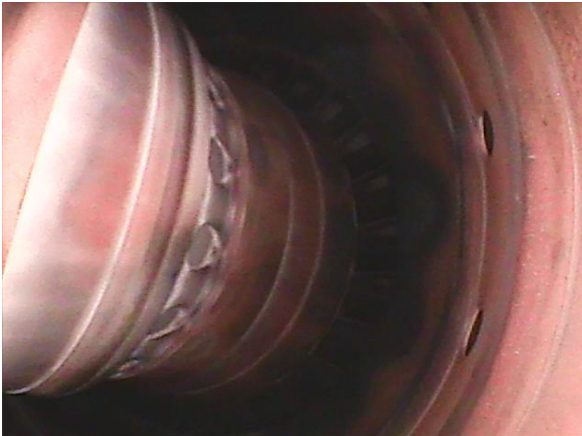
<p>a)Crack, Qty and size</p> <p>b)Thermal erosion</p> <p>c)Hot spots</p> <p>d)Buckling or warpage</p>	<p>Minor</p> <p>Burn spots</p> <p>Minor burn spots near 1st stage nozzles</p>
<p>B</p> <p>Torch Tube</p>

Some contamination in compressor section; burn spots noticed near 1st stage nozzles, and on 2nd and 3rd stage nozzles; 1st stage nozzles show signs of wear from thermal exposure and minor pitting.

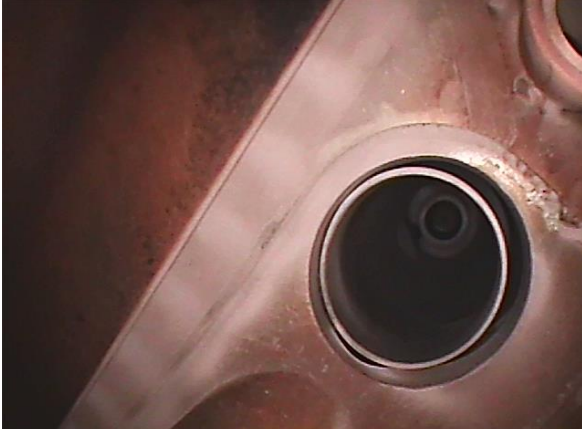
<p>a)Thermal erosion</p>	<p>Normal Condition</p>

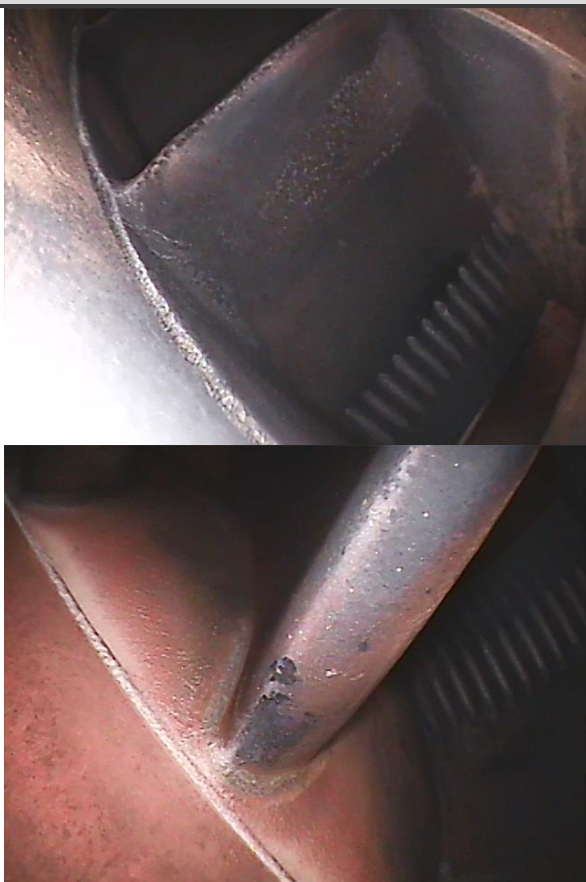
<p>a)Cracks, Qty, length, orientation</p> <p>b)Thermal erosion, Depth and area</p> <p>c)FOD, Area</p>	<p>Minor</p> <p>Thermal erosion and pitting</p> <p>Coating missing, burn spots, and pitting noticed</p>
<p>B</p> <p>1st Stg Turbine Blades</p>

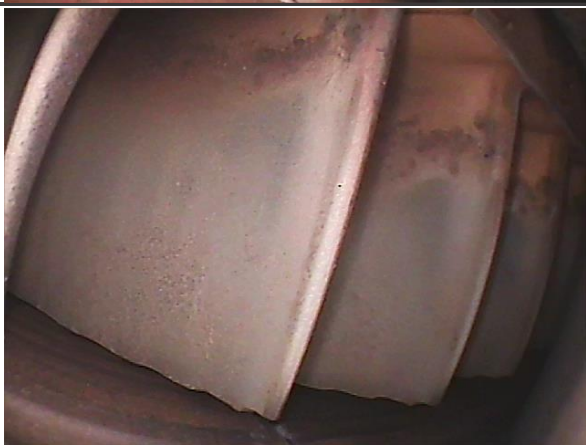
<p>a)Cracks, Qty, length, orientation</p> <p>b)Thermal erosion, Depth & area</p> <p>c)FOD, Area</p> <p>d)Tip rub, gap width</p>	<p>Normal Condition</p> <p>Blade tip rub, gap width</p> <p>Some thermal wear noticed at base of blades</p>

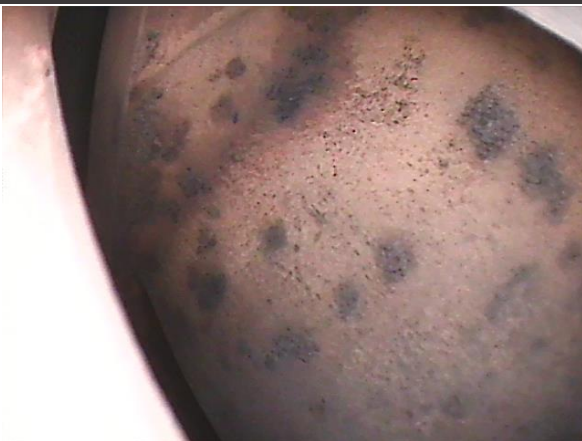
<p>a)Cracks, Qty, length, orientation</p> <p>b)Thermal erosion, Depth and area</p> <p>c)FOD, Area</p>	<p>Minor</p> <p>Burn spots</p> <p>Burn spots</p>
<p>C</p> <p>2nd Stg Turbine Blades</p>

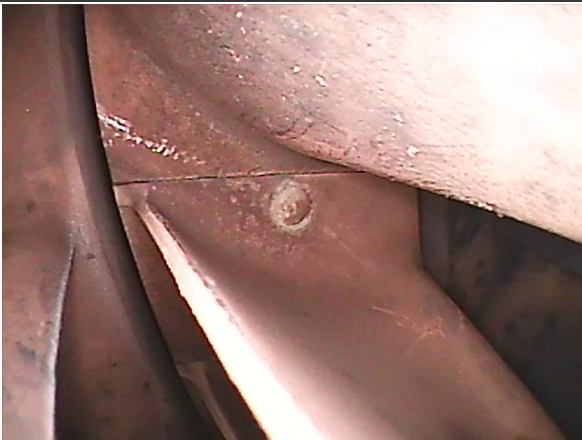
<p>a)Cracks, Qty, length, orientation</p> <p>b)Thermal erosion, Depth and area</p> <p>c)FOD, Area</p> <p>d)Tip rub, gap width</p>	<p>Normal Condition</p>
<p>C</p> <p>3rd Stg Turbine Blades</p>

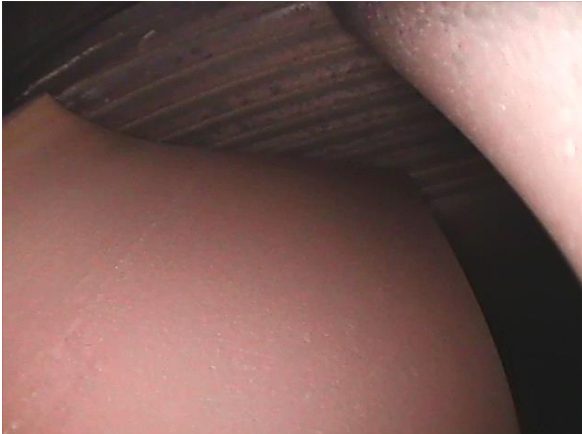
<p>a)Cracks, Qty, length, orientation</p> <p>b)Thermal erosion, Depth and area</p> <p>c)FOD, Area</p>	<p>Normal Condition</p>

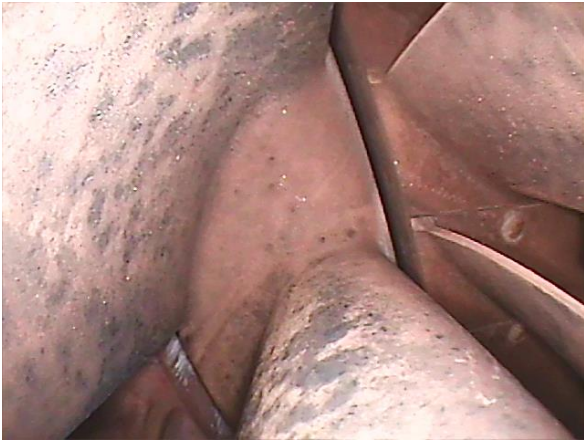
Access location Description	Picture	Inspection for	Severity / Comments
D 3rd Stg Turbine Nozzles

a)Cracks, Qty, length, orientation b)Thermal erosion, Depth and area c)FOD, Area d)Tip rub, gap width	Minor Burn spots Burn spots
