BORESCOPE INSPECTION REPORT

GAS TURBINE ENGINE
SATURN
HOT END DRIVE

Engine Serial Number
OHF10-S0767

Inspection Date
Thursday, May 25, 2017

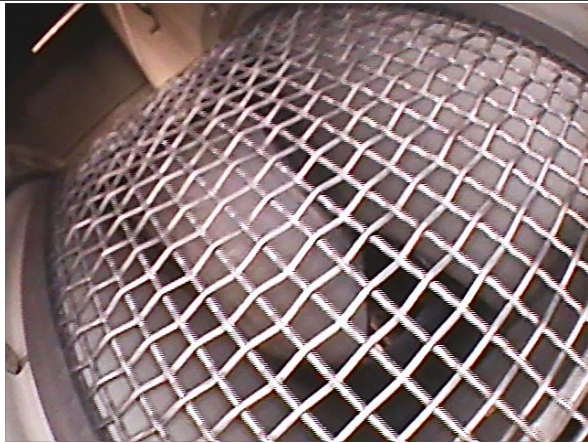
Access location Description	Picture	Inspection for	Severity / Comments
A Air Inlet Screen

a) Potential FOD b) Cracks, damaged mesh	Normal Condition Not applicable
A 1st Stg Guide Vanes

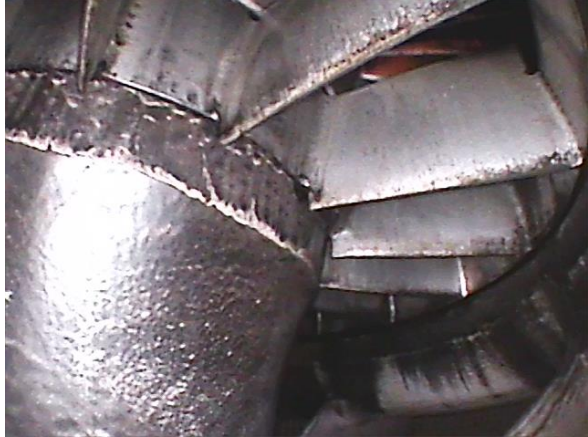
a) Nicks, dents, Qty and size b) Excess fouling c) Corrosive pitting. Affected Area	Normal Condition Contamination, minor
A 1st Stg Blades

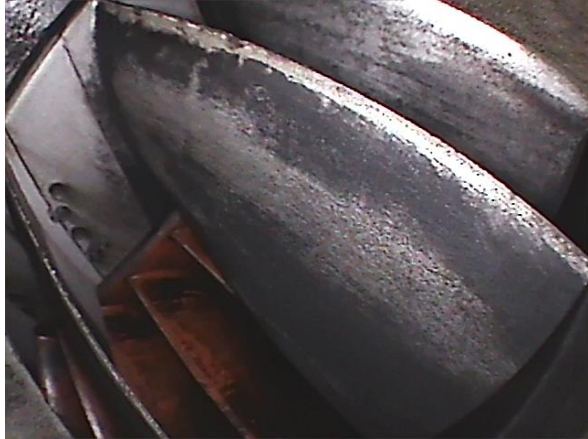
a) Nicks and dents. Qty & size b) Excess fouling c) Corrosive pitting, Area d) Tip rub, Gap & curling	Normal Condition Contamination, minor

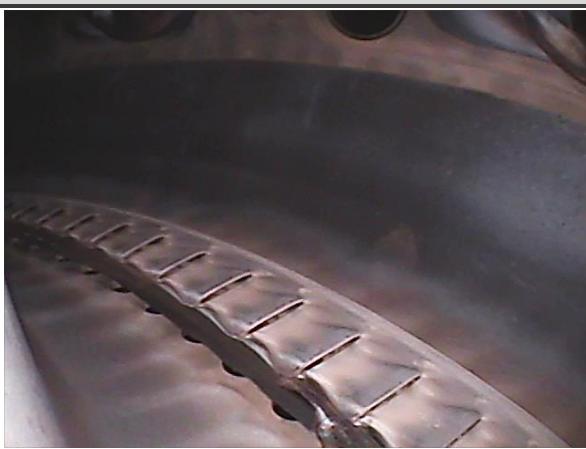
Access location Description	Picture	Inspection for	Severity / Comments
<p>B</p> <p>Compressor Exit Guide Vanes</p>

<p>a)Nicks and dents. Quantity and size</p> <p>b)Excess of fouling</p> <p>c)Corrosive pitting. Affected area</p>	<p>Normal Condition</p>
<p>B</p> <p>Injectors</p>

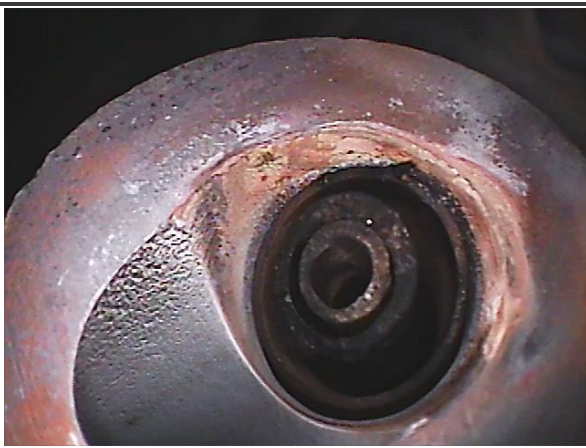
<p>a)Pilot center erosion</p> <p>b)Fuel hole contaminated, blocked</p> <p>c)Cracks</p> <p>d)Liquid: broken fuel spoke</p>	<p>Minor</p> <p>Carbon build up</p> <p>Carbon build up on injectors</p>
<p>B</p> <p>Combustor Interior</p>

Replace exhaust bellows; detergent wash regularly; follow Solar's recommended maintenance practices.

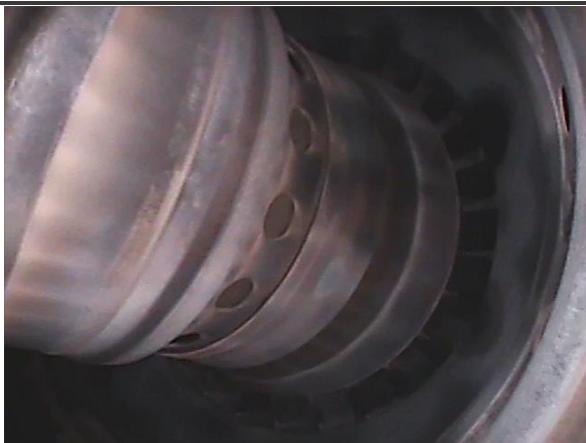
<p>a)Crack, Qty and size</p> <p>b)Thermal erosion</p> <p>c)Hot spots</p> <p>d)Buckling or warpage</p>	<p>Normal Condition</p> <p>Burn spots</p>

Contamination on first few stages of compressor section; some burn spots in combustor and on first stage nozzles; exhaust bellows has crack and needs to be replaced.

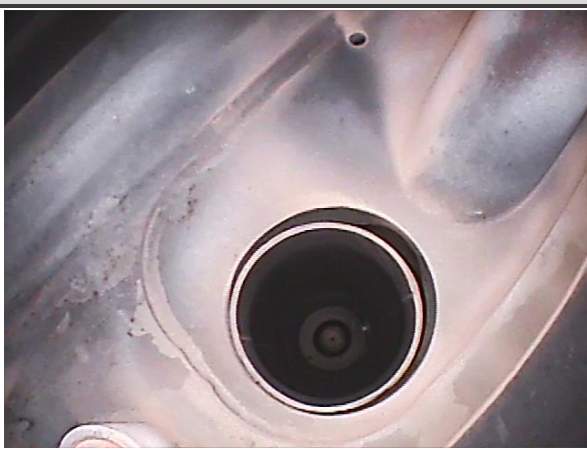
Access location Description	Picture	Inspection for	Severity / Comments
B Torch Tube

a) Thermal erosion	Normal Condition
B 1st Stg Turbine Nozzles

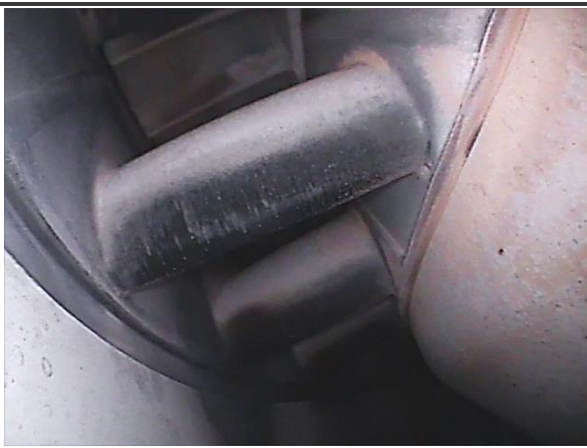
a) Cracks, Qty, length, orientation b) Thermal erosion, Depth and area c) FOD, Area	Normal Condition Burn spots
B 1st Stg Turbine Blades

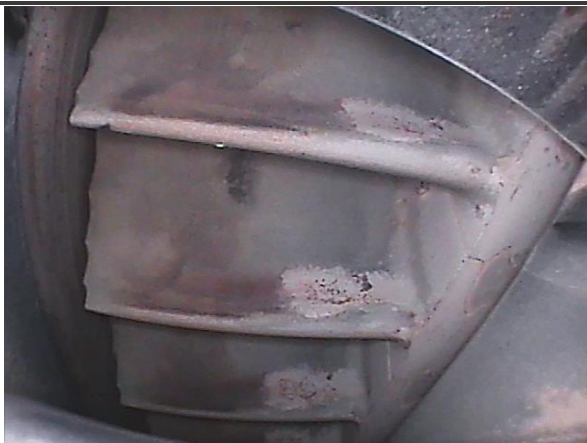
a) Cracks, Qty, length, orientation b) Thermal erosion, Depth & area c) FOD, Area d) Tip rub, gap width	Normal Condition Blade tip rub, gap width

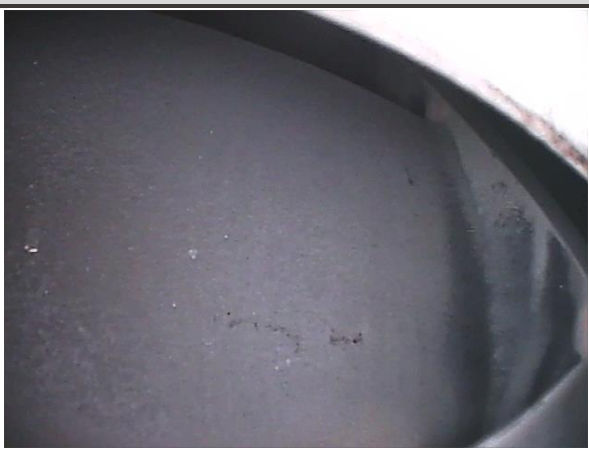
Access location Description	Picture	Inspection for	Severity / Comments
<p>C</p> <p>2nd Stg Turbine Nozzles</p>

<p>a)Cracks, Qty, length, orientation</p> <p>b)Thermal erosion, Depth and area</p> <p>c)FOD, Area</p>	<p>Normal Condition</p>
<p>C</p> <p>2nd Stg Turbine Blades</p>

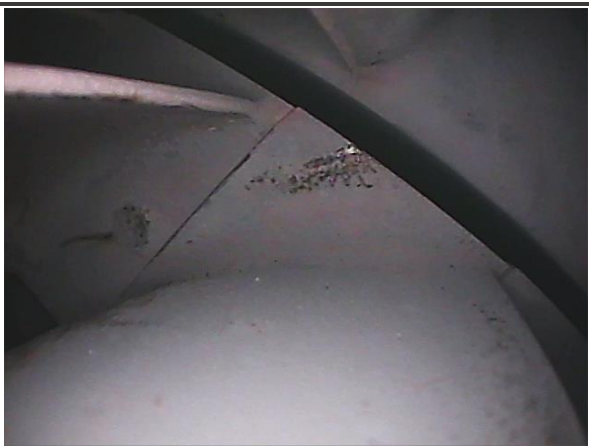
<p>a)Cracks, Qty, length, orientation</p> <p>b)Thermal erosion, Depth and area</p> <p>c)FOD, Area</p> <p>d)Tip rub, gap width</p>	<p>Normal Condition</p>
<p>C</p> <p>3rd Stg Turbine Blades</p>

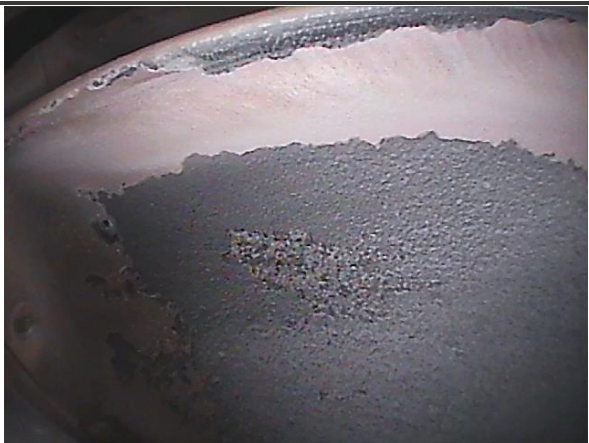
Access Port	Location	Inspection for	Normal Condition	Minor	Moderate	Severe	Comments
<u>B</u>	1st Stg Turbine Nozzles	a)Cracks, Qty, length, orientation b)Thermal erosion, Depth and area c)FOD, Area	✓				
<u>B</u>	1st Stg Turbine Blades	a)Cracks, Qty, length, orientation b)Thermal erosion, Depth & area c)FOD, Area d)Tip rub, gap width	✓				
<u>C</u>	2nd Stg Turbine Nozzles	a)Cracks, Qty, length, orientation b)Thermal erosion, Depth and area c)FOD, Area	✓				
<u>C</u>	2nd Stg Turbine Blades	a)Cracks, Qty, length, orientation b)Thermal erosion, Depth and area c)FOD, Area d)Tip rub, gap width	✓				
<u>C</u>	3rd Stg Turbine Blades	a)Cracks, Qty, length, orientation b)Thermal erosion, Depth and area c)FOD, Area		✓			Coating missing

<p>a)Cracks, Qty, length, orientation</p> <p>b)Thermal erosion, Depth and area</p> <p>c)FOD, Area</p>	<p>Minor</p> <p>Missing coating</p> <p>Coating missing</p>

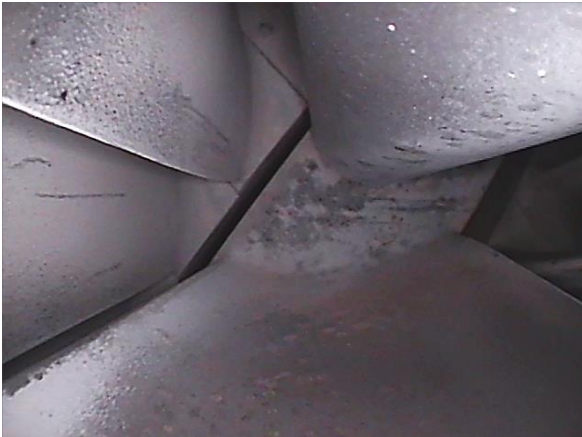
Access location Description	Picture	Inspection for	Severity / Comments
D 3rd Stg Turbine Nozzles

a)Cracks, Qty, length, orientation b)Thermal erosion, Depth and area c)FOD, Area d)Tip rub, gap width	Normal Condition
X 2nd Stage Vanes

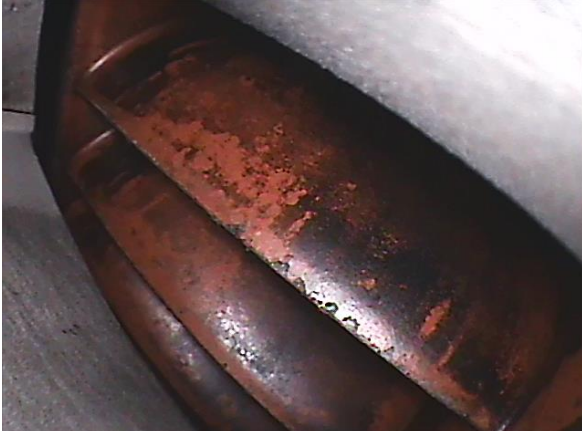
Normal Condition Contamination, minor
X Exhaust Bellows

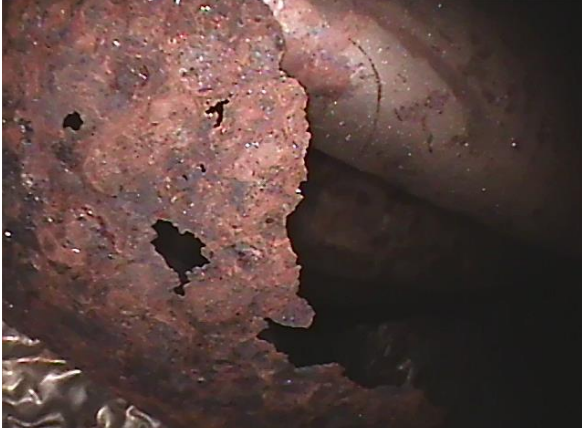
Access Port	Location	Inspection for	Normal Condition	Minor	Moderate	Severe	Comments
<u>D</u>	3rd Stg Turbine Nozzles	a)Cracks, Qty, length, orientation b)Thermal erosion, Depth and area c)FOD, Area d)Tip rub, gap width	✓				
<u>X</u>	2nd Stage Vanes		✓				
<u>X</u>	Exhaust Bellows	TBD				✓	Exhaust Bellows has cracks. Replace ASAP

TBD	Severe Corrosion Exhaust Bellows has cracks. Replace ASAP
