Weatherford® Pumping Unit Inspection #E234943-20210813155323 **CUSTOMER SERVICE LOCATION LEASE WELL NUMBER** ND ND Corporation Ray, ND

Pumping Unit Inspection #E234943-20210813155323

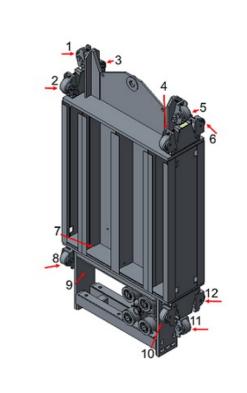
GUIDE WHEELS

GUIDE
GUIDE WHEEL #1	GOOD CONDITION
GUIDE WHEEL #2	GOOD CONDITION
GUIDE WHEEL #3	GOOD CONDITION
GUIDE WHEEL #4	GOOD CONDITION
GUIDE WHEEL #5	GOOD CONDITION
GUIDE WHEEL #6	GOOD CONDITION
GUIDE WHEEL #7	CONDITION REQUIRES UNIT SHUTDOWN
GUIDE WHEEL #8	CONDITION REQUIRES UNIT SHUTDOWN
GUIDE WHEEL #9	CONDITION REQUIRES UNIT SHUTDOWN
GUIDE WHEEL #10	CONDITION REQUIRES UNIT SHUTDOWN
GUIDE WHEEL #11	CONDITION REQUIRES UNIT SHUTDOWN
GUIDE WHEEL #12	CONDITION REQUIRES UNIT SHUTDOWN
