Weatherford® Pumping Unit Inspection #E214129-20210813153451

CUSTOMER	SERVICE LOCATION	LEASE	WELL NUMBER
ND Corporation	Ray, ND	ND yard	ND yard

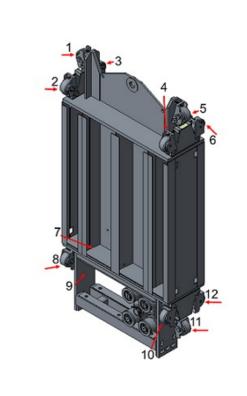
GUIDE WHEELS

GUIDE
GUIDE WHEEL #1	GOOD CONDITION
GUIDE WHEEL #2	GOOD CONDITION
GUIDE WHEEL #3	GOOD CONDITION
GUIDE WHEEL #4	GOOD CONDITION
GUIDE WHEEL #5	GOOD CONDITION
GUIDE WHEEL #6	GOOD CONDITION
GUIDE WHEEL #7	CONDITION REQUIRES UNIT SHUTDOWN
GUIDE WHEEL #8	CONDITION REQUIRES UNIT SHUTDOWN
GUIDE WHEEL #9	CONDITION REQUIRES UNIT SHUTDOWN
GUIDE WHEEL #10	CONDITION REQUIRES UNIT SHUTDOWN
GUIDE WHEEL #11	CONDITION REQUIRES UNIT SHUTDOWN
GUIDE WHEEL #12	CONDITION REQUIRES UNIT SHUTDOWN
