INSPECTION REPORT

Pressure Vessel Survey			
Location:	Point Tupper	EM&I Report No.:	PT-D2006-090512-DM-R0
Client Name:		Client Ref No.:	PT-11564905-002-D2006
Client Rep.:		Inspector Name:	Doug MacDonald
WO No.:		Inspection Date:	May 12, 2009
SPO No.:		System:	Propane + Liquids
Workscope No.:	PT-2009-D2006-INT-01	EM&I Job No:	EMJ0132.43
Tag No.:	D2006	Equipment Description:	Off-Spec Storage Vessel D-2006
Date of Last Inspection:	NA	Previous Records Seen:	NA
Drawing No.:	LA-B22-F-22-8006-01-Z4, 98-CA-399735-1D-5

D2006 OFF-SPEC STORAGE VESSEL

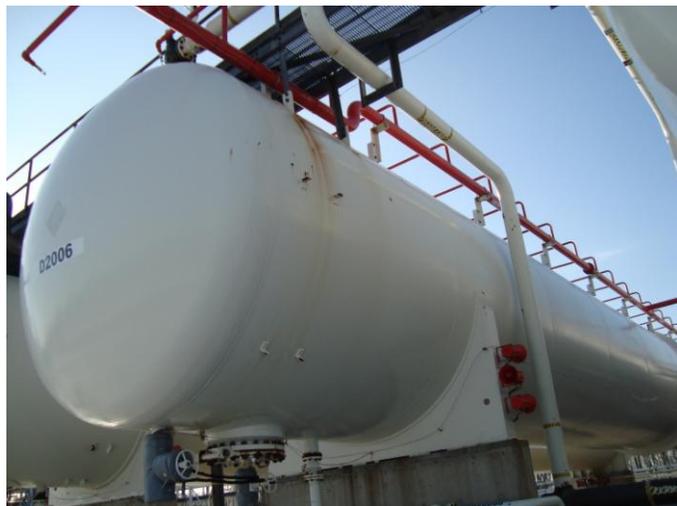
Photo 1 – Overall view of vessel D2006 – North end with manway.

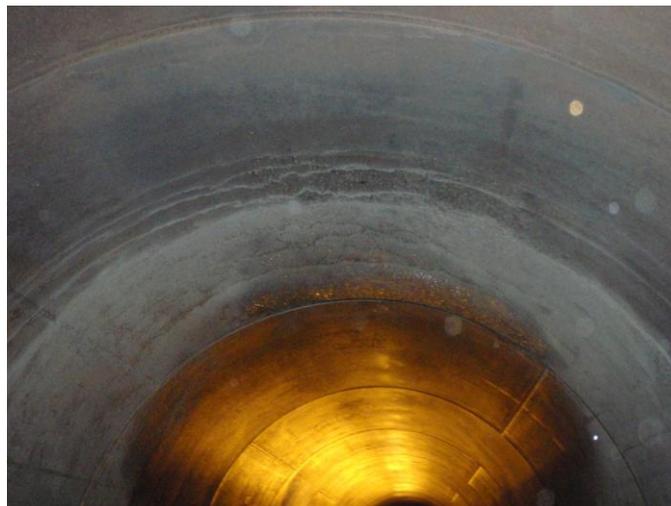
Internal surfaces of vessel generally in good condition exhibiting just light surface corrosion and mill scale. Some minor pitting was discovered in the bottom of the vessel between the 4 and 7 o'clock positions and between the 1st and 3rd circumferential weld seams north of the vortex breaker (see details in photos 7-9). All pitting was less than the specified shell corrosion allowance of 1.6 mm.

Photo 6 – Overall view internal vessel from north end manway looking south.
