INSPECTION REPORT

| Pressure Vessel Survey | | | |
| Location: | Point Tupper | EM&I S Report No.: | PT-D2100A-090805-JT-R0 |
| Tag No.: | D-2100A | Equipment Description: | Propane Storage Vessel D-2100A |

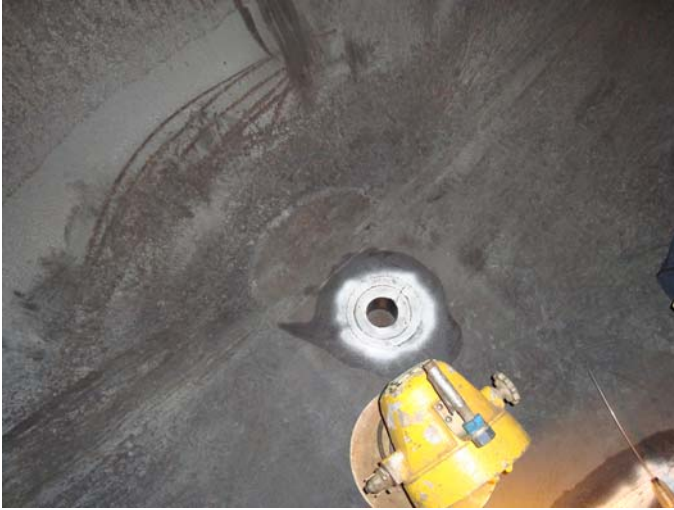
No signs of distortion, cracks, corrosion, wall loss or any type of defect on manway, nozzels or connections was found.

Photo 1 – Nozzle N10, view looking down

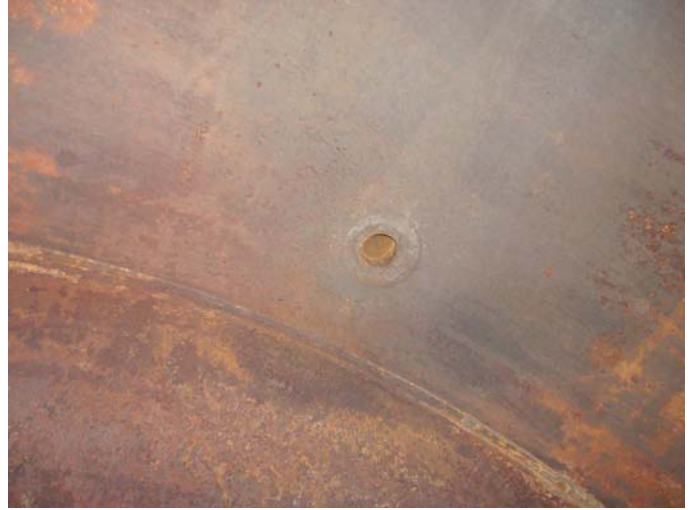
Photo 2 – Nozzle N7, view looking up

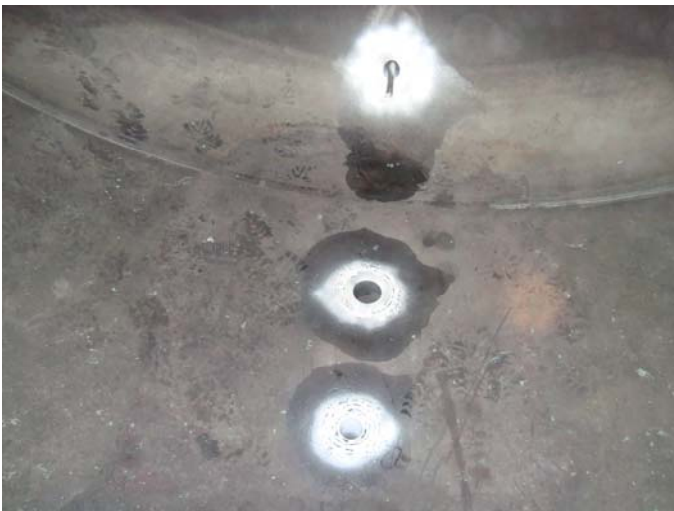
Photo 7 – Profile view of nozzles N6, N3B, N4B, looking South

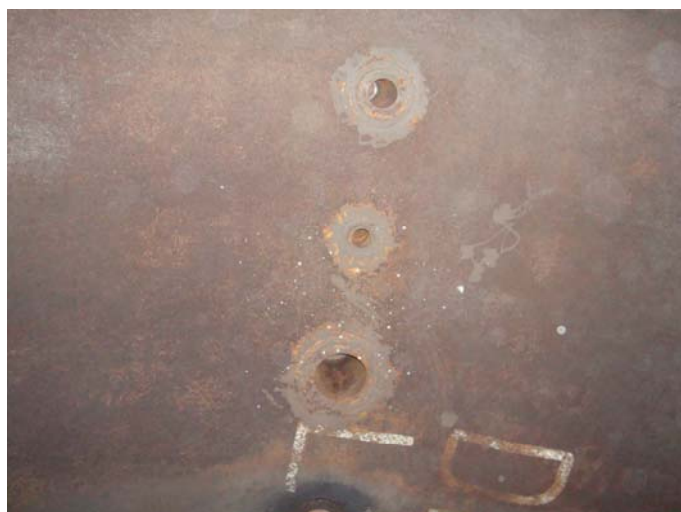
Photo 11 – Profile view looking up at Nozzle N3A, N4A, N8 at South end of vessel

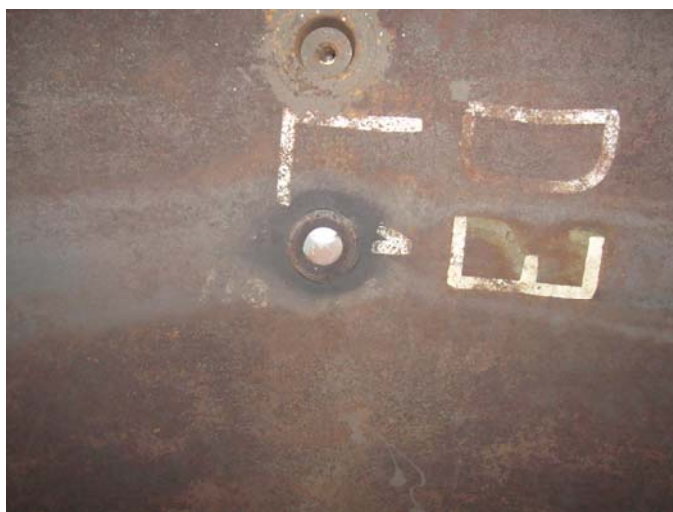
Photo 12 – Profile shot at Nozzle N1 looking up at South end of vessel

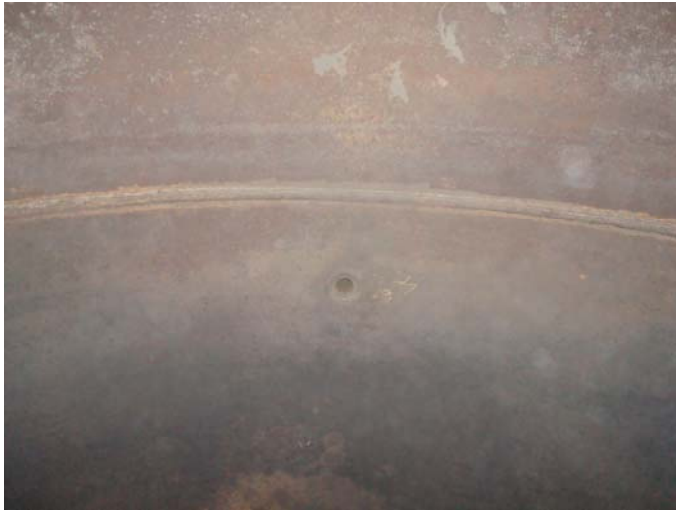
During inspection, no evidence of corrosion, cracking, pitting or deterioration was found on welded joints.

Photo 13 – Profile shot of Nozzle N9 and upper portion of circ. seam #12 at South end

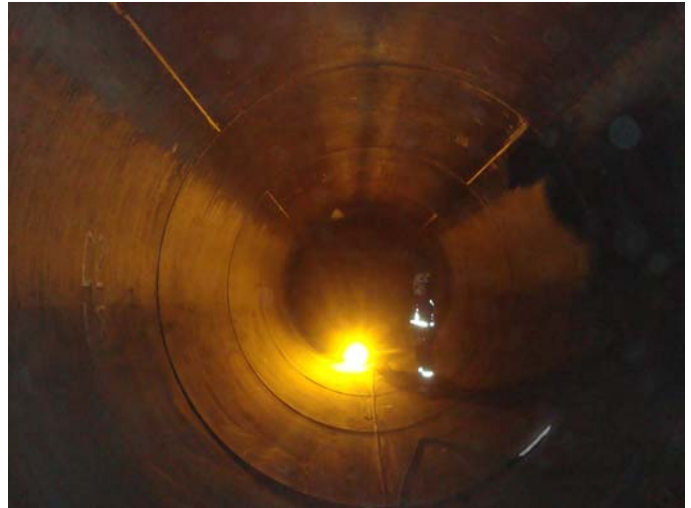
No signs of cracks, blisters, distortion, erosion/corrosion (other than pitting) or any forms of deterioration evident on interior shell. Generalized pitting found throughout shell particularly between lower half of circ. seams #11 to #13. A random selection of the most pronounced isolated pitting evident on both North and South heads as well as other locations throughout shell was measured and recorded for future reference and follow up. They are as listed below:

Photo 18 – Profile shot of interior vessel, looking North

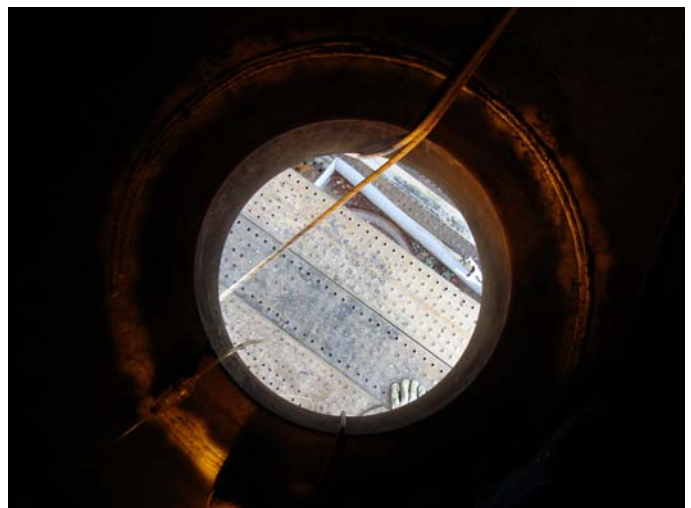
No evidence of corrosion/erosion or any mechanical damage on manway gasket and cover seals.

Photo 20 – Profile shot of Man-way M24 looking down from interior
