**Weatherford®****Pumping Unit Inspection #E234943-20210813162323**

| CUSTOMER | SERVICE LOCATION | LEASE | WELL NUMBER |
|---|---|---|---|
| ND Corporation | Ray, ND | ND | Yard |

| UNIT DESIGNATION | 1100-500-306 |

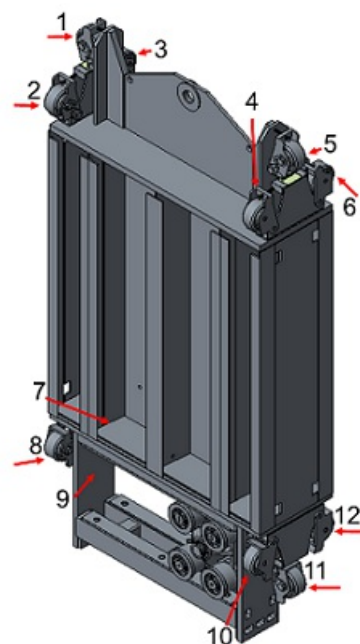
| GUIDE WHEEL #7 | CONDITION REQUIRES UNIT SHUTDOWN |
| GUIDE WHEEL #8 | CONDITION REQUIRES UNIT SHUTDOWN |
| GUIDE WHEEL #9 | CONDITION REQUIRES UNIT SHUTDOWN |
| GUIDE WHEEL #10 | CONDITION REQUIRES UNIT SHUTDOWN |
| GUIDE WHEEL #11 | CONDITION REQUIRES UNIT SHUTDOWN |
| GUIDE WHEEL #12 | CONDITION REQUIRES UNIT SHUTDOWN |
