**Weatherford®****Pumping Unit Inspection #E234943-20210813152459**

CUSTOMER	SERVICE LOCATION	LEASE	WELL NUMBER
ND Corporation	Ray, ND	ND	Yard

SUBMITTED DATE	08/13/2021
ORDER #	
PUMPER/GAUGER	
LATITUDE	48.345141
LONGITUDE	-103.041230
CUSTOMER REPRESENTATIVE	MARLON HARRY
UNIT DESIGNATION	1100-500-306
API NUMBER	
UNIT SERIAL NUMBER	03205-320-0866
GEAR REDUCER SERIAL NUMBER	9-718
UNIT NOT IN OPERATION	NO
UNIT NOT IN OPERATION DESCRIPTION	
UNIT NOT INSPECTED	NO
UNIT NOT INSPECTED DESCRIPTION	
PRIMARY JOB TASK / PURPOSE FOR BEING ON-SITE	INSPECTION
MANUFACTURE DATE	
CURRENT INSPECTION DATE	8/13/2021 3:24:59 PM
THIS IS A UNIT TRANSFER	NO
NEXT INSPECTION ON	
BARCODE / ASSET NUMBER	
CUSTOMER SPECIFIC INFORMATION	
UNIT SHUT DOWN UPON ARRIVAL	NO
UNIT SHUT DOWN FOR INSPECTION	NO
THIS IS A NEW UNIT INSTALLATION	NO

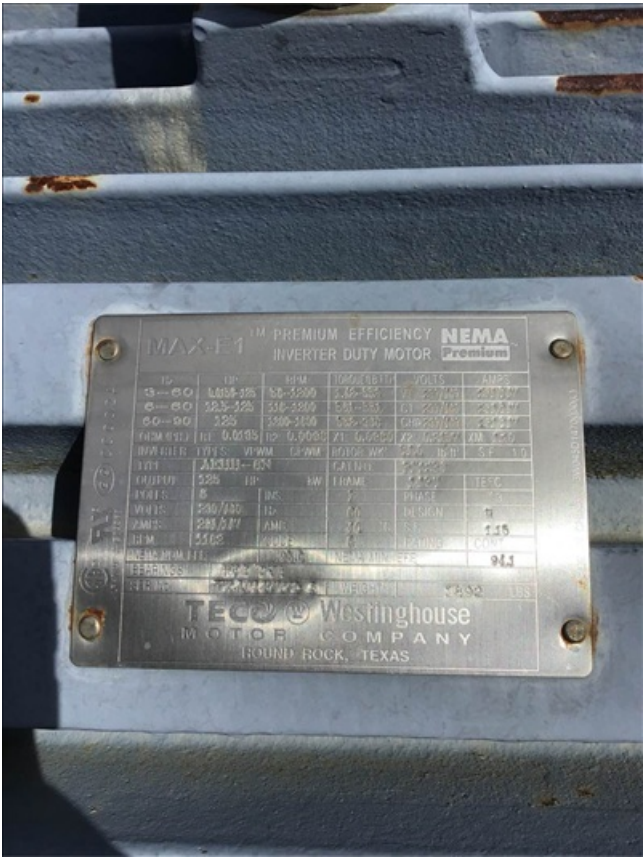
PRIME MOVER SERIAL NUMBER

TYPE (GAS/ELECTRIC)	ELECTRIC
BRAND	
MODEL	TECO
SERIAL NUMBER	UZAC147074-1
FRAME NUMBER	445T
RPM	1182
HORSEPOWER	125
SHEAVE DIAMETER (INCHES)	16
BELT CONDITION	SHOWING SIGNS OF WEAR
SHAFT CONDITION	GOOD CONDITION
SHAFT SIZE (INCHES)	3 3/8
GEAR REDUCER SHEAVE CONDITION	GOOD CONDITION
GEAR REDUCER SHEAVE DIAMETER (INCHES)	20
GAS ENGINE OIL USED (GALLONS)	
GAS ENGINE OIL REQUIRED FILTERING	
OIL SAMPLE TAKEN
